## Annual Inspection

Mid Suffolk District Council

Thurston - Thedwastre Park

Adj to New Green Centre, Station Hill, Thurston, Suffolk,  
IP31 3QU

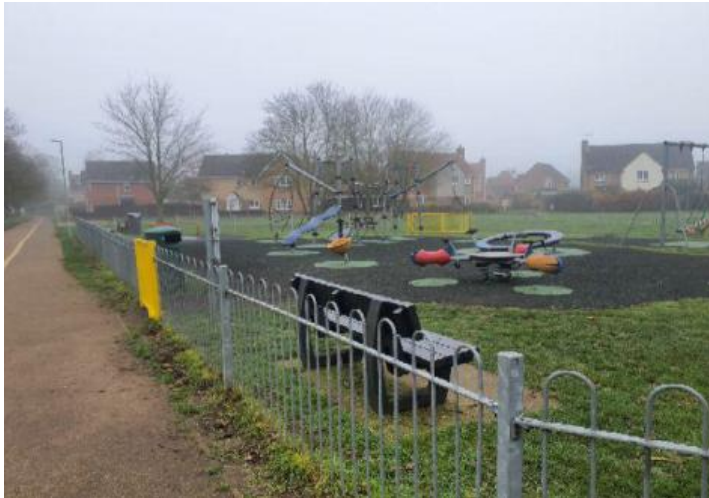
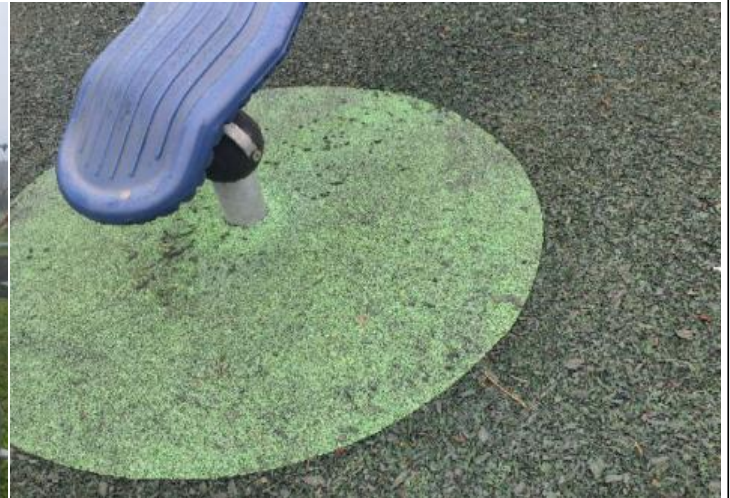
**Finding:** The wetpour is crumbling in areas

**Action:** Monitor for any further deterioration and repair as required

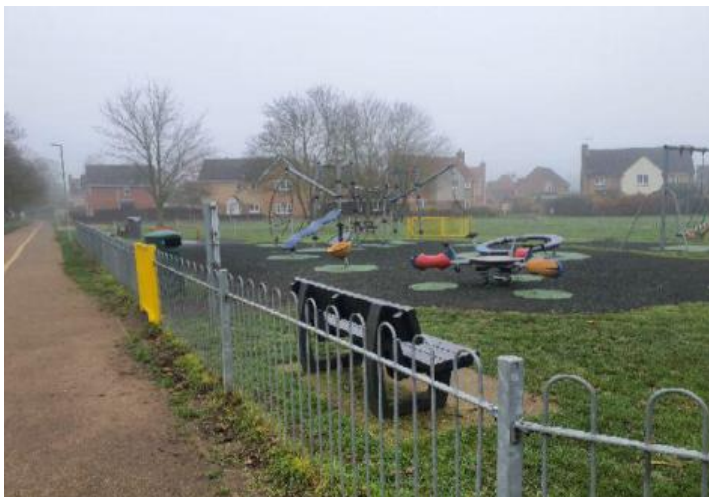
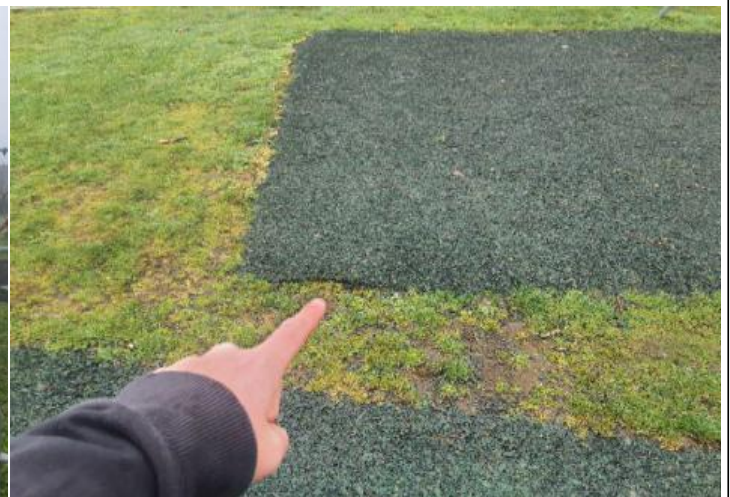
**Finding:** The surface is lifting at the edges and creating trip points

**Action:** Repair perimeter of surfacing to remove trip points

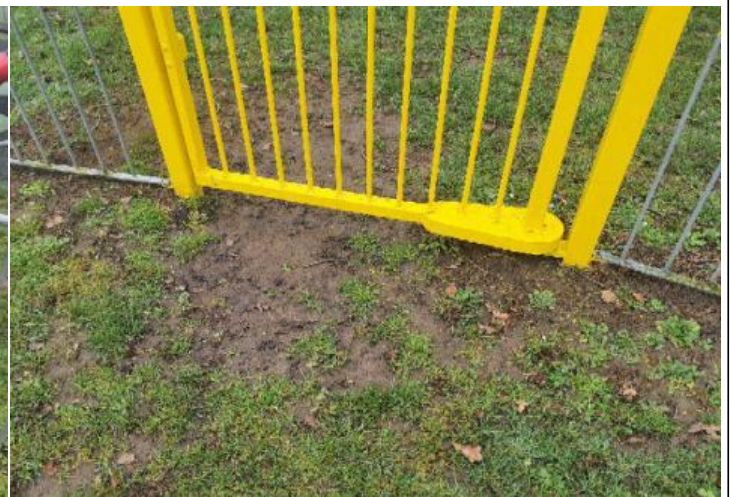
**Finding:** The surface has eroded in some areas and may be slippery in wet conditions

**Action:** Reinstate the surface

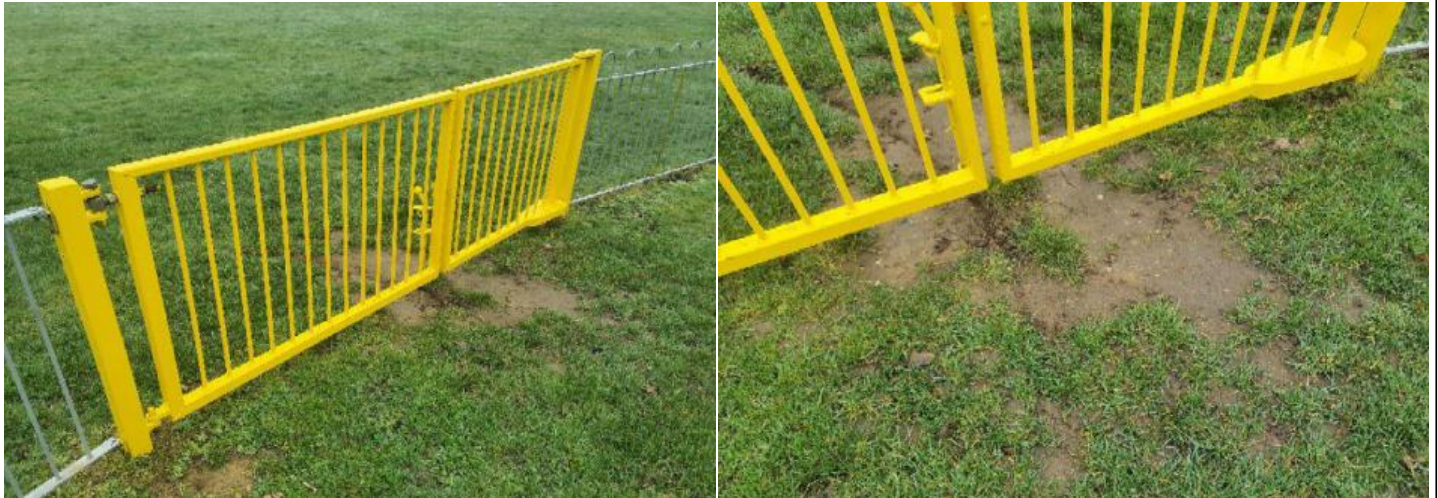
**Finding:** The surface has eroded in some areas and may be slippery in wet conditions  
**Action:** Reinstate the surface

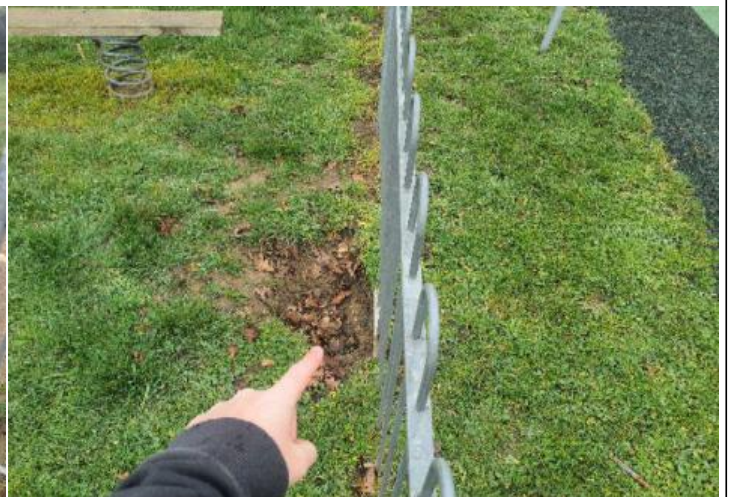
**Finding:** There are holes in the surface that may cause users to trip or roll ankles

**Action:** Infill to provide a sound reasonably level surface.

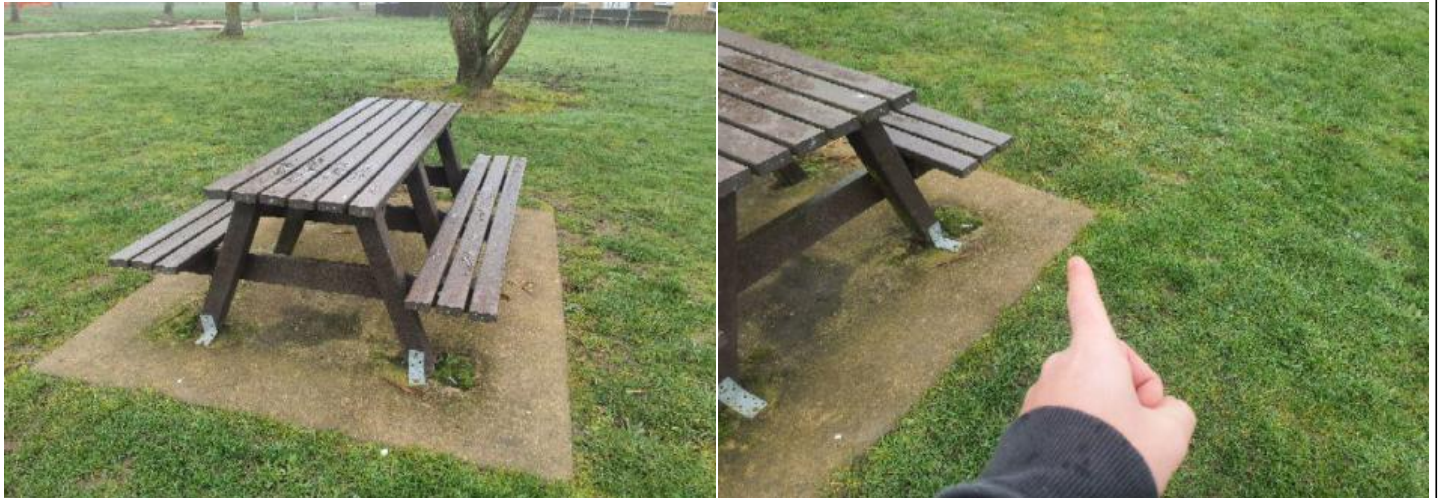
**Finding:** There are trip hazards at the edges of the surface **Action:** Remove trip hazard

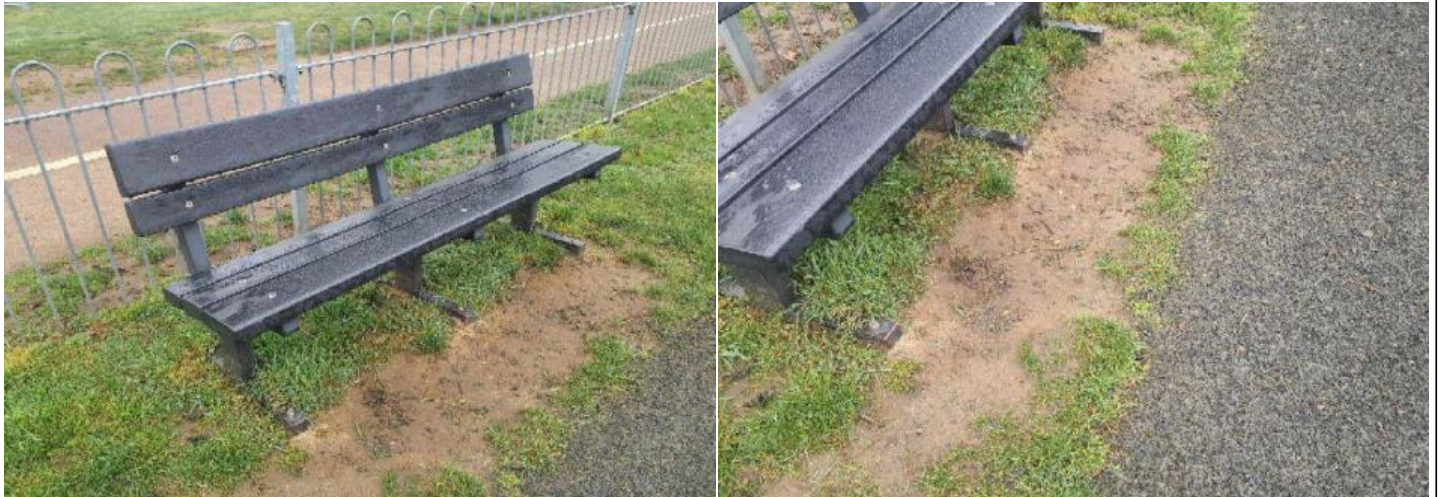
**Finding:** The surface has eroded in some areas and may be slippery in wet conditions **Action:** Reinstate the surface

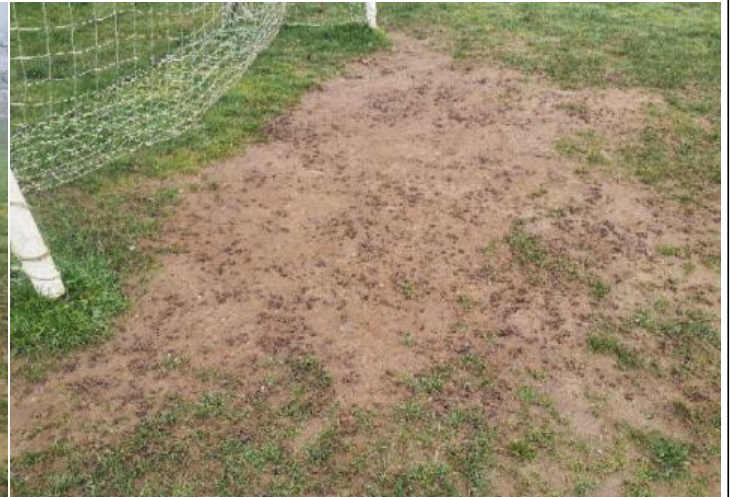
**Finding:** The surface has eroded in some areas and may be slippery in wet conditions

**Action:** Reinstate the surface

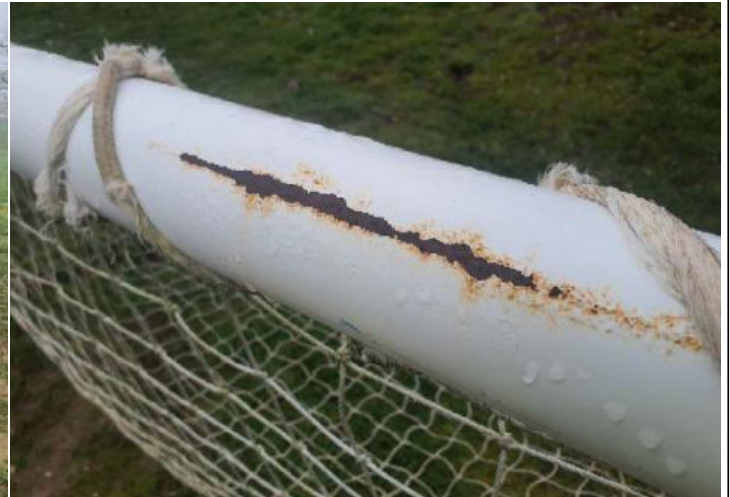
**Finding:** The paintwork on this item has been damaged or worn exposing the metal underneath which is rusting / corroding

**Action:** Treat affected areas and repaint

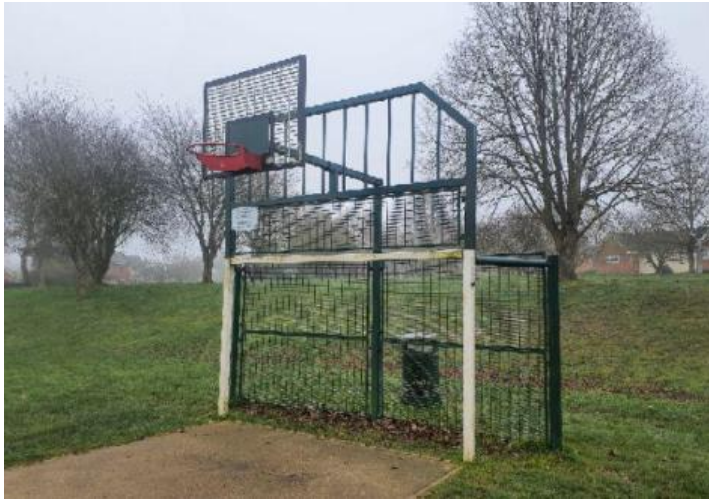
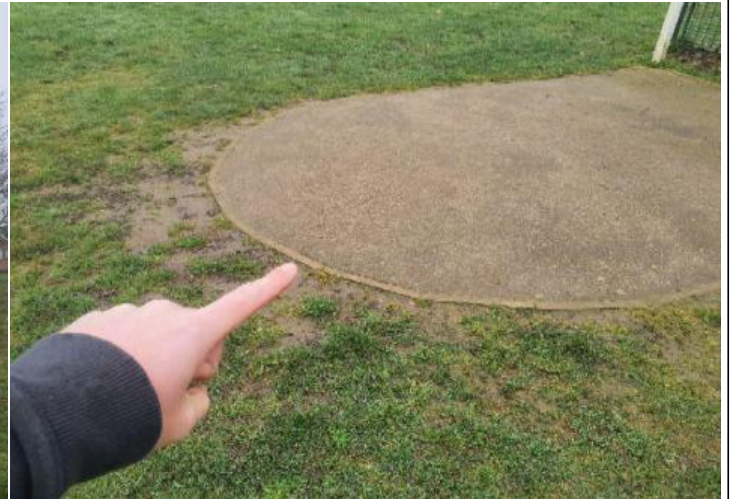
**Finding:** There are trip hazards at the edges of the surface **Action:** Remove trip hazard

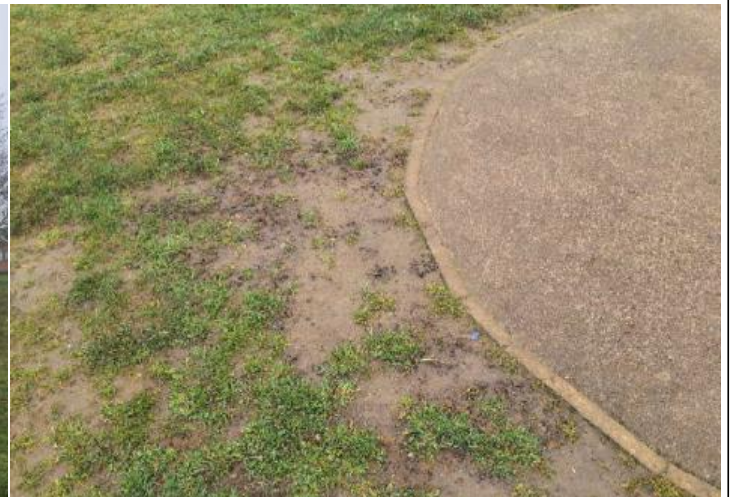
**Finding:** The surface has eroded in some areas and may be slippery in wet conditions **Action:** Reinstate the surface

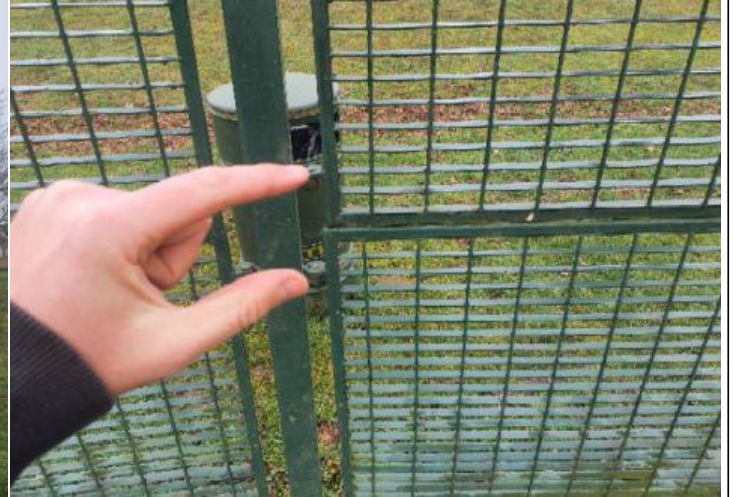
**Finding:** A number of fixing(s) have worked loose

**Action:** Secure all loose fixings

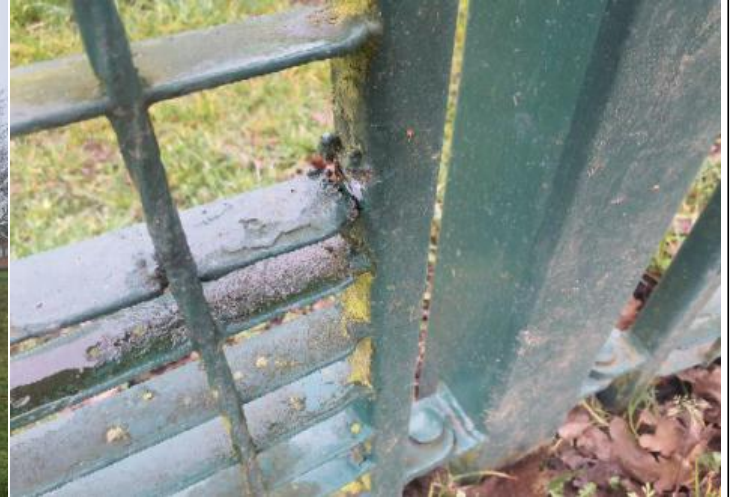
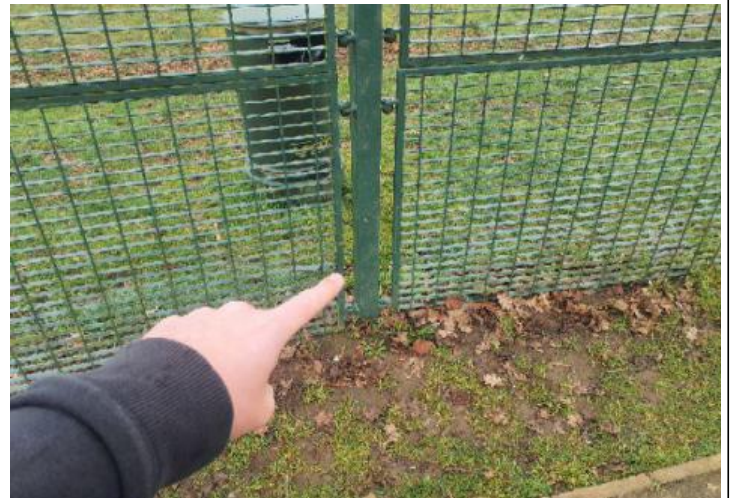
**Finding:** The weld(s) on this item have failed

**Action:** Repair item

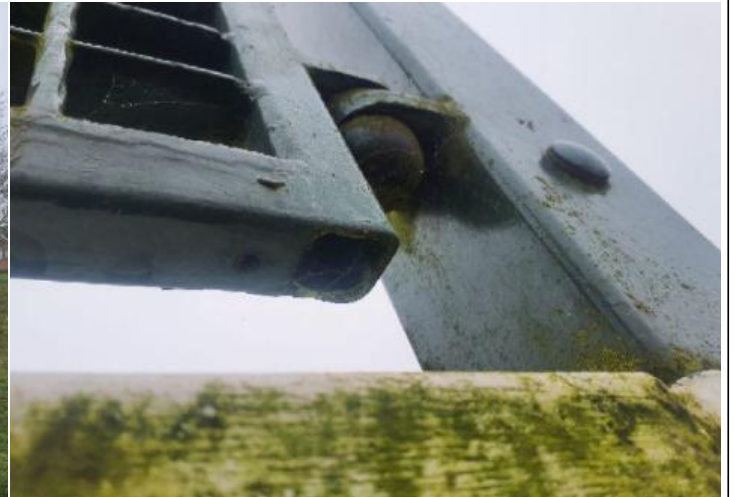
**Finding:** Insert/s missing or damaged

**Action:** Replace

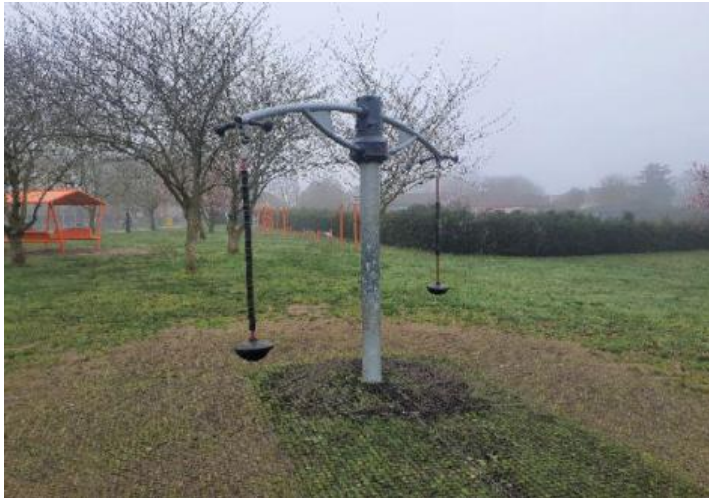
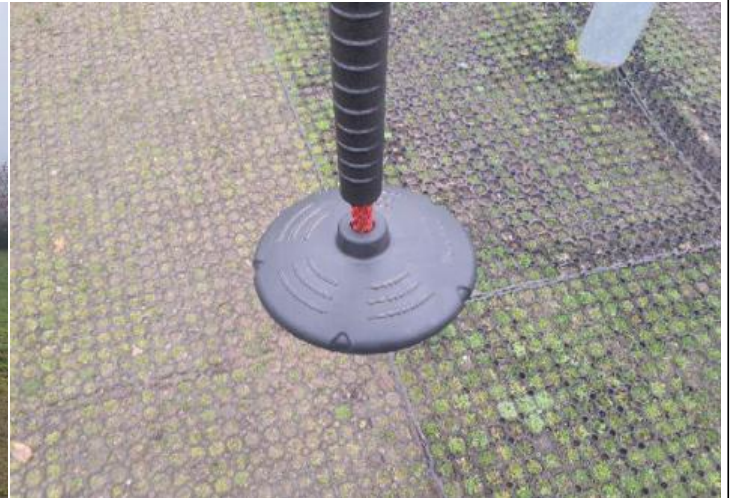
**Finding:** The seat connection cannot be inspected without dismantling the seat

**Action:** Dismantle the seat to inspect the seat connection for wear

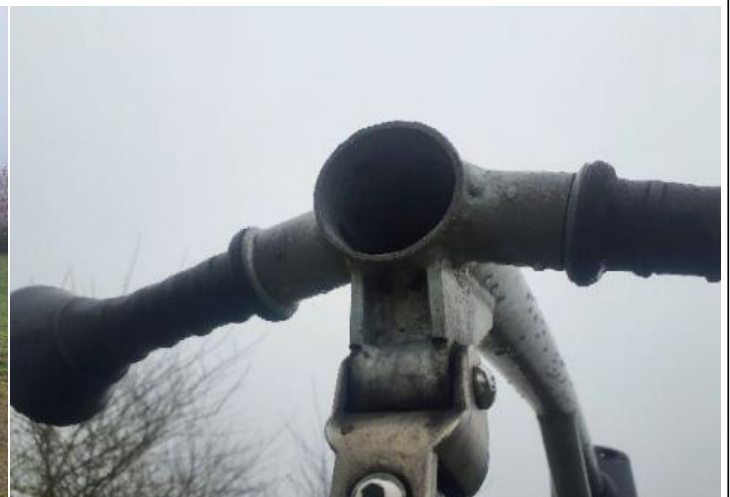
**Finding:** There is / are post or end caps missing / damaged on the item

**Action:** Replace missing / damaged post or end caps

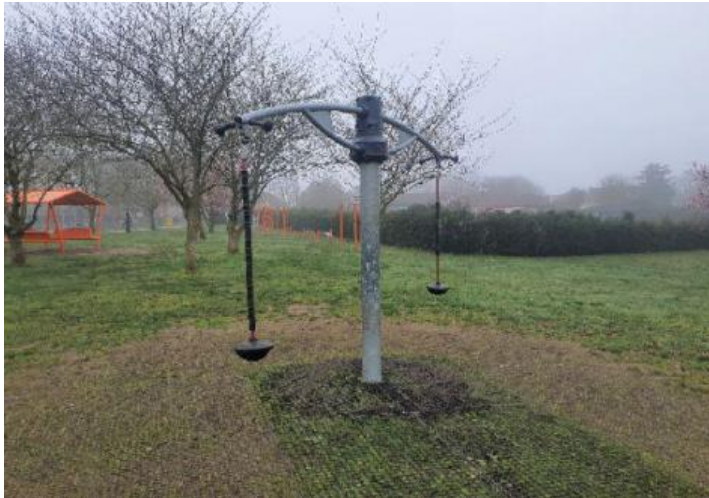
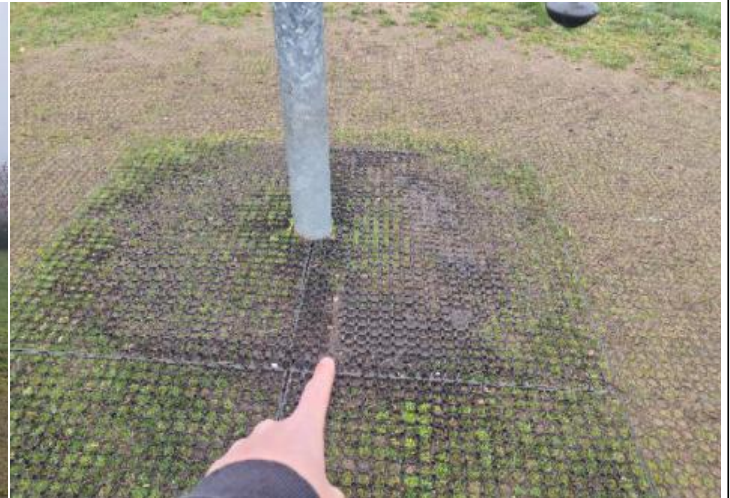
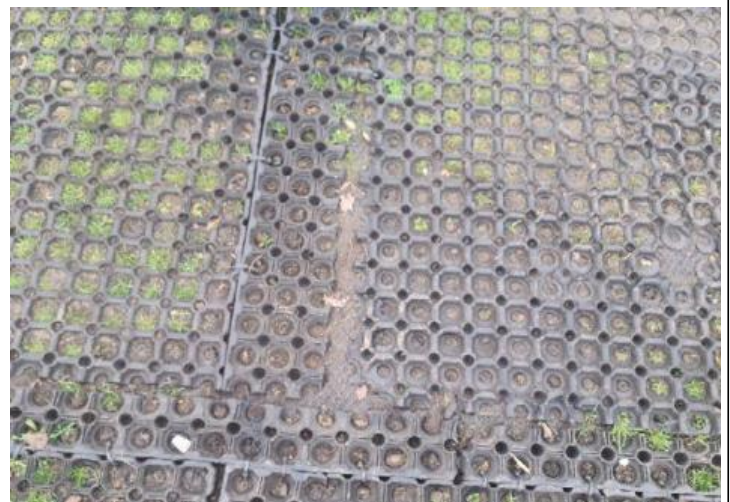
**Finding:** There is moderate damage to the surface

**Action:** Repair the damaged areas of surfacing

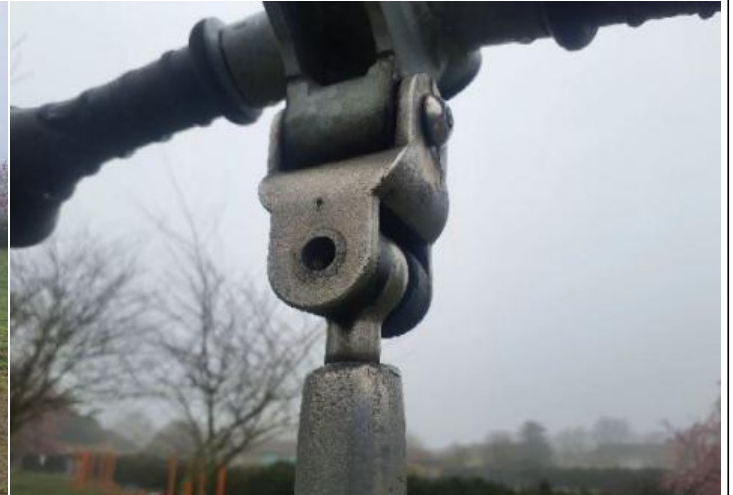
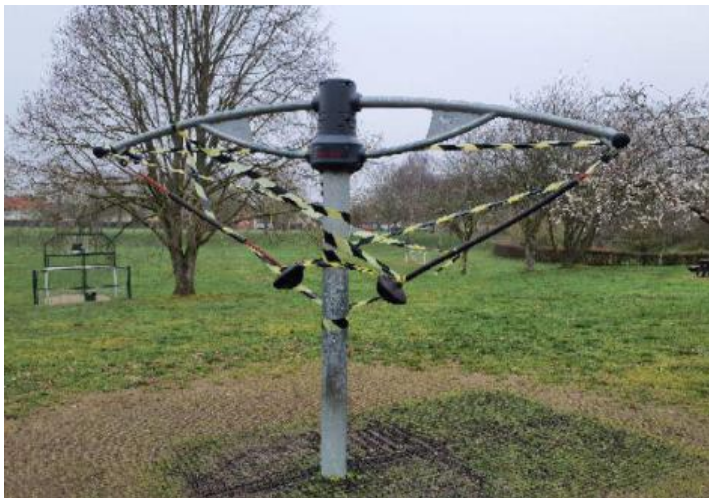
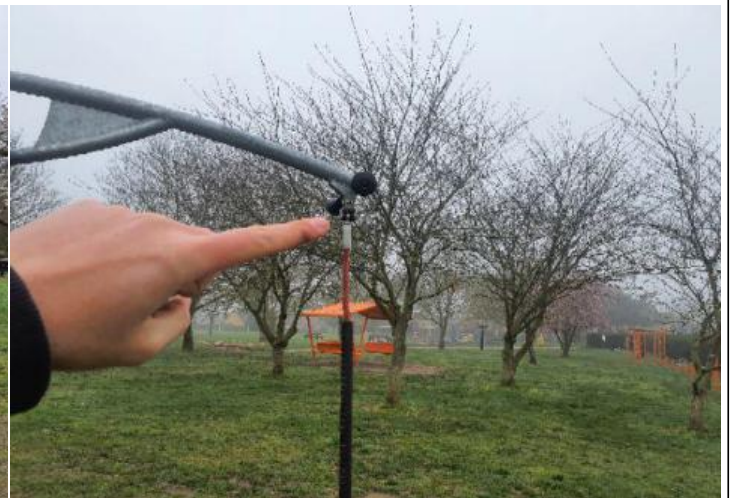
**Finding:** There is or are fixings missing from one of the suspensions (The inspector taped the item at the time of inspection as a temporary measure but further action is required asap)

**Action:** Replace all missing fixings

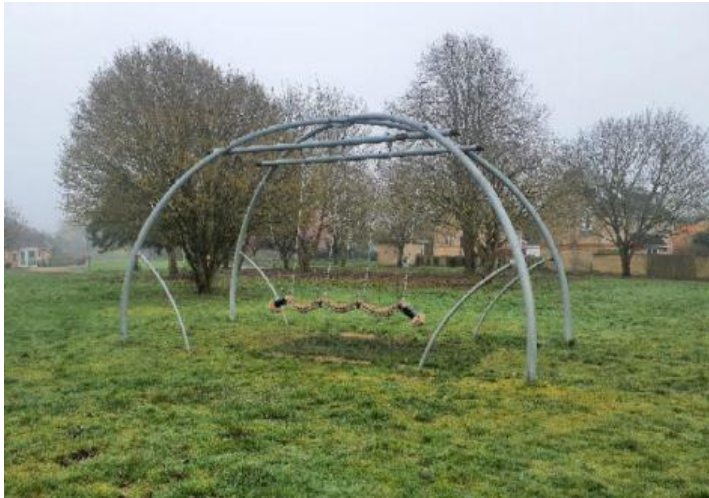
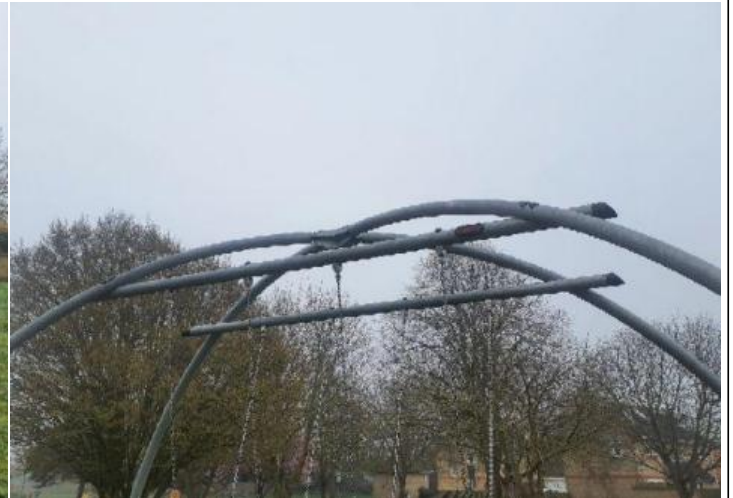
**Finding:** NOTE - The fixings or components for this item were in excess of 2.5m above the standing surface and could not be fully accessed by the inspector. We have completed a visual inspection of the fixings from ground level but a maintenance inspection should be undertaken to assess the condition, security and wear of the components at intervals in accordance with the manufacturers recommendations.

**Action:** Inspect in accordance with the manufacturers recommendations

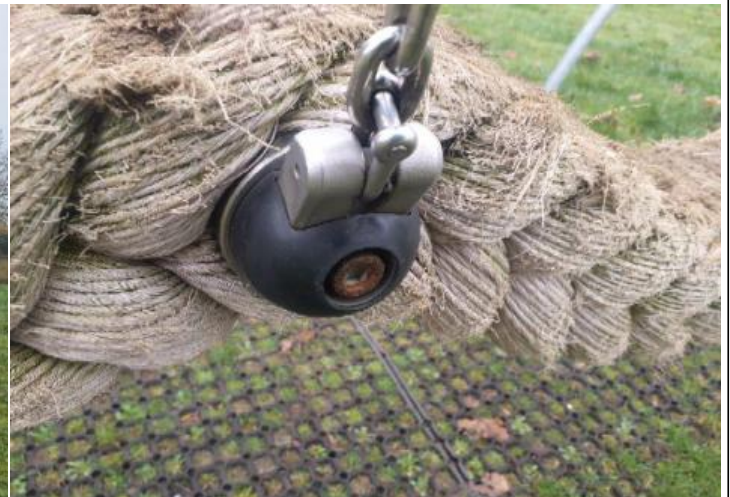
**Finding:** Bolt cap cover/s missing or damaged  
**Action:** Replace

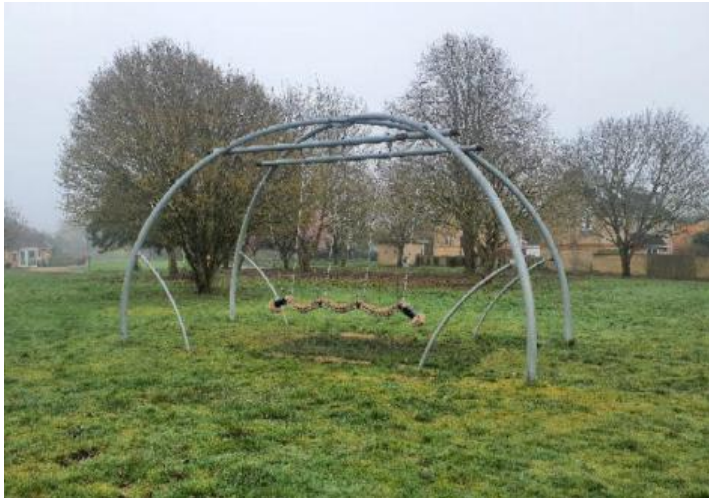
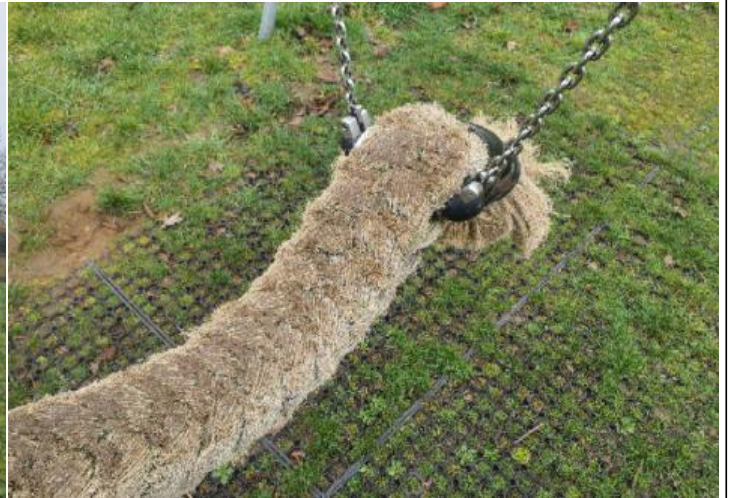
**Finding:** The seat has minor damage or wear

**Action:** Monitor for any further deterioration and replace as required

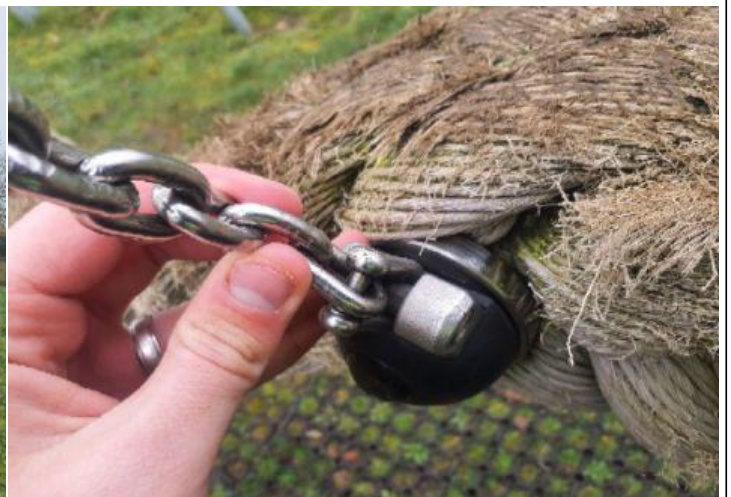
**Finding:** There is some notable evidence of chain wear

**Action:** Monitor for any further deterioration and replace when 40% worn

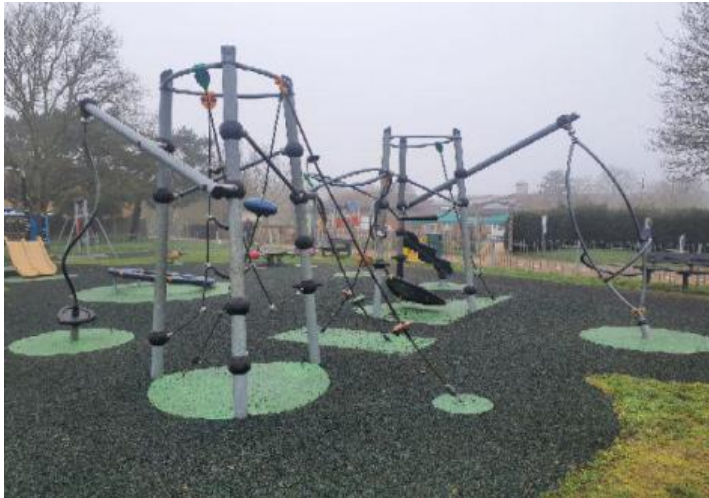
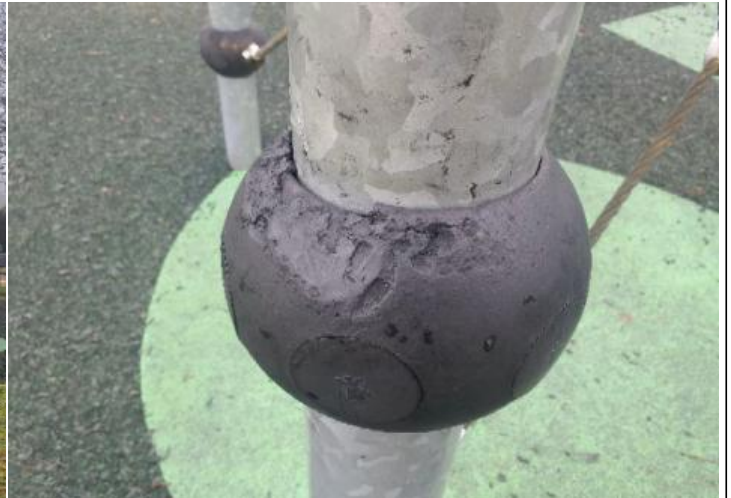
**Finding:** The rubber coating is deteriorating

**Action:** Monitor for any further deterioration and replace as required

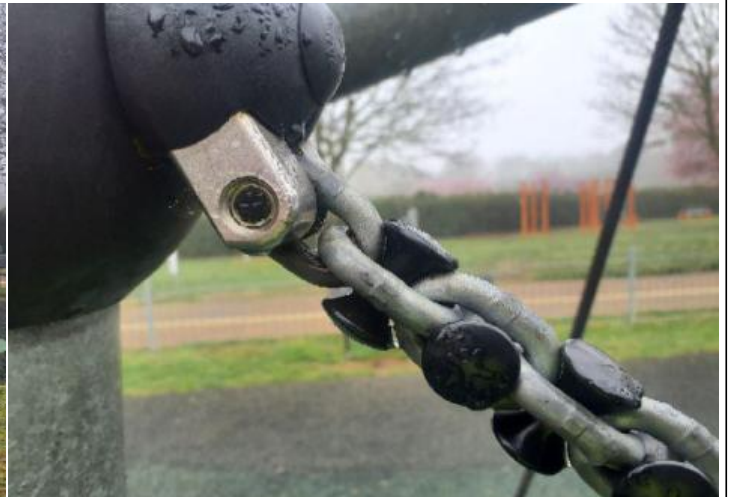
**Finding:** There is some notable evidence of chain wear

**Action:** Monitor for any further deterioration and replace when 40% worn

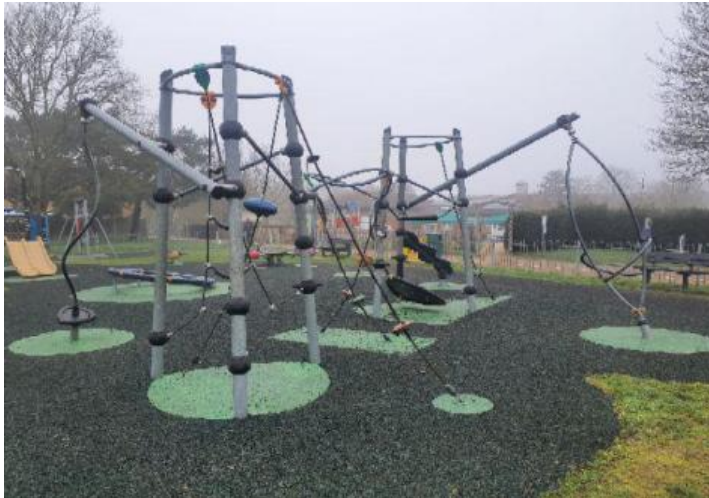
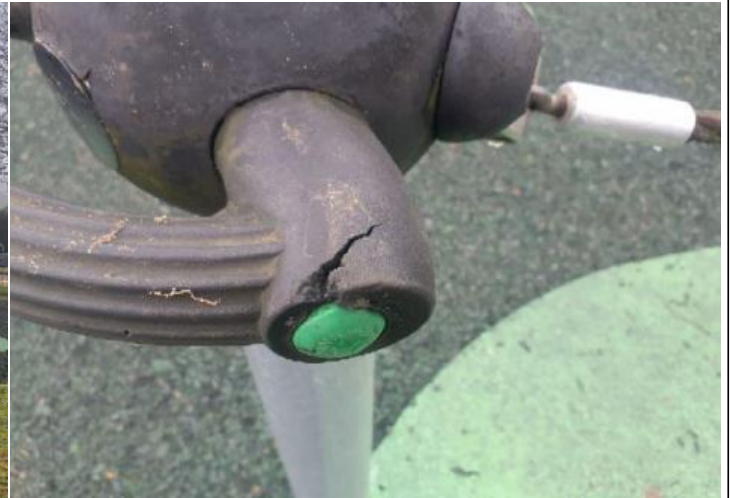
**Finding:** The item has been damaged

**Action:** Monitor for any further deterioration and replace as required

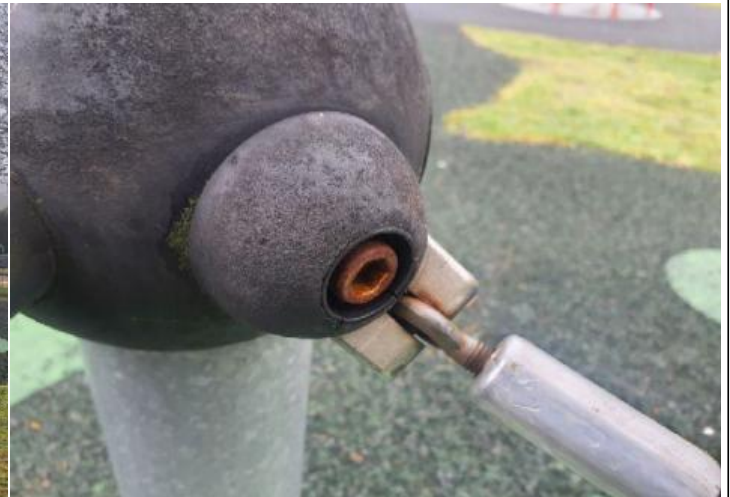
**Finding:** Bolt cap cover/s missing or damaged

**Action:** Replace

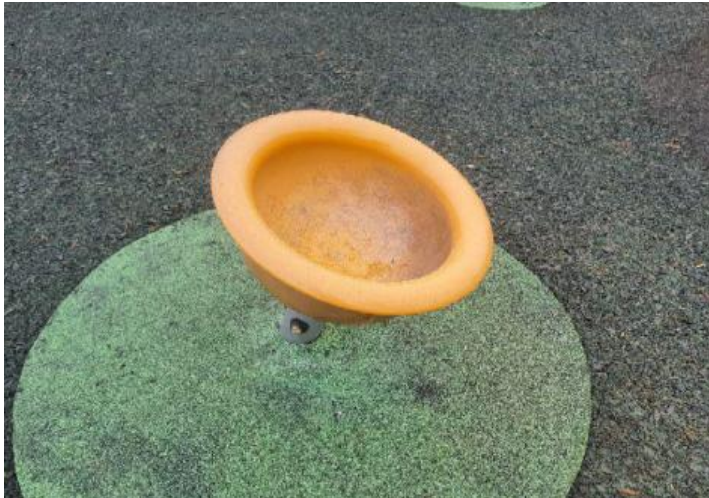
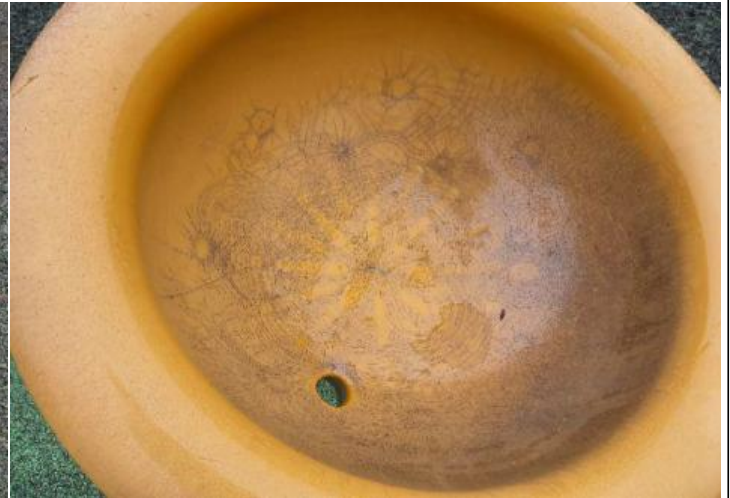
**Finding:** The item has been damaged

**Action:** Monitor for any further deterioration and replace as required

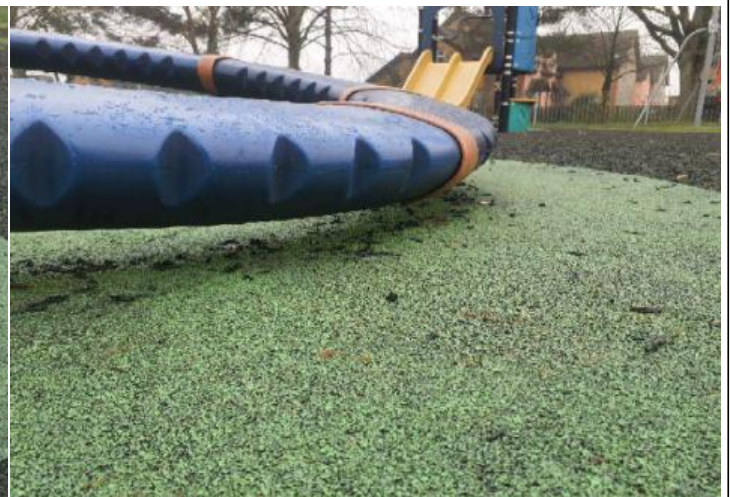
**Finding:** The clearance to the underside less than 117mm and does not meet the manufacturers recommendations

**Action:** Monitor - No action given the risk assessment

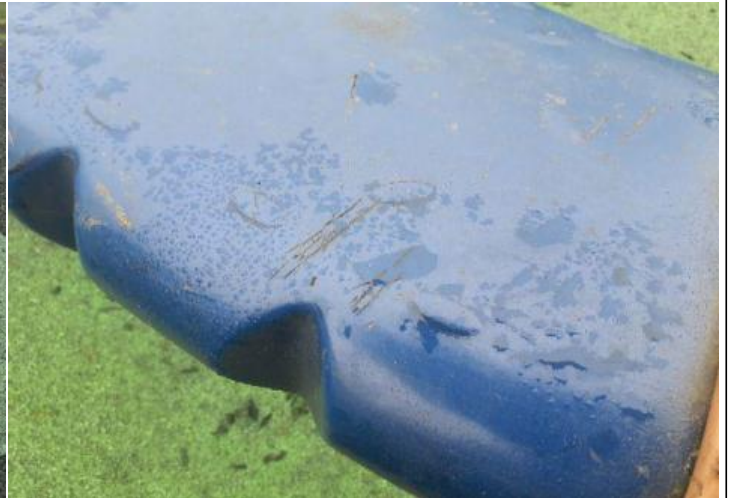
**Finding:** The item has been damaged

**Action:** Monitor for any further deterioration and replace as required

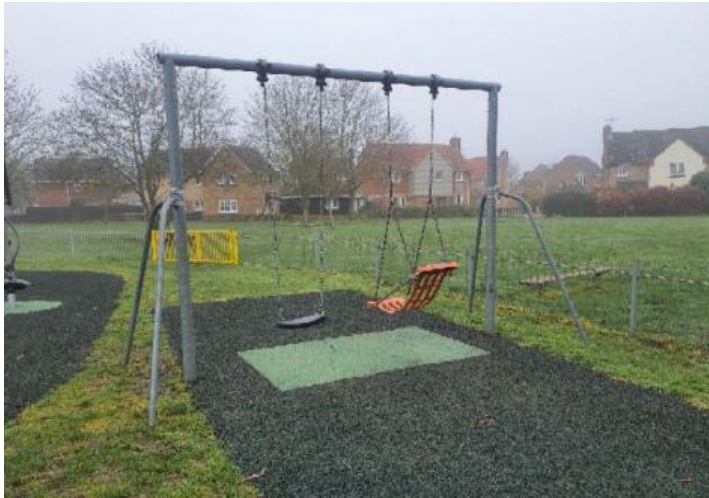
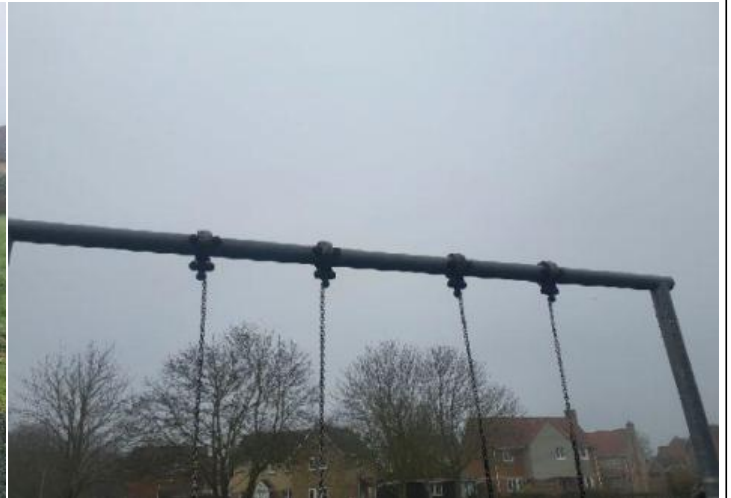
**Finding:** NOTE - The fixings or components for this item were in excess of 2.5m above the standing surface and could not be fully accessed by the inspector. We have completed a visual inspection of the fixings from ground level but a maintenance inspection should be undertaken to assess the condition, security and wear of the components at intervals in accordance with the manufacturers recommendations.

**Action:** Inspect in accordance with the manufacturers recommendations

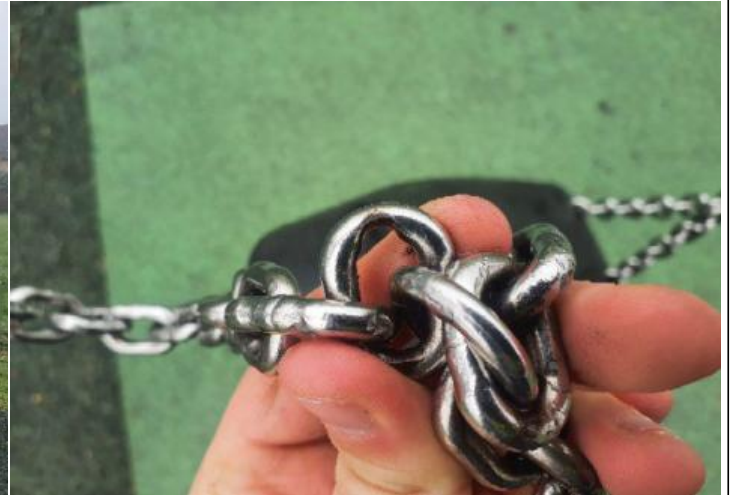
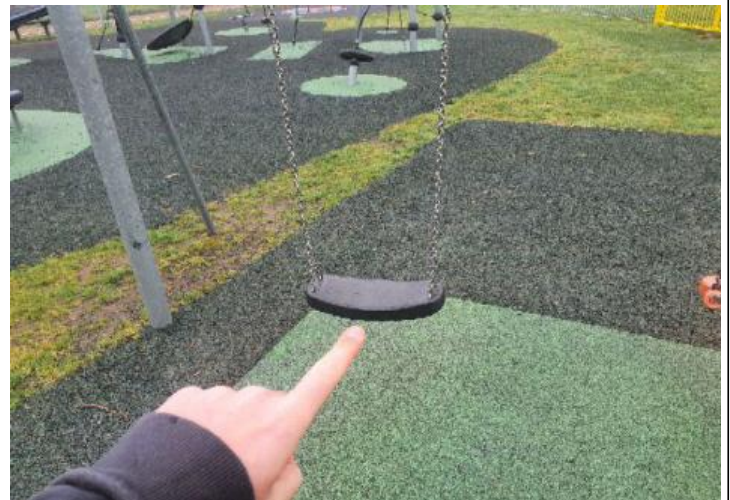
**Finding:** The chain links are worn excessively and require renewing

**Action:** Replace worn chains

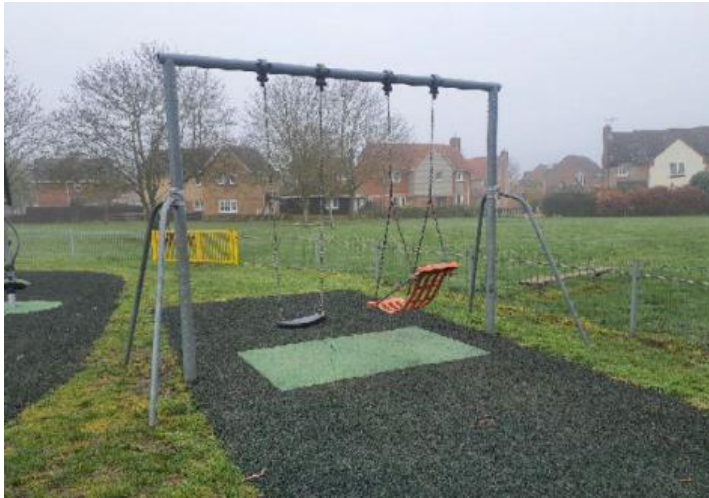
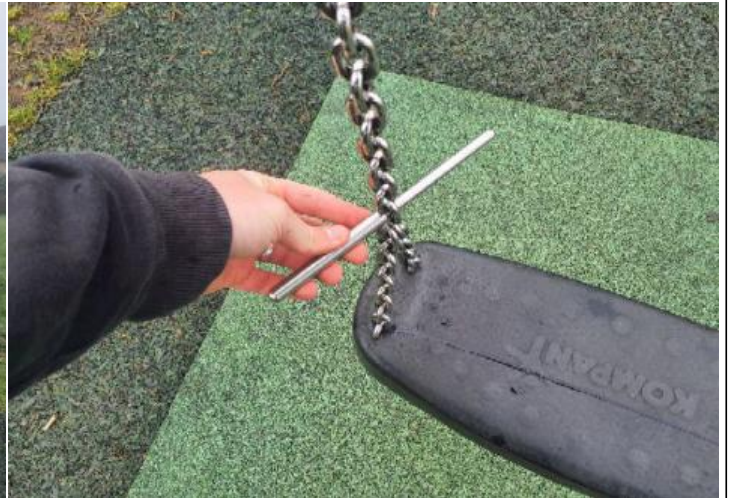
**Finding:** The connecting links are in excess of 8.6mm and less than 12mm and fail the requirements of BS EN 1176 Part 1; clause 4.2.13, Chains

**Action:** Monitor use and replace with compliant links at the next maintenance cycle

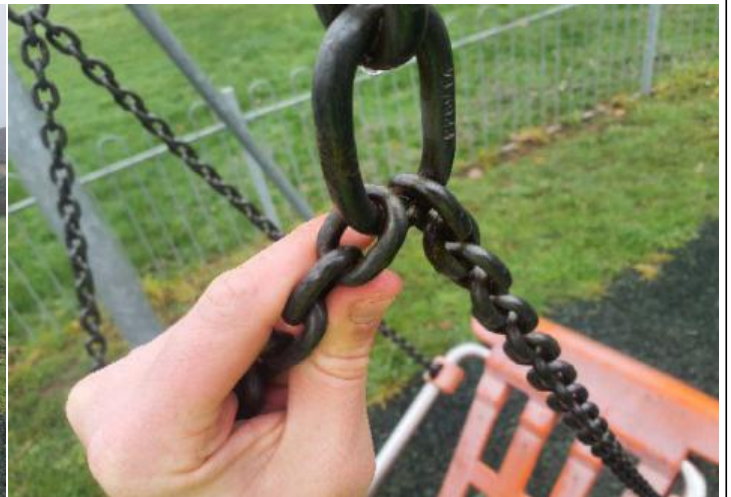
**Finding:** There is some notable evidence of chain wear

**Action:** Monitor for any further deterioration and replace when 40% worn

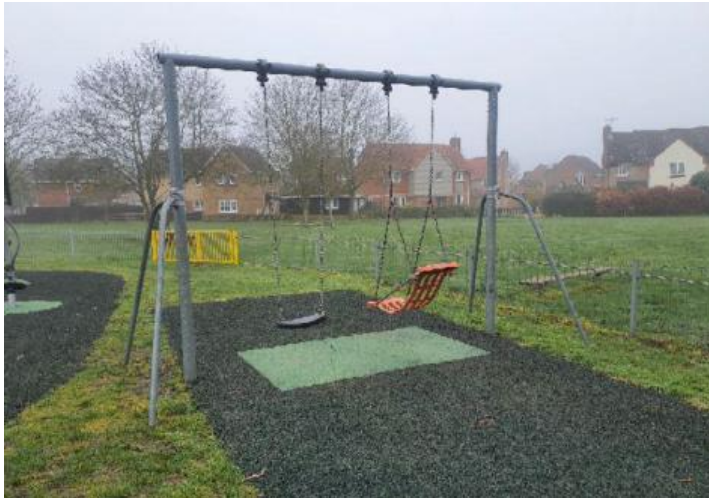
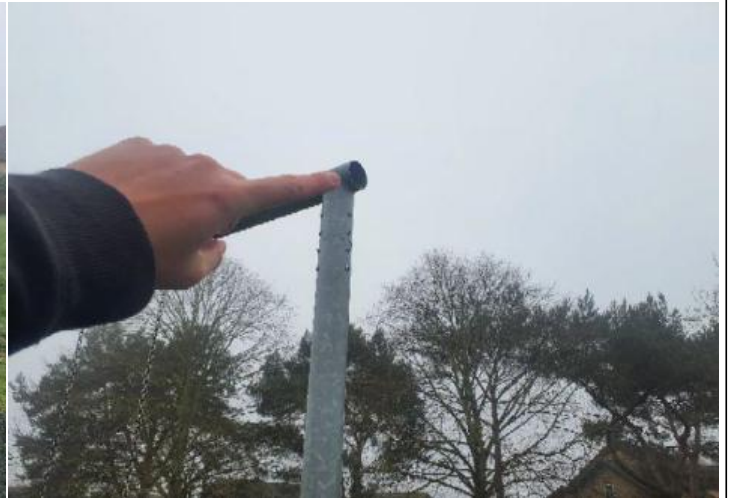
**Finding:** There is / are post or end caps missing / damaged on the item  
**Action:** Replace missing / damaged post or end caps

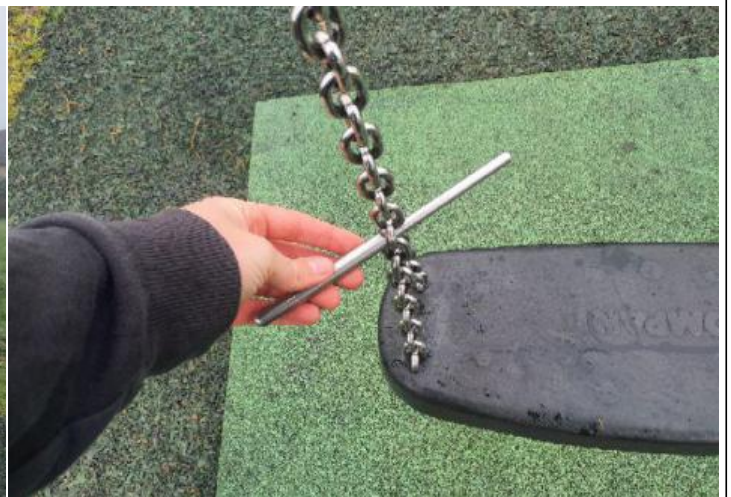
**Finding:** The connecting links are in excess of 8.6mm and less than 12mm and fail the requirements of BS EN 1176 Part 1; clause 4.2.13, Chains  
**Action:** Monitor use and replace with compliant links at the next maintenance cycle

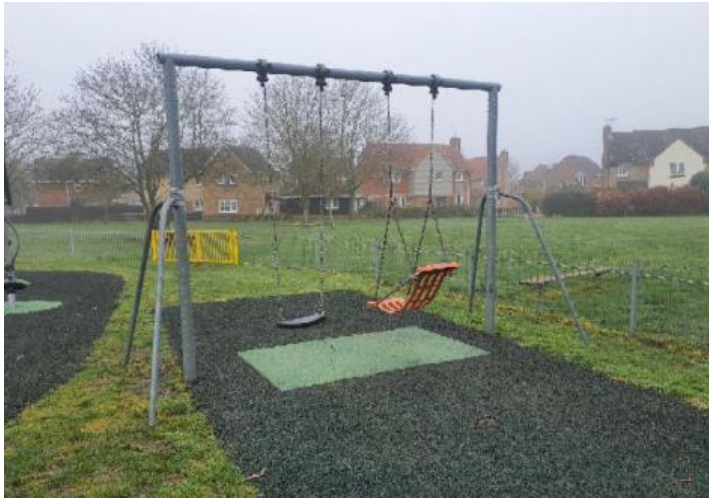
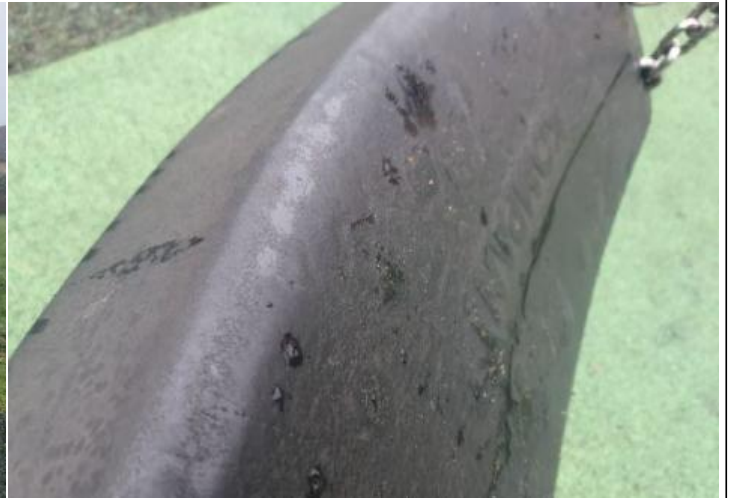
**Finding:** The seat has minor damage or wear

**Action:** Monitor for any further deterioration and replace as required

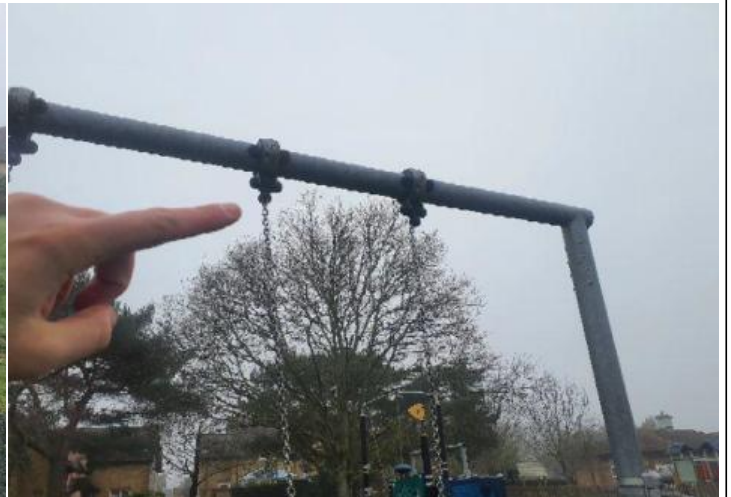
**Finding:** The suspension lugs are showing signs of wear

**Action:** Monitor for any further deterioration and repair as required
