## Annual Inspection

Mid Suffolk District Council

Thurston - Thedwastre Park

Adj to New Green Centre, Station Hill, Thurston, Suffolk,  
IP31 3QU

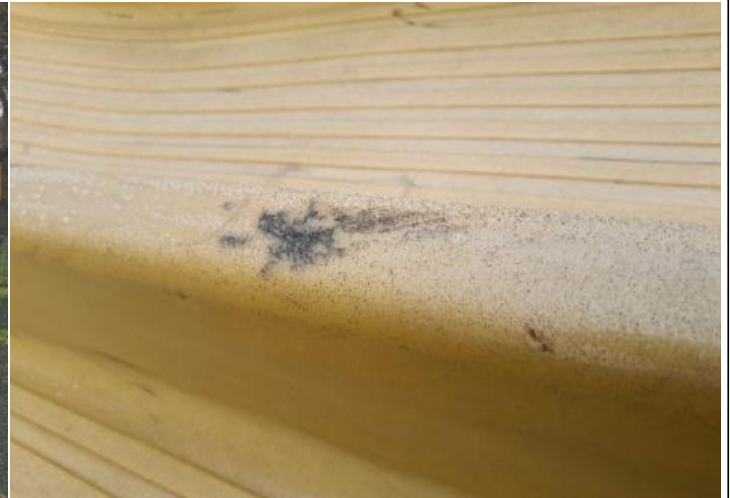
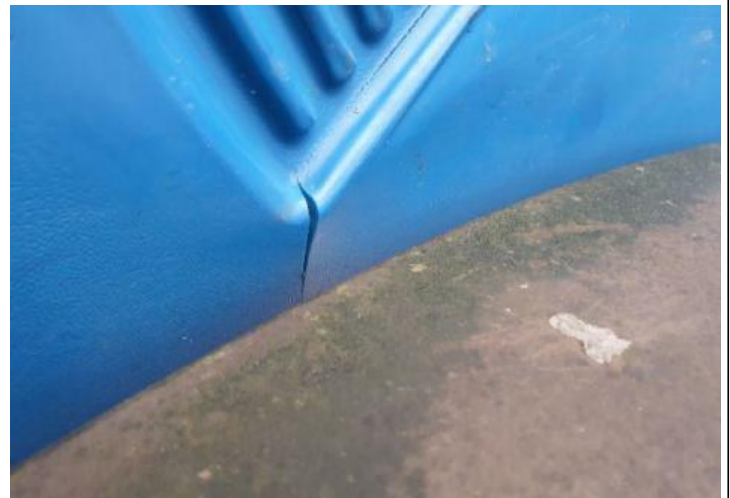
**Finding:** The item has been damaged

**Action:** Monitor for any further deterioration and replace as required

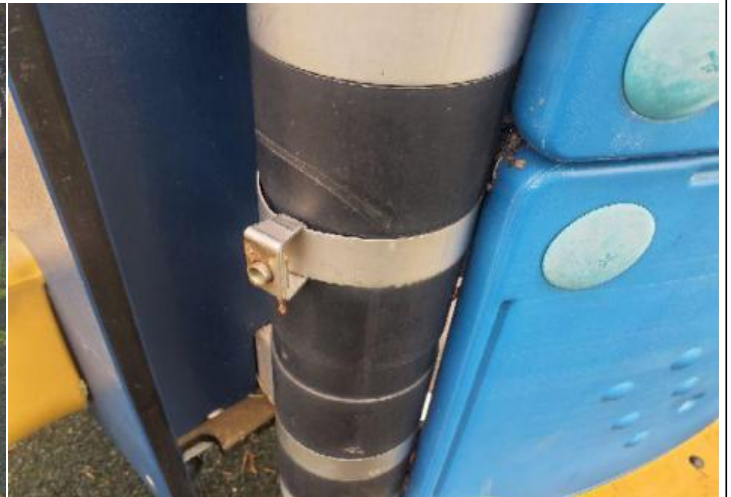
**Finding:** The item has missing component(s)

**Action:** Replace missing components

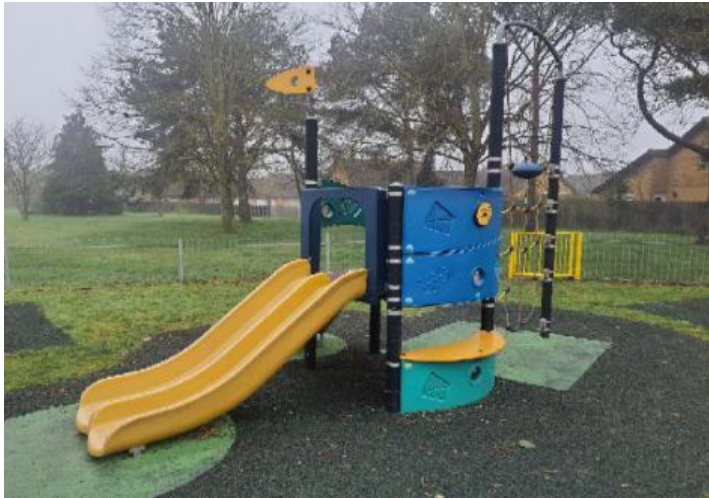
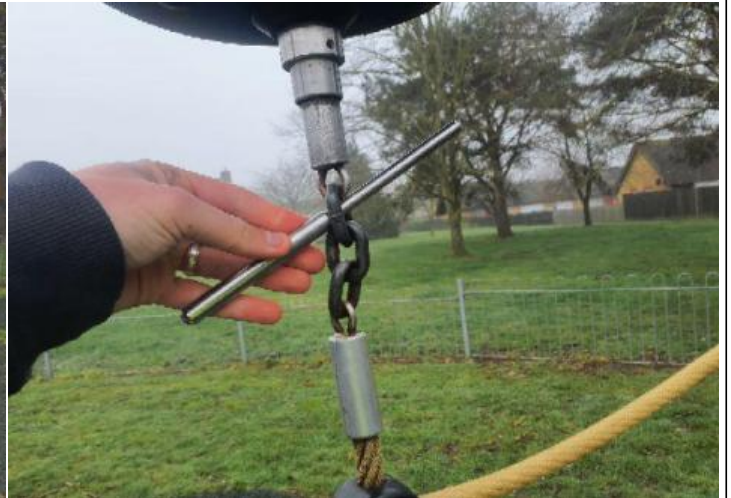
**Finding:** The chain openings are in excess of 8.6mm and do not meet the recommendations of BS EN 1176 Part 1

**Action:** Monitor - No action given the risk assessment

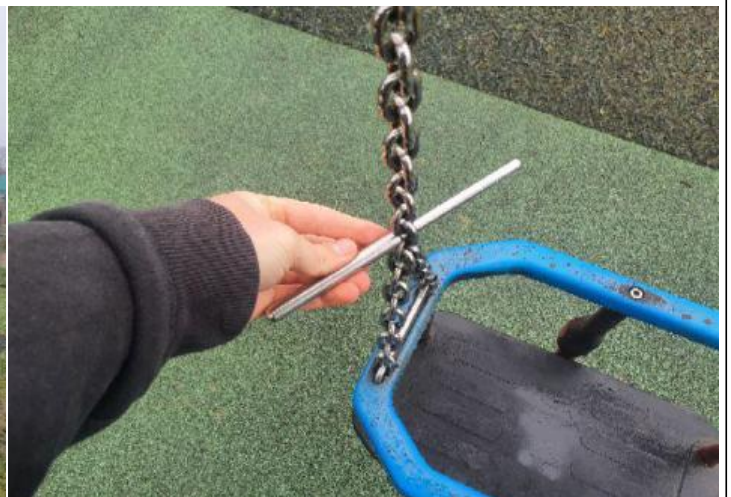
**Finding:** The chain openings are in excess of 8.6mm and do not meet the recommendations of BS EN 1176 Part 1

**Action:** Monitor - No action given the risk assessment

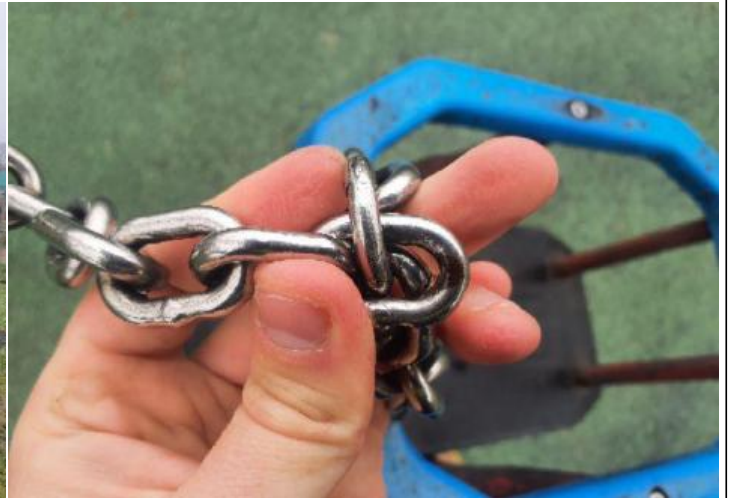
**Finding:** There is some notable evidence of chain wear

**Action:** Monitor for any further deterioration and replace when 40% worn

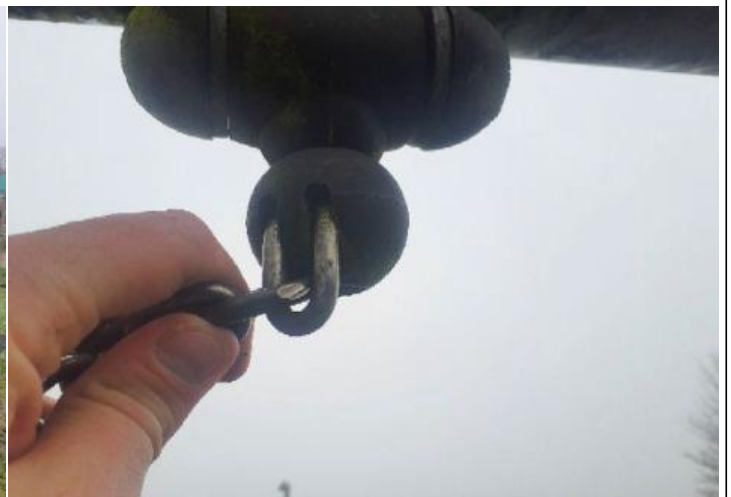
**Finding:** The suspension lugs are showing signs of wear

**Action:** Monitor for any further deterioration and repair as required

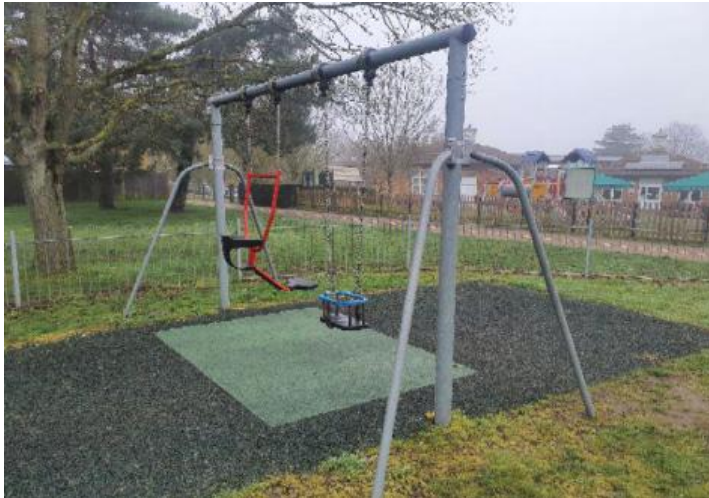
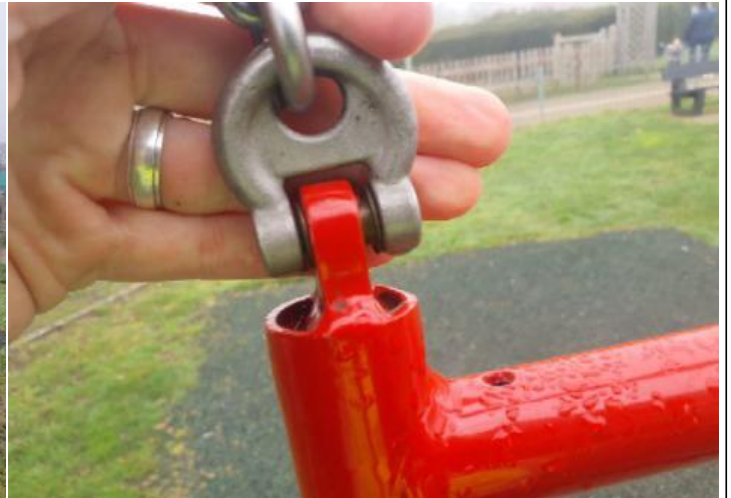
**Finding:** The bushes are showing signs of wear

**Action:** Monitor for any further deterioration and replace as required

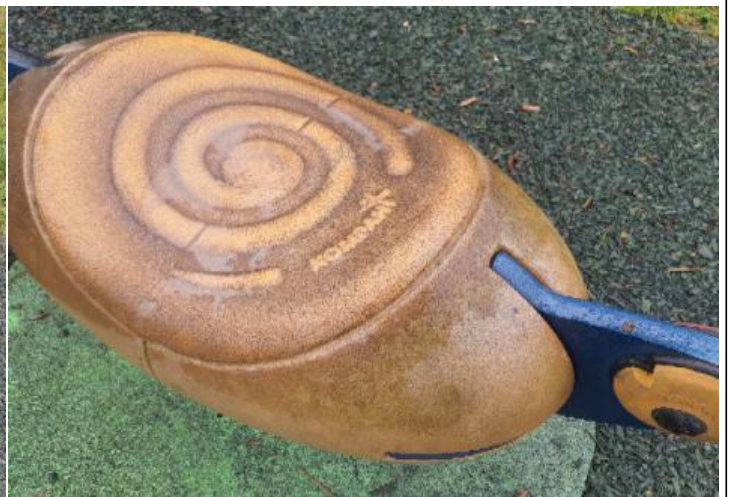
**Finding:** The seat has minor damage or wear

**Action:** Monitor for any further deterioration and replace as required

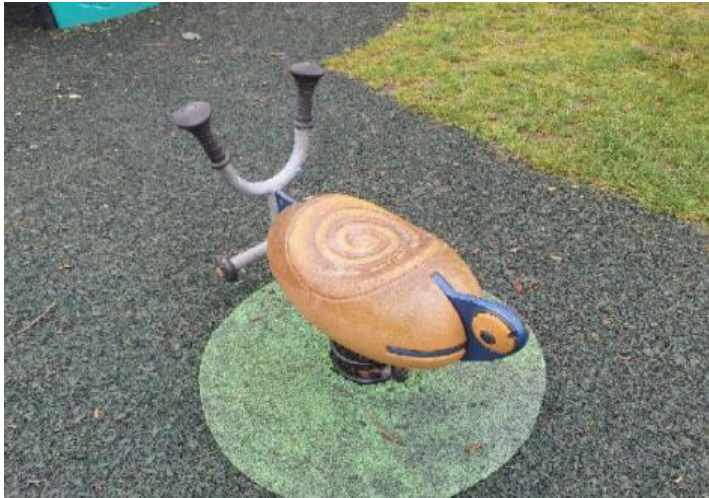
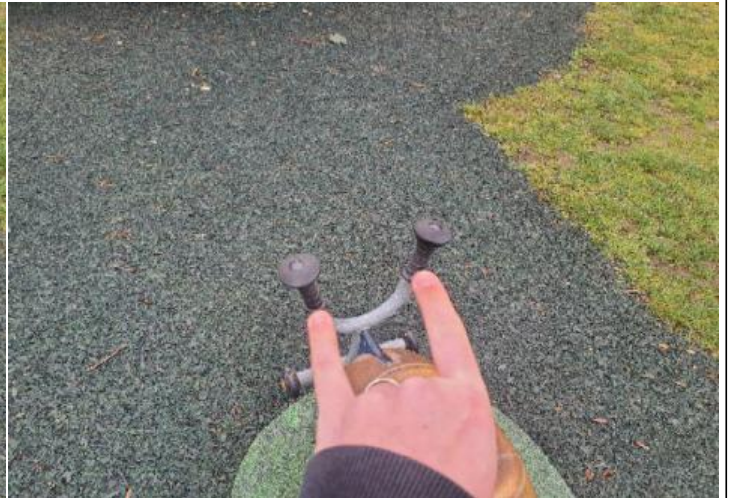
**Finding:** A number of fixing(s) have worked loose

**Action:** Secure all loose fixings

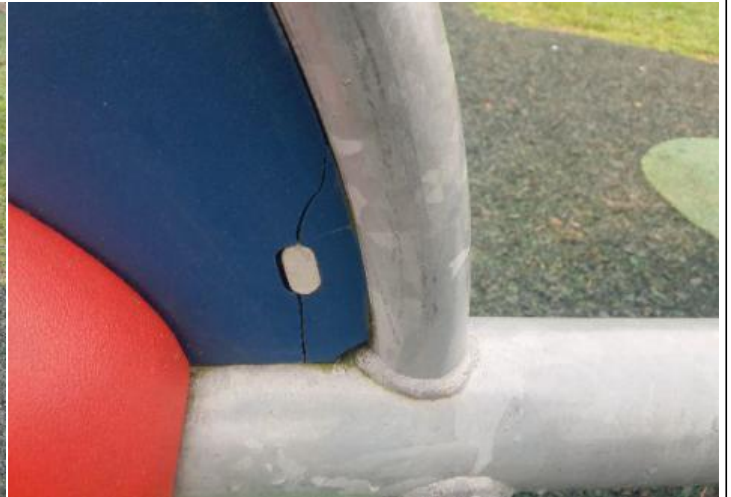
**Finding:** The item has been damaged

**Action:** Monitor for any further deterioration and replace as required
