the **play inspection** company

Annual Inspection

Mid Suffolk District Council

Thurston Playing Field

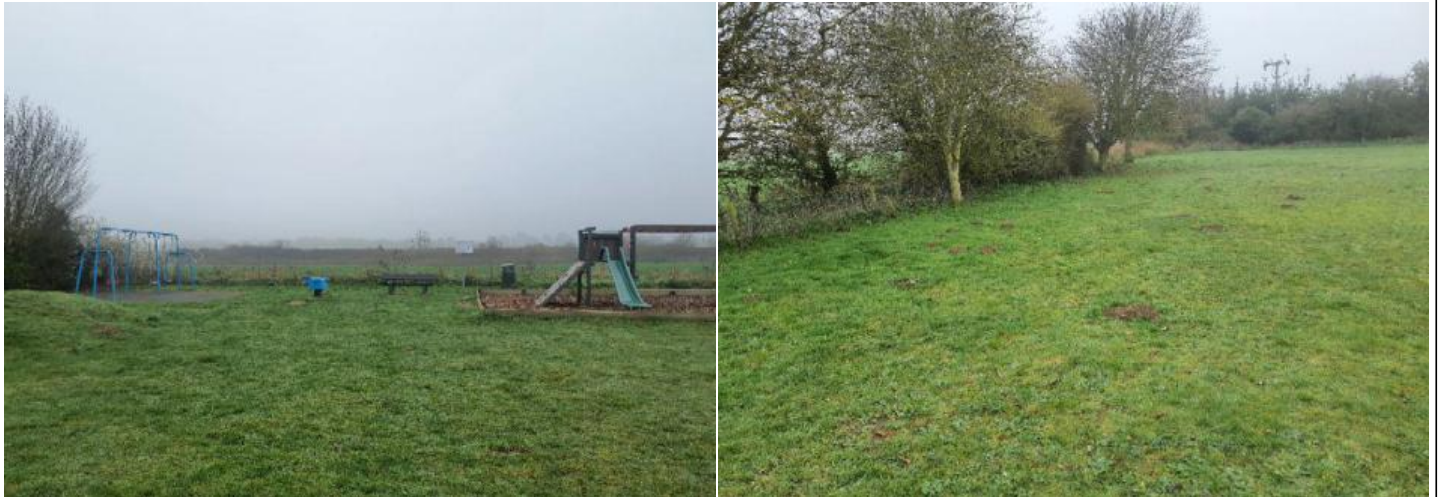
Item: Ancillary Items - Site General
Manufacturer: Owner/Operator

Finding: There are a number of molehills within the area and these may present unforeseen hazards for users

Action: Remove moles by appropriate means, reinstate surfaces to level and maintain the area

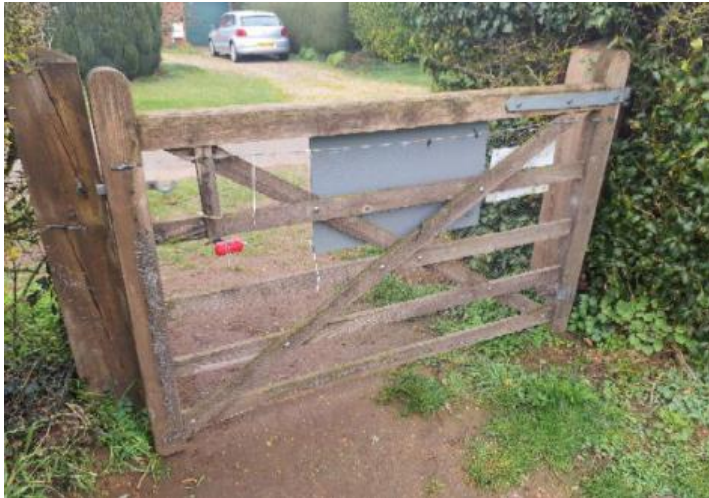
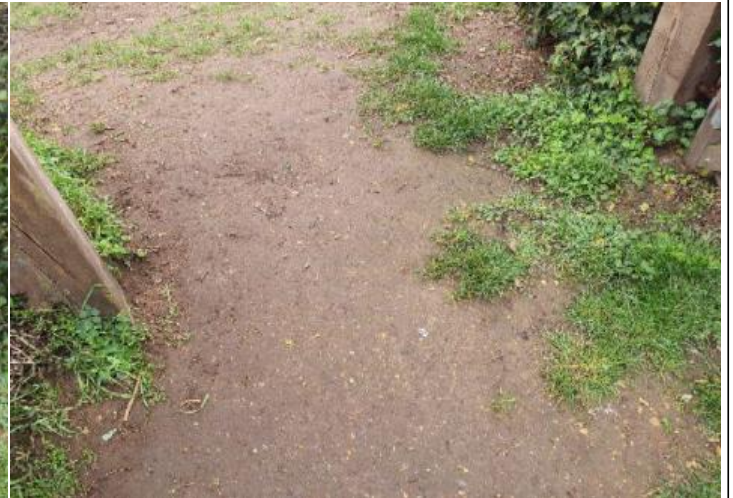
Item: Gates - Gate
Manufacturer: Not Identified

Finding: The surface has eroded in some areas and may be slippery in wet conditions
Action: Reinstate the surface

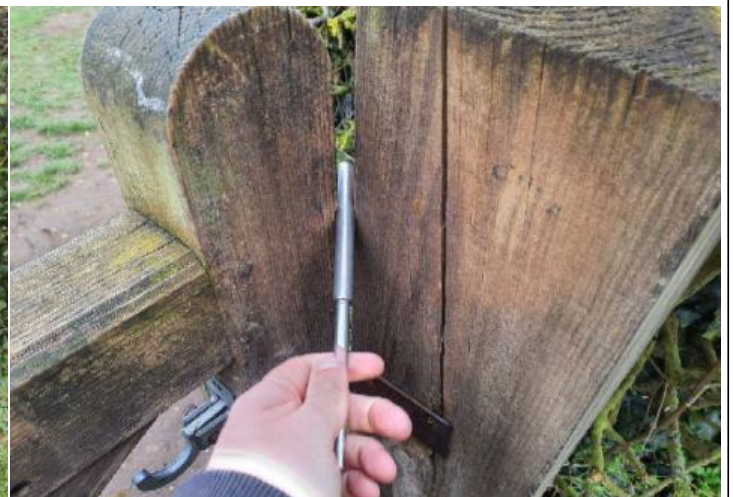
Item: Gates - Gate
Manufacturer: Not Identified

Finding: There are openings that are less than 12mm that could trap or crush fingers
Action: Provide a 12mm gap throughout full range of motion at both sides of gate

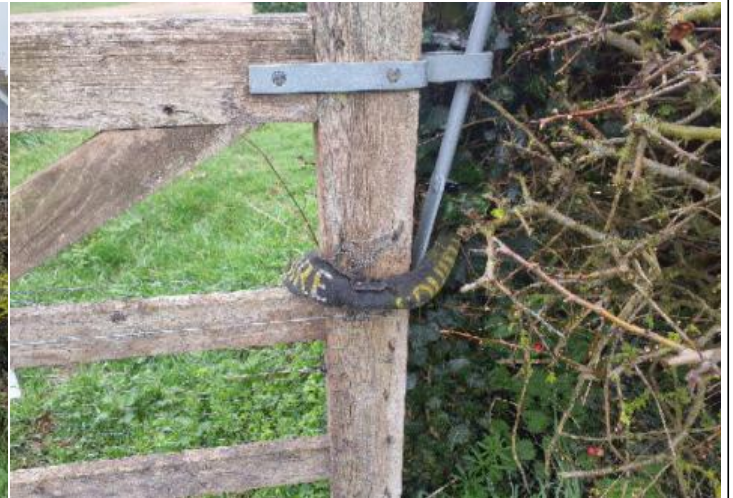
Item: Gates - Gate - Maintenance
Manufacturer: Not Identified

Finding: The maintenance gate was correctly padlocked at the time of inspection, however this means that the inspector was unable to fully assess the gate

Action: Ensure that there are 12mm gaps throughout the full range of motion on gate/s and between leaves where relevant

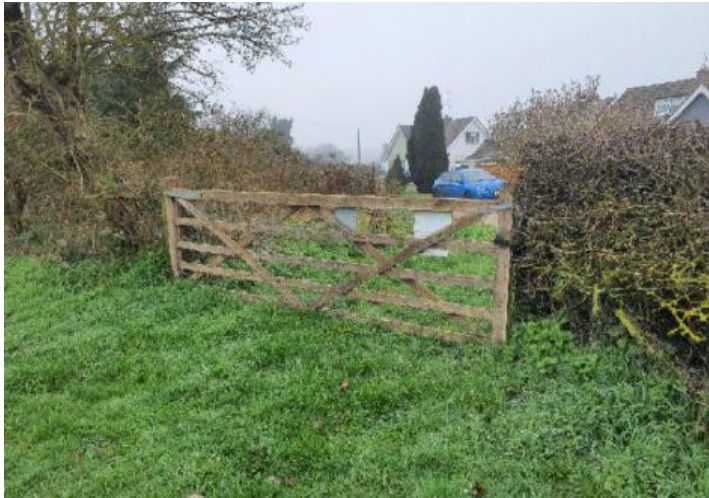
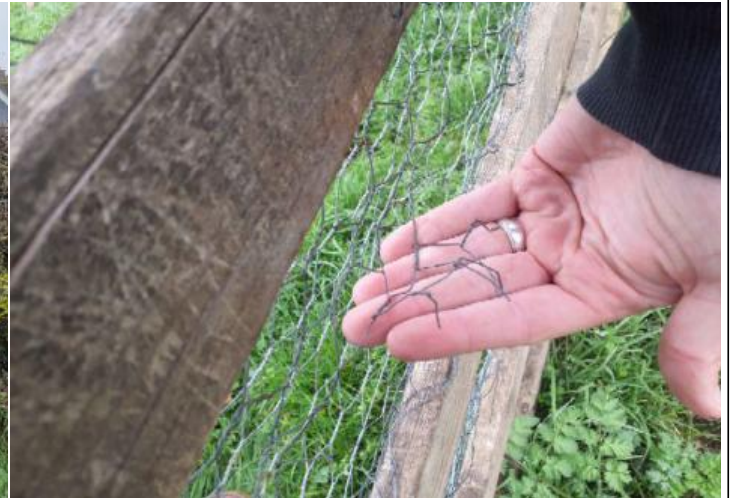
Item: Gates - Gate - Maintenance
Manufacturer: Not Identified

Finding: The mesh is damaged

Action: Replace

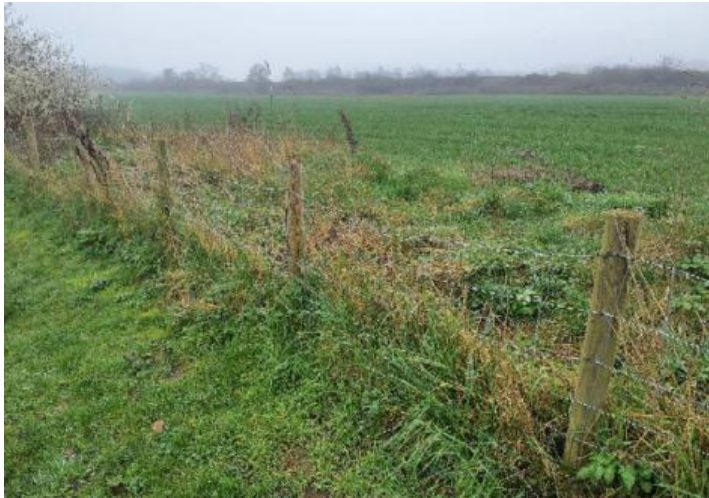
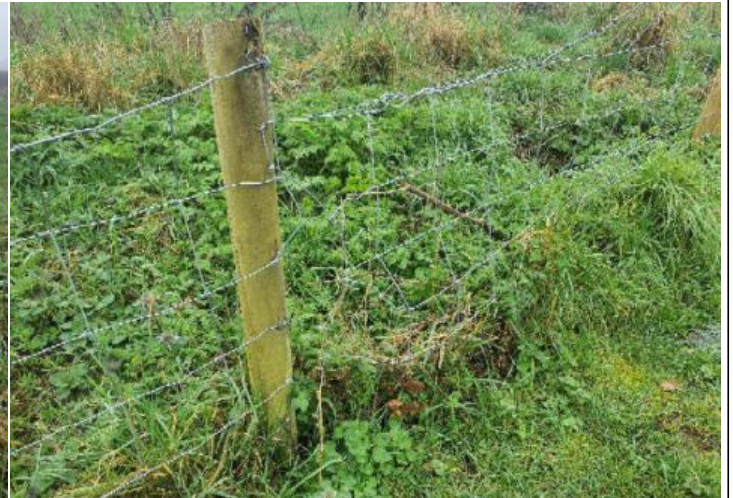
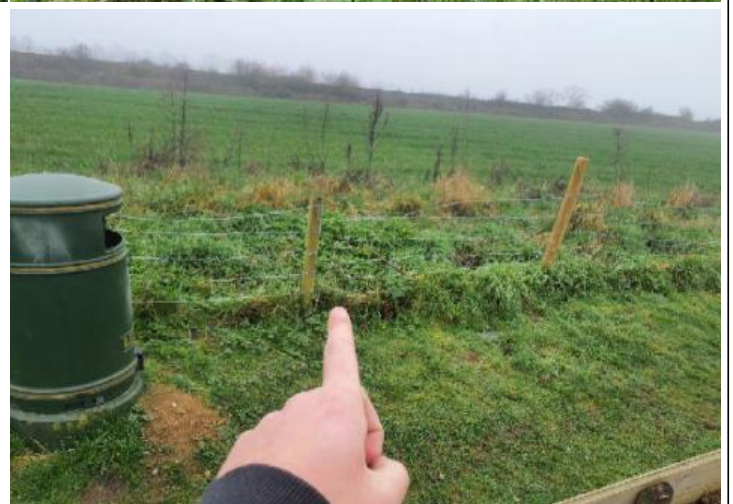
Item: Fences - Fence
Manufacturer: Not Identified

Finding: The fence is severely damaged in places

Action: Repair or replace all affected sections

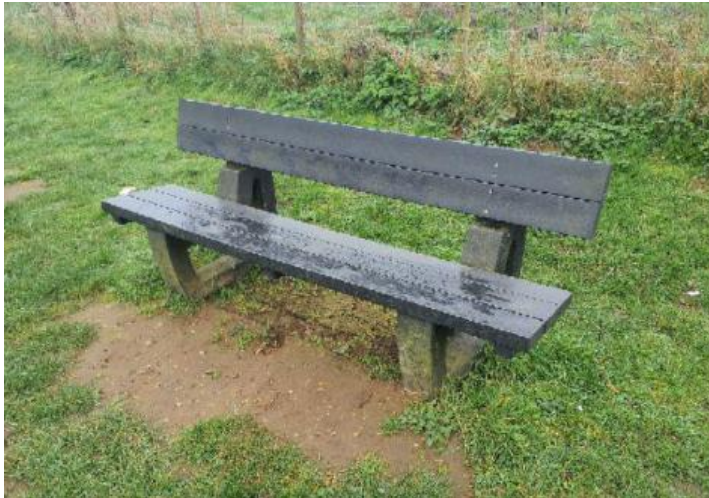
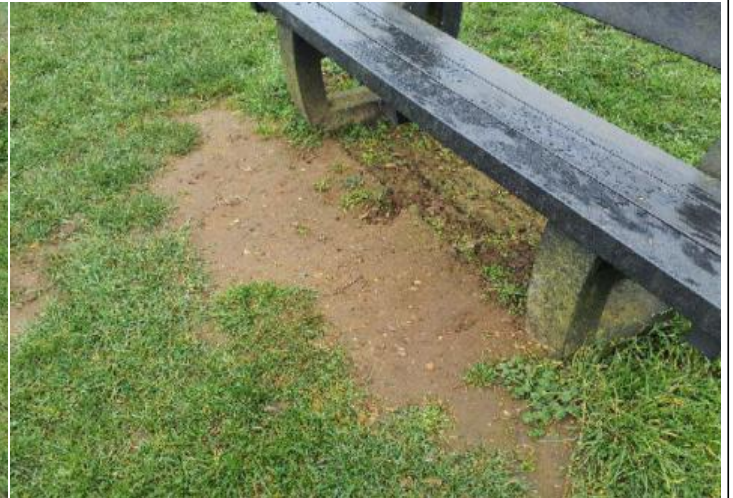
Item: Ancillary Items - Bench
Manufacturer: Not Identified

Finding: The surface has eroded in some areas and may be slippery in wet conditions
Action: Reinstate the surface

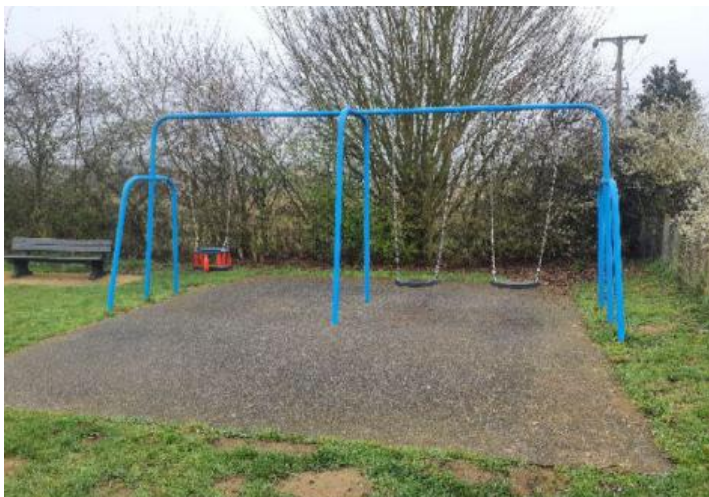
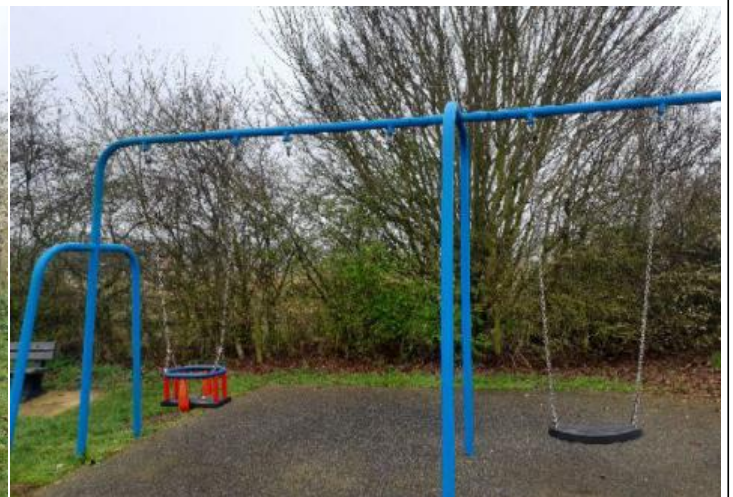
Item: Swings - 2 Bay (2 Flat, 2 Cradle)
Manufacturer: Not Identified

Finding: The seat(s) and suspension were missing at the time of inspection and the inspector was unable to make a full compliance assessment

Action: Replace missing seat(s) and suspension(s) (subject to any other findings needing correction)

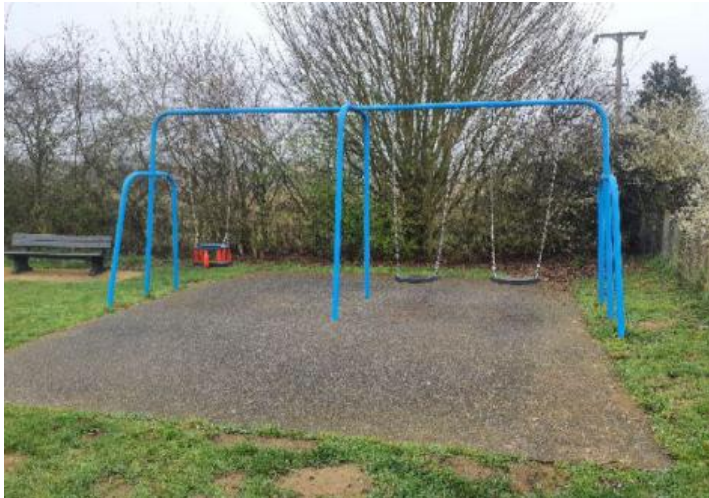
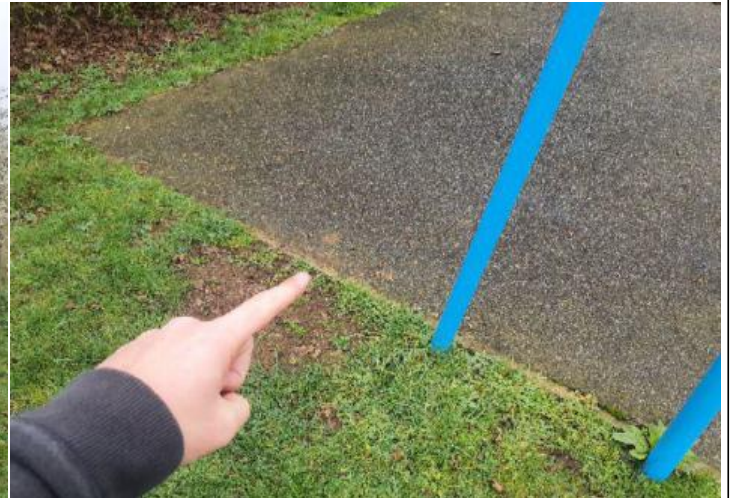
Item: Swings - 2 Bay (2 Flat, 2 Cradle)
Manufacturer: Not Identified

Finding: There are trip hazards at the edges of the surface **Action:** Remove trip hazard

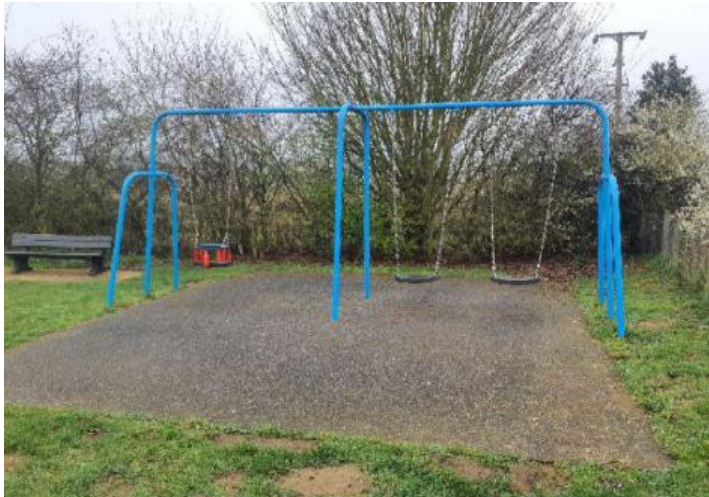
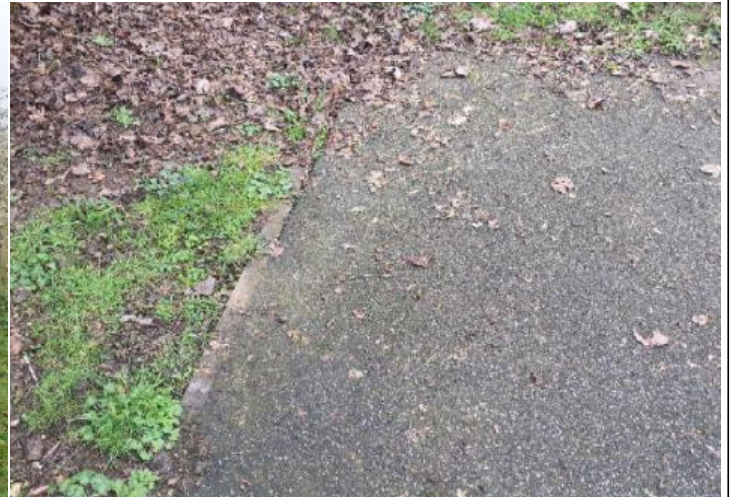
Item: Swings - 2 Bay (2 Flat, 2 Cradle)
Manufacturer: Not Identified

Finding: There is algae, silt or moss growth on the surface resulting in slippery conditions **Action:** Clean and treat appropriately

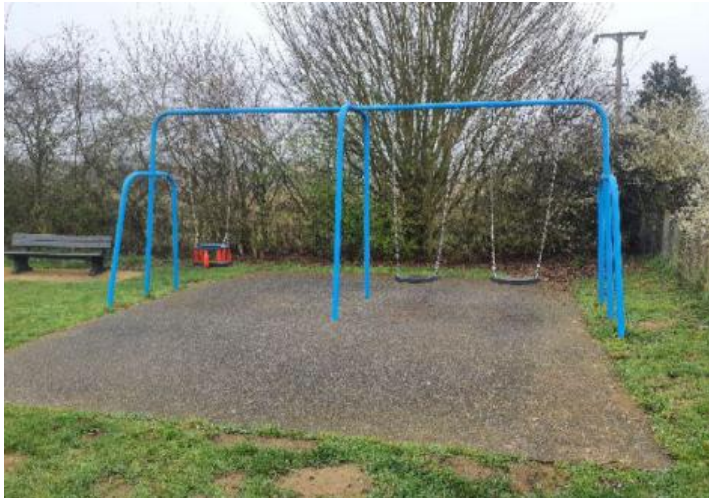
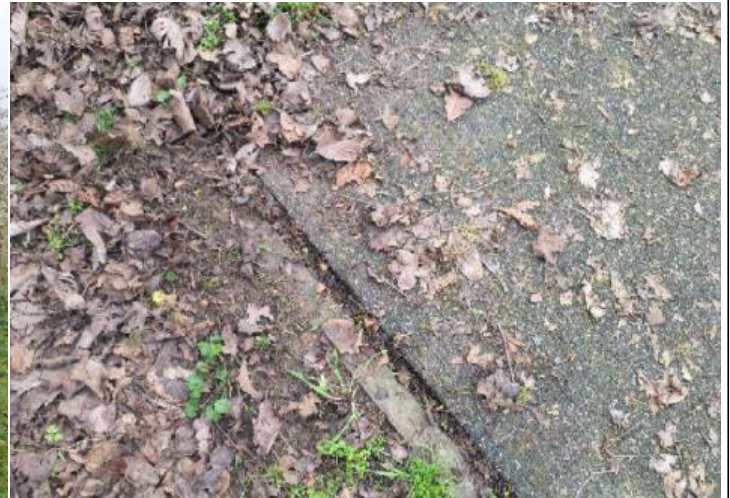
Item: Swings - 2 Bay (2 Flat, 2 Cradle)
Manufacturer: Not Identified

Finding: There are gaps opening between the surfacing and the edging surround or between the joints in the surfacing
Action: Monitor for any further deterioration and repair as required

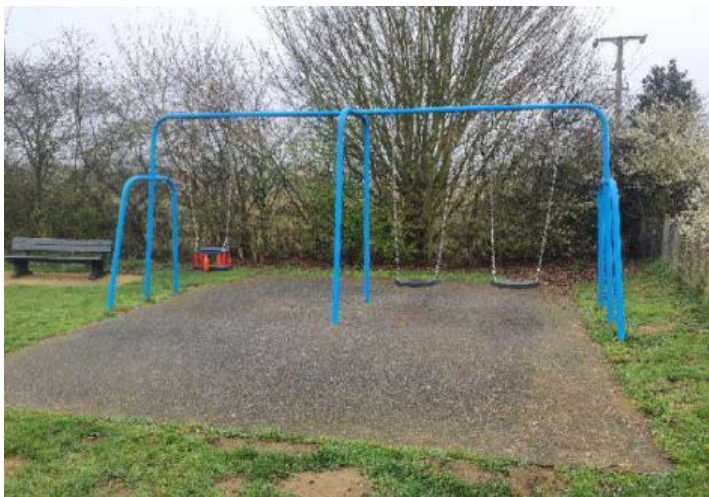
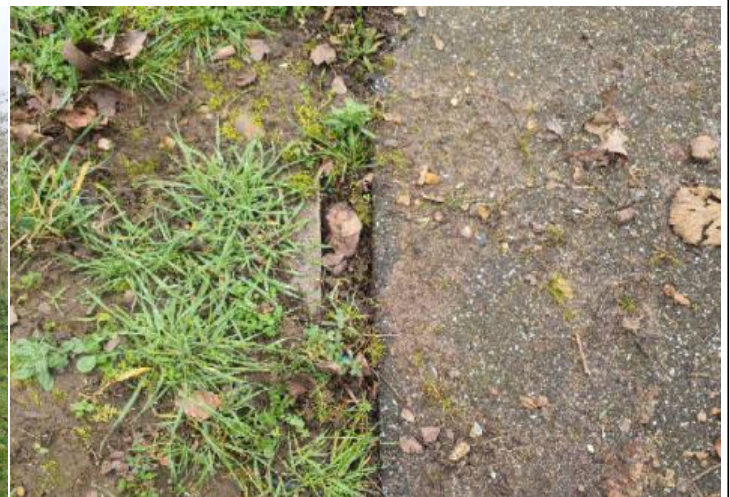
Item: Swings - 2 Bay (2 Flat, 2 Cradle)
Manufacturer: Not Identified

Finding: There are significant gaps (over 30mm) between the surface and the edging or between the joints in the surface; these are large enough for a small foot to enter
Action: Repair surfacing

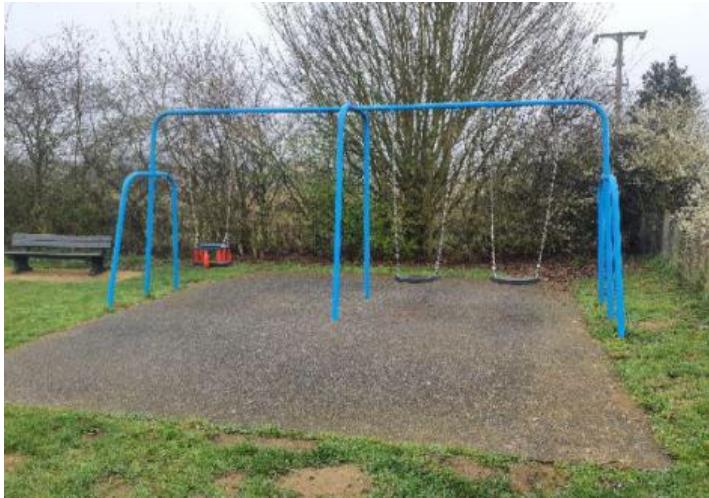
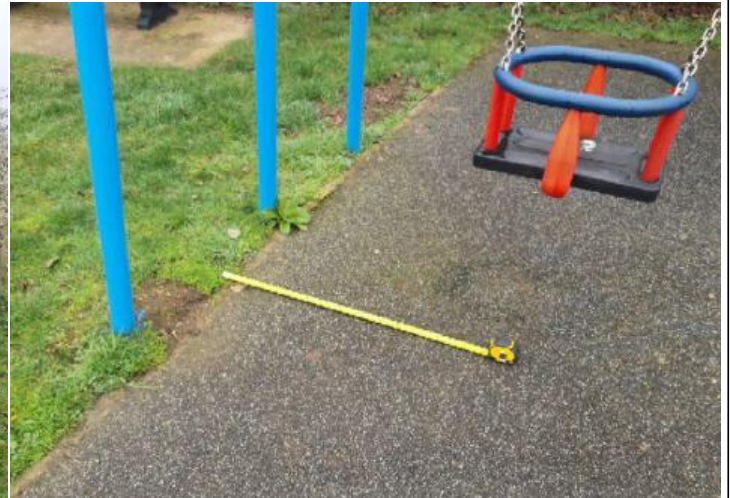
Item: Swings - 2 Bay (2 Flat, 2 Cradle)
Manufacturer: Not Identified

Finding: The surfacing width under the seat/s is / are less than 875mm when measured from the centre of the seat outwards, and fail the requirements of BS EN 1176 Part 2

Action: Monitor - No action given the risk assessment

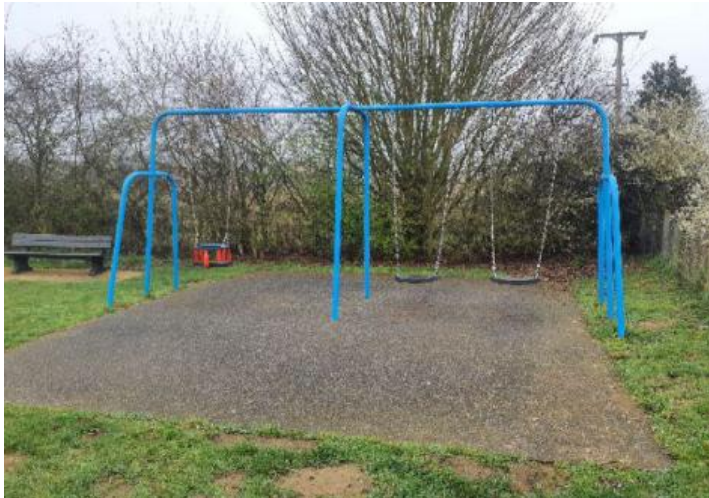
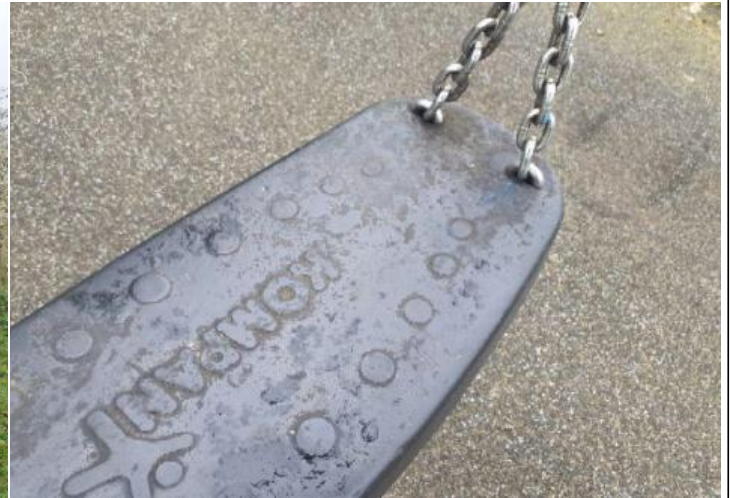
Item: Swings - 2 Bay (2 Flat, 2 Cradle)
Manufacturer: Not Identified

Finding: The seat has minor damage or wear

Action: Monitor for any further deterioration and replace as required

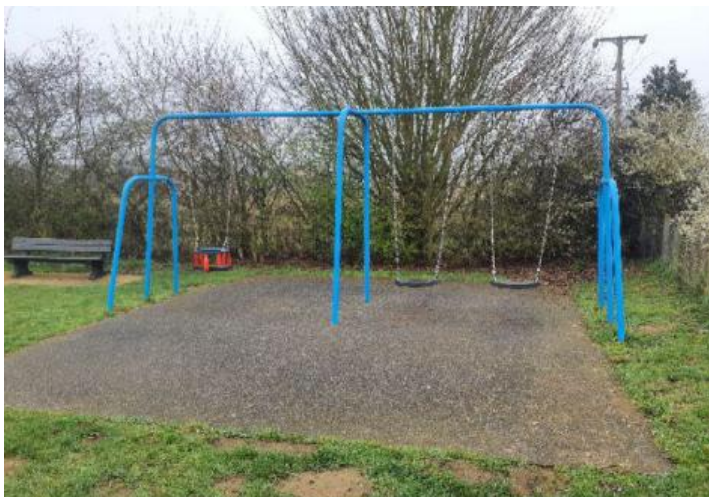
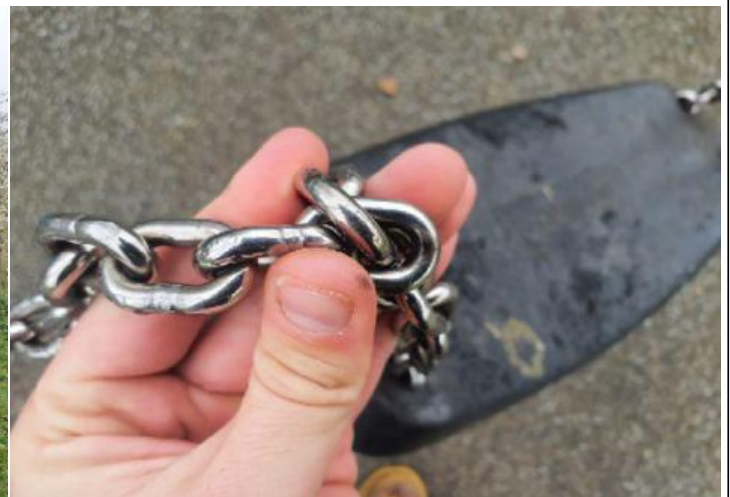
Item: Swings - 2 Bay (2 Flat, 2 Cradle)
Manufacturer: Not Identified

Finding: There is some notable evidence of chain wear

Action: Monitor for any further deterioration and replace when 40% worn

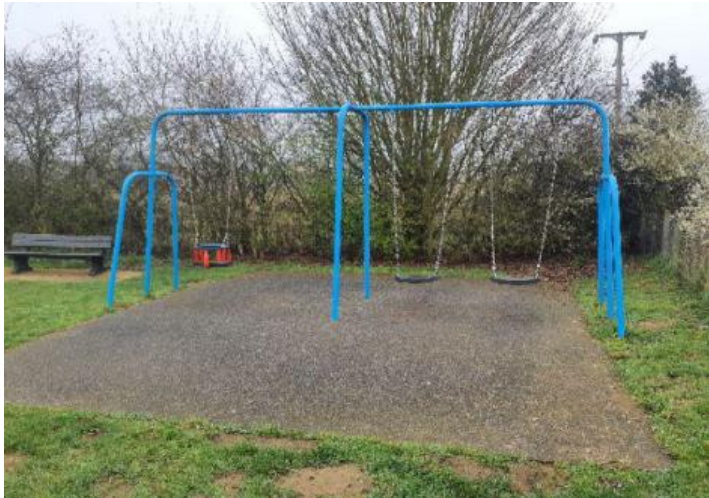
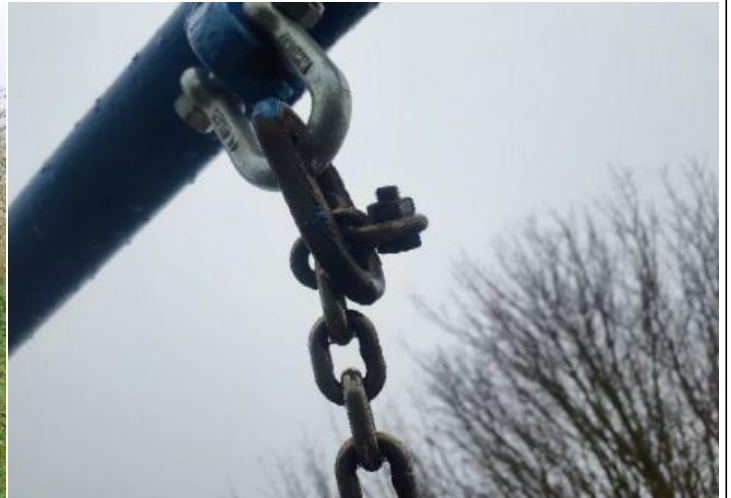
Item: Swings - 2 Bay (2 Flat, 2 Cradle)
Manufacturer: Not Identified

Finding: Crucifix or T connectors should have at least two complete chain links through the connector to meet with the manufacturers recommendations

Action: Rectify installation to ensure at least two complete links are through the connectors

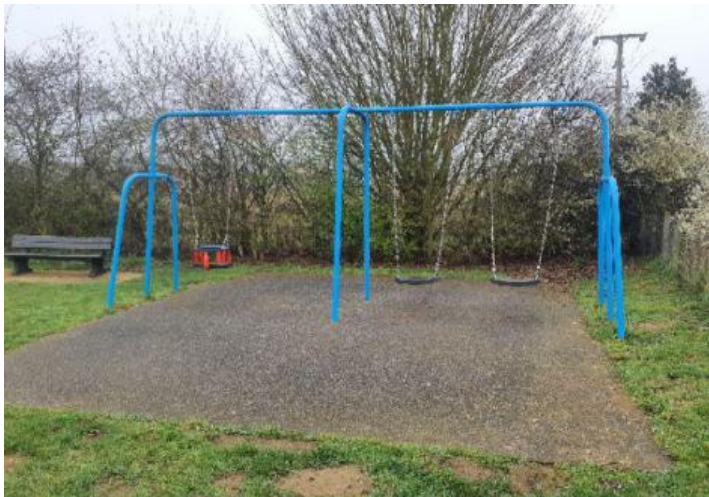
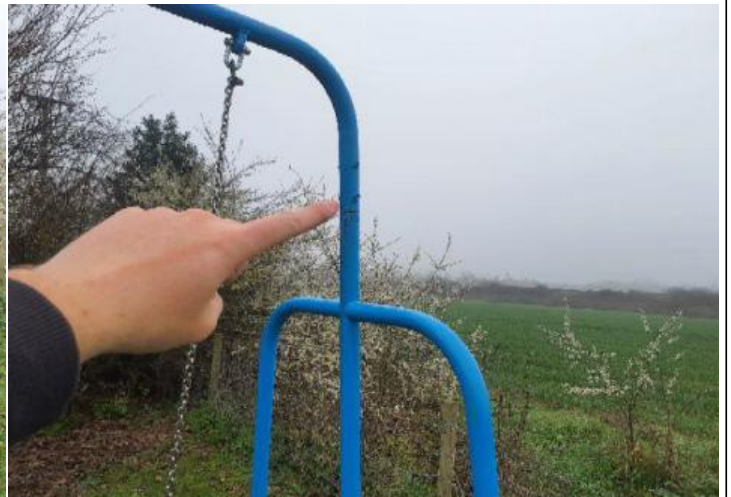
Item: Swings - 2 Bay (2 Flat, 2 Cradle)
Manufacturer: Not Identified

Finding: A number of fixing(s) have worked loose

Action: Secure all loose fixings

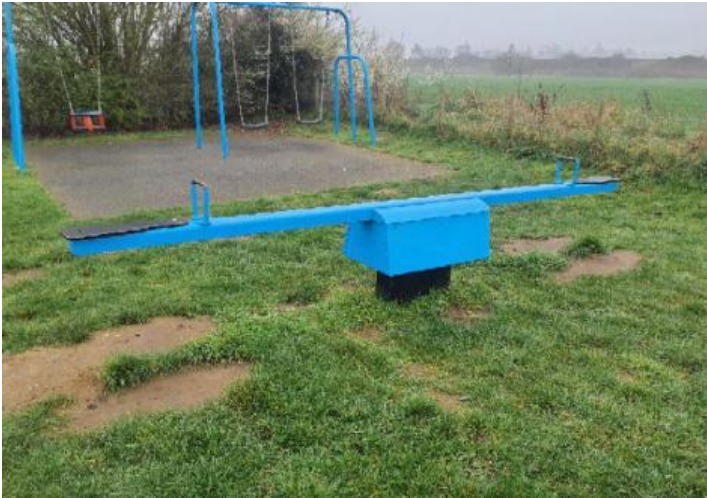
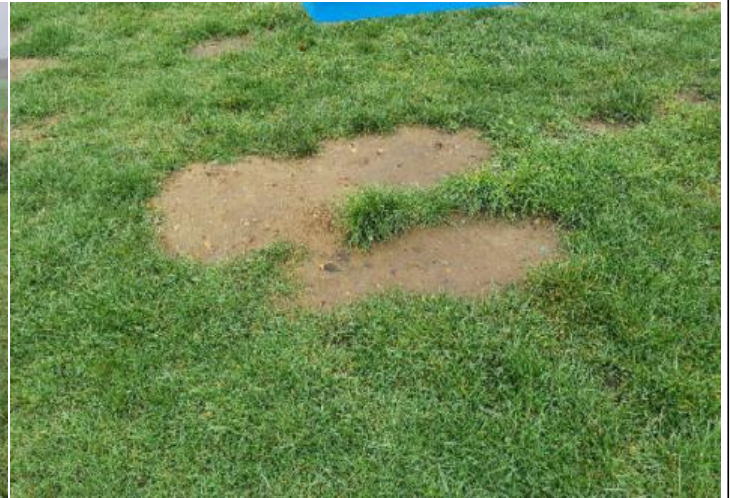
Item: Rocking Equipment - See Saw
Manufacturer: Wicksteed Playgrounds

Finding: The surface has eroded in some areas and may be slippery in wet conditions
Action: Reinstate the surface

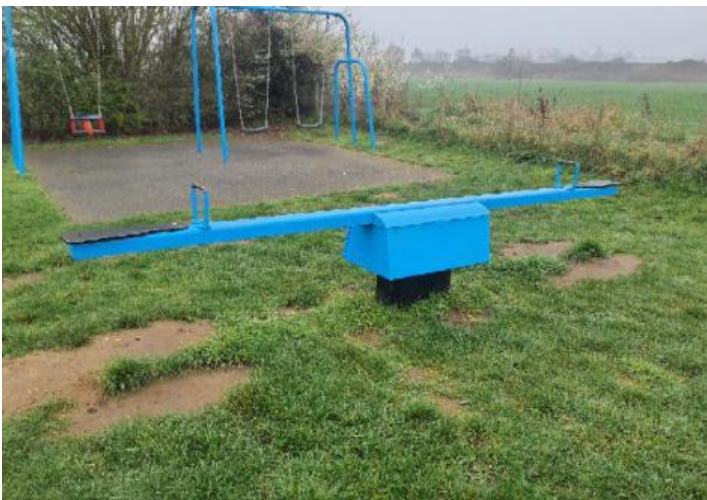
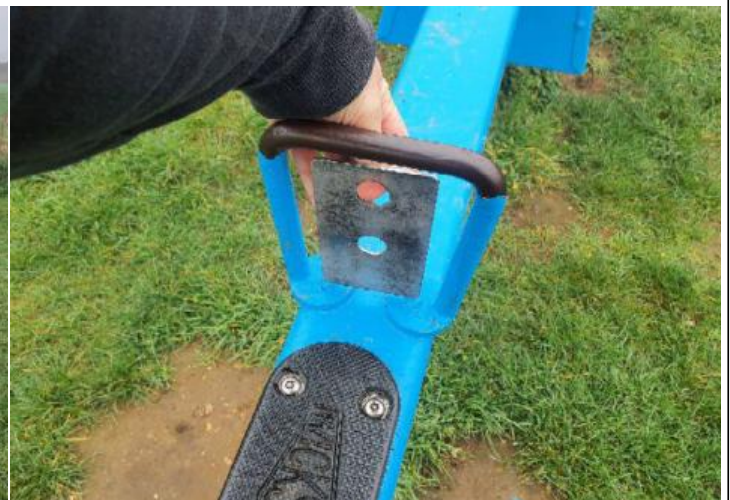
Item: Rocking Equipment - See Saw
Manufacturer: Wicksteed Playgrounds

Finding: The item fails to meet the requirements of BS EN 1176 Part 1 4.2.7.2 for head and neck entrapment in the frame
Action: Monitor - No action given the risk assessment

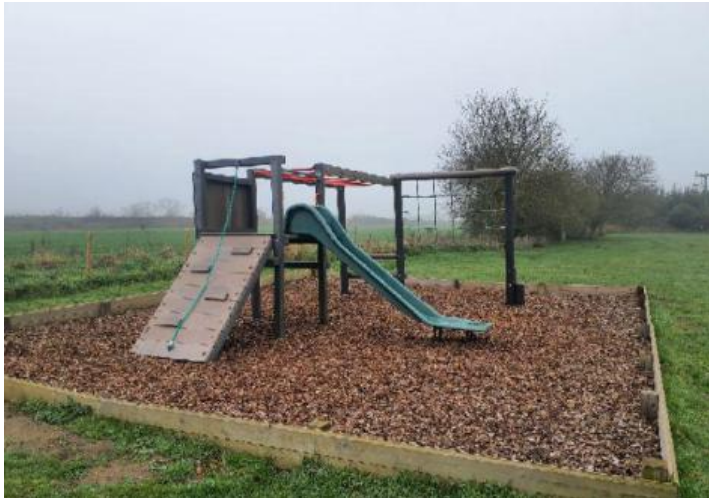
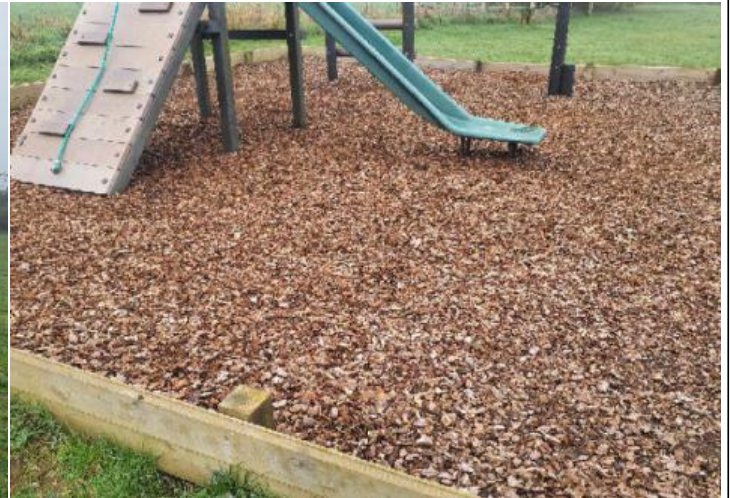
Item: Activity Equipment - Multi Play (Junior)
Manufacturer: Not Identified

Finding: The depth of the loose fill surfacing is lower than the recommended depth specified in BS EN 1176 for a fall height over 2.0m. A minimum depth of 400mm is recommended (including an extra 100mm to allow for compaction and displacement as per BS EN 1176 Part 1 - Table 4)

Action: Top up loosefill to recommended levels

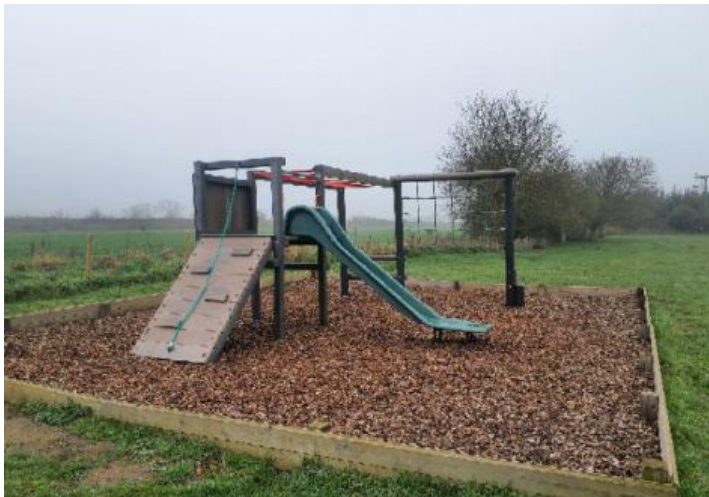
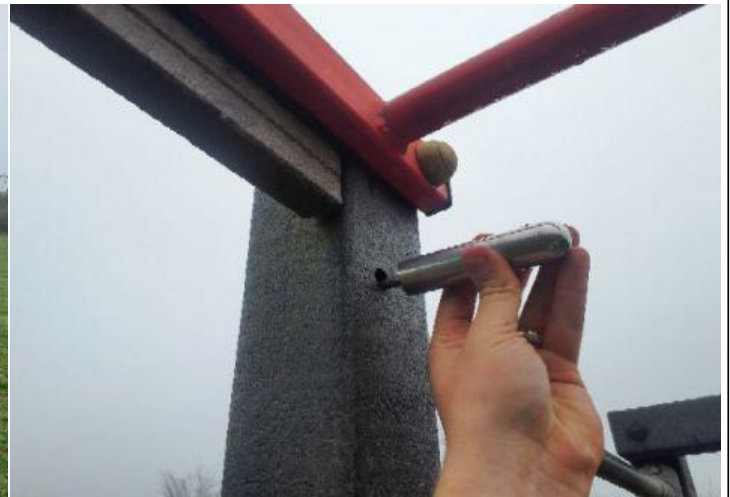
Item: Activity Equipment - Multi Play (Junior)
Manufacturer: Not Identified

Finding: There is/are finger entrapment/s in the post due to missing inserts and the item fails to meet the requirements of BS EN 1176 Part 1 4.2.7.6 Entrapment of fingers

Action: Provide inserts to remove entrapment

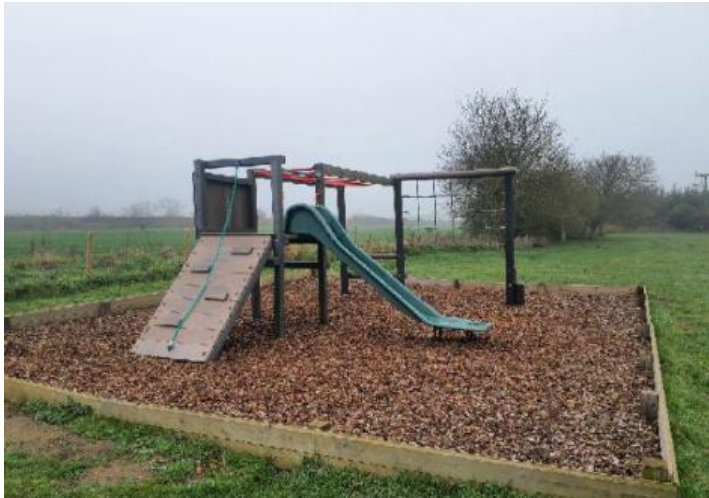
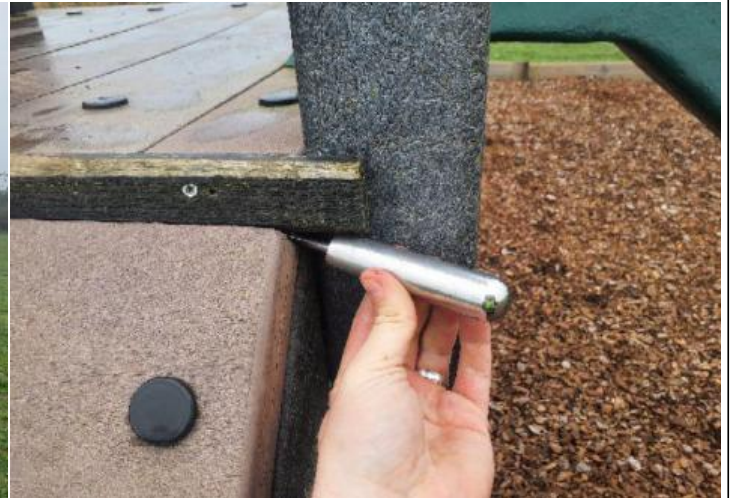
Item: Activity Equipment - Multi Play (Junior)
Manufacturer: Not Identified

Finding: There is/are finger entrapment/s in the climbing wall and the item fails to meet the requirements of BS EN 1176 Part 1 4.2.7.6 Entrapment of fingers

Action: Monitor - No remedial work recommended

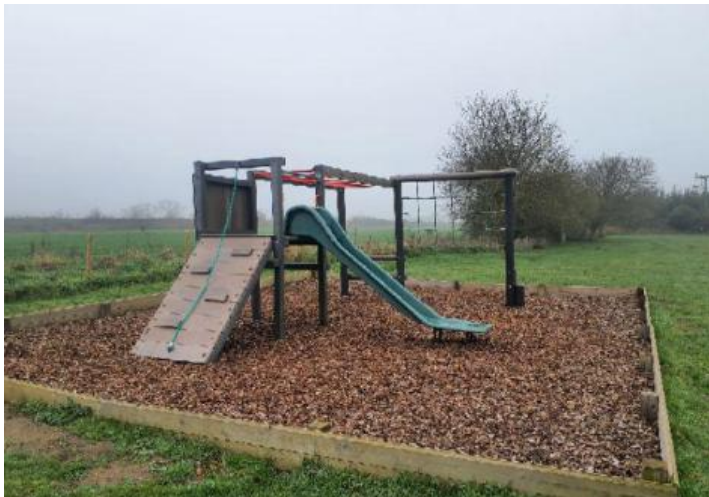
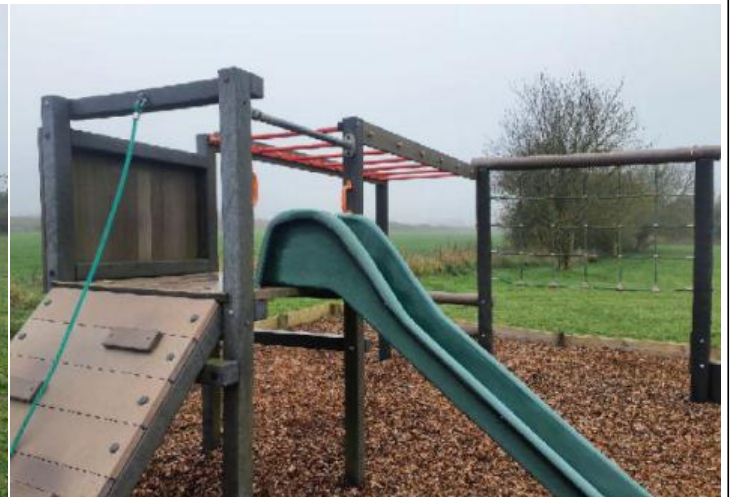
Item: Activity Equipment - Multi Play (Junior)
Manufacturer: Not Identified

Finding: There is a large amount of movement within the structure

Action: Ensure all fixings are secured and monitor for any further deterioration and replace as required

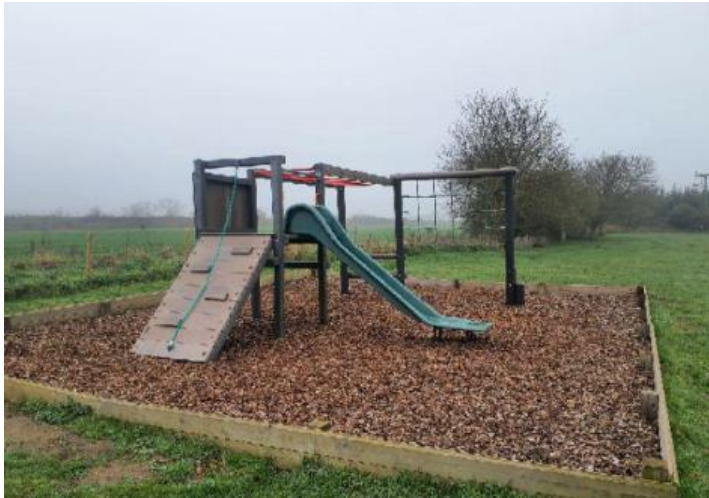
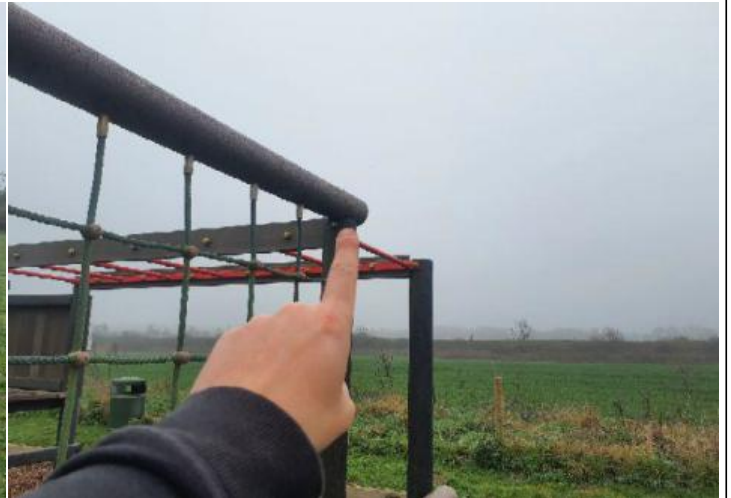
Finding: A number of fixing(s) have worked loose

Action: Secure all loose fixings

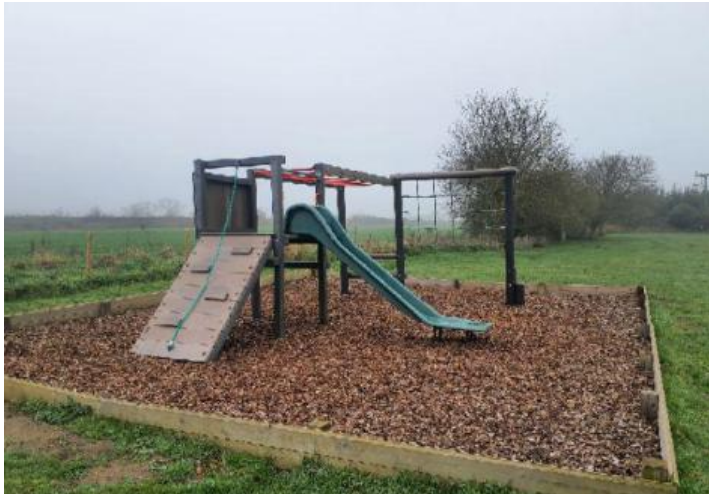
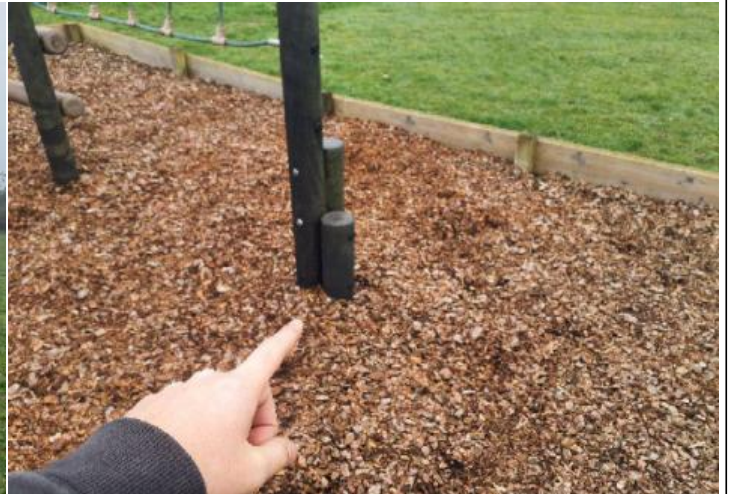
Finding: The item is slightly loose in its foundations

Action: Monitor for any further deterioration and repair as required

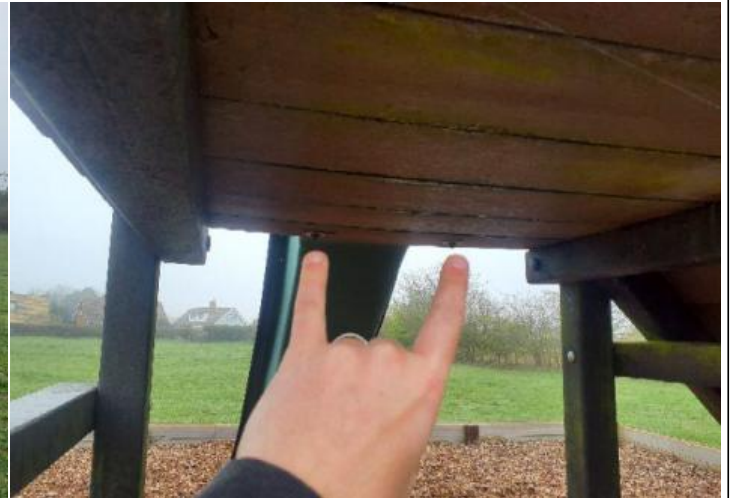
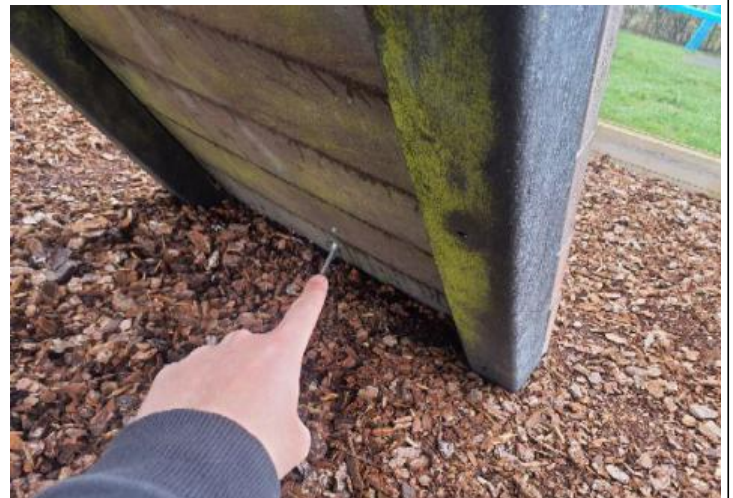
Finding: There are projecting bolt thread(s) present

Action: Remove excess thread length and deburr or provide cap

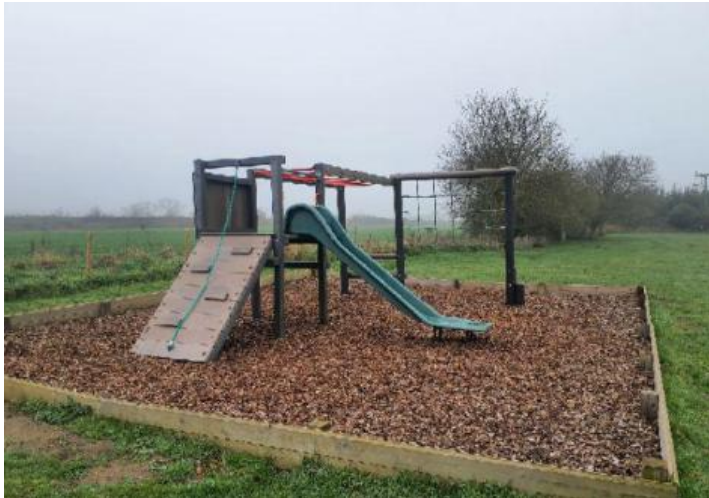
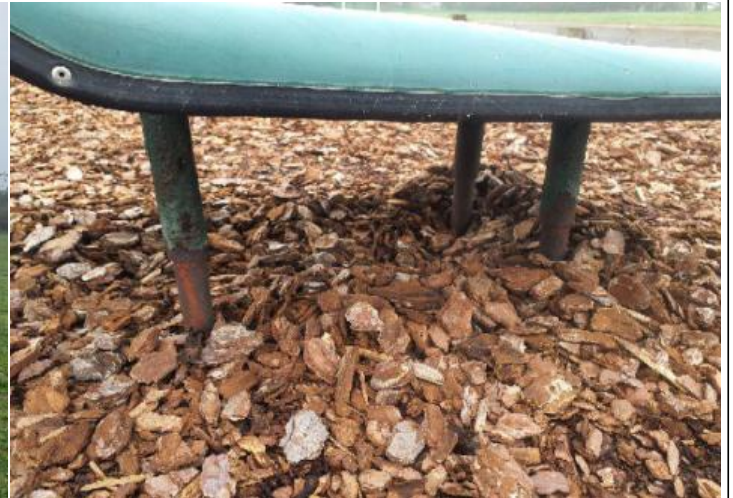
Finding: The paintwork on this item has been damaged or worn exposing the metal underneath which is rusting / corroding

Action: Treat affected areas and repaint

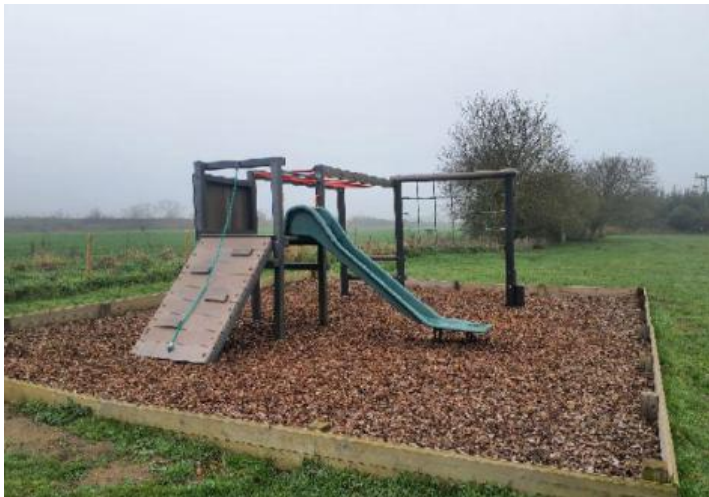
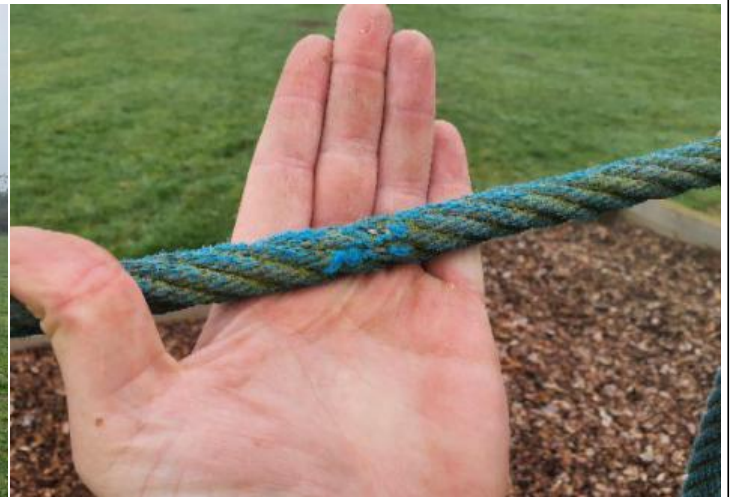
Finding: The ropes/nets are worn/damaged in places

Action: Monitor for any further deterioration and repair or replace as required

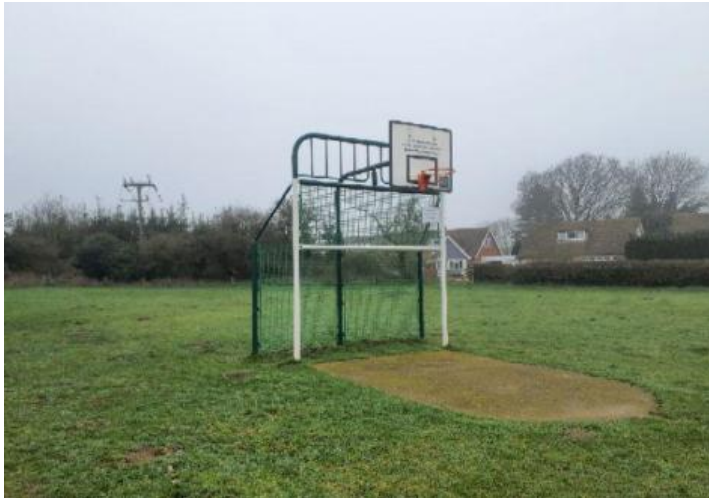
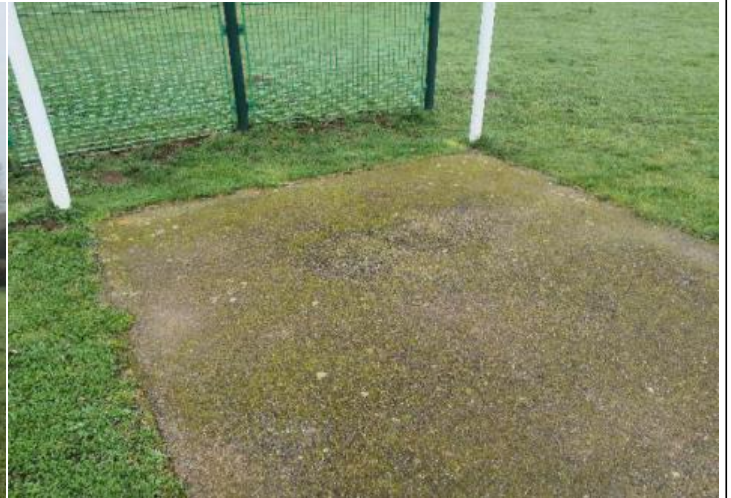
Finding: There is algae, silt or moss growth on the surface resulting in slippery conditions

Action: Clean and treat appropriately

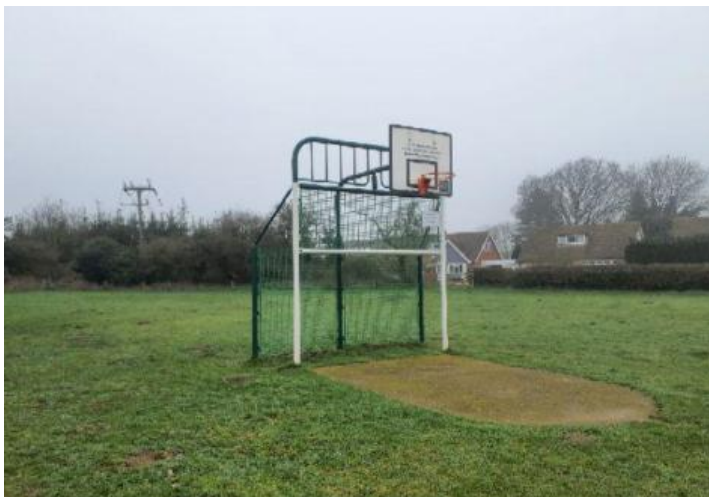
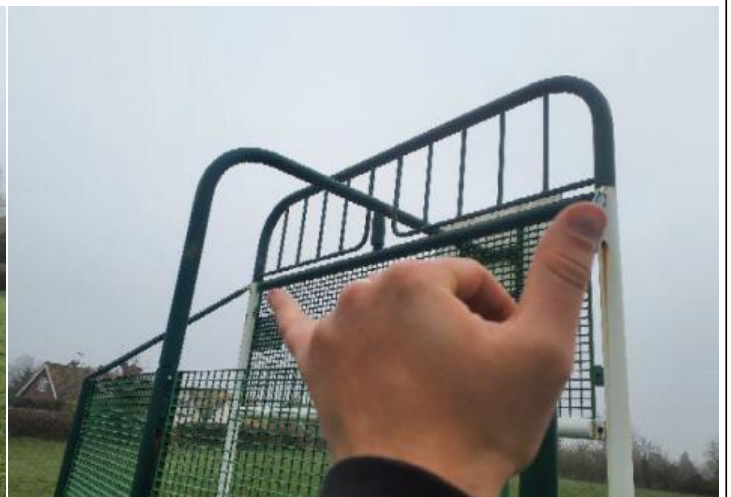
Finding: A number of fixing(s) have worked loose

Action: Secure all loose fixings
