the **play inspection** company

Annual Inspection

Mid Suffolk District Council

Thurston Playing Field

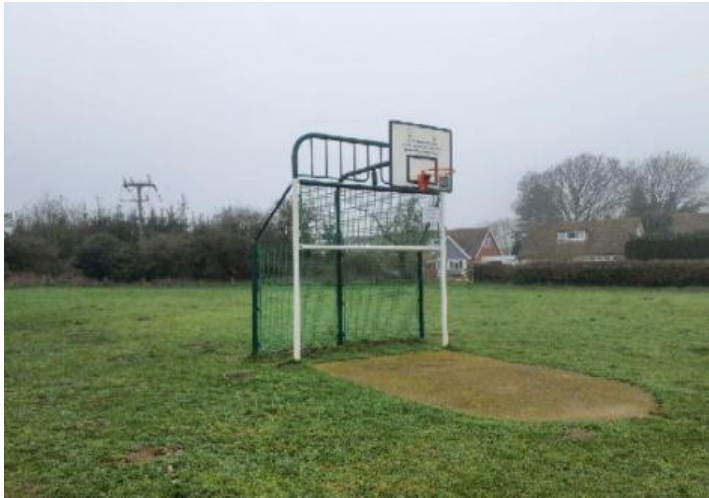
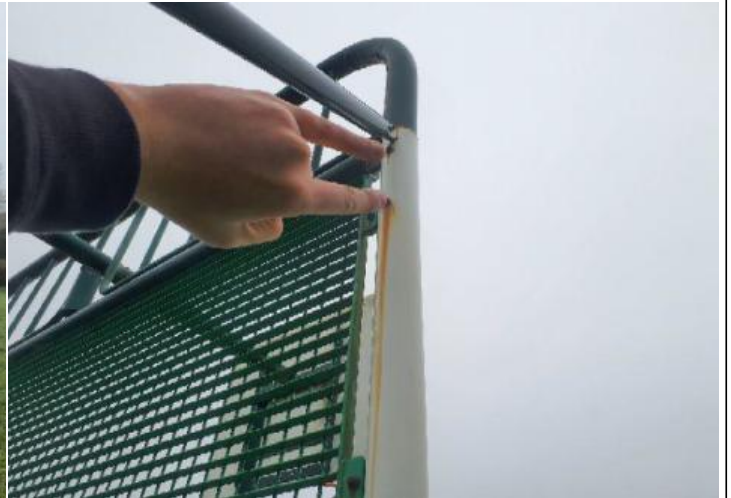
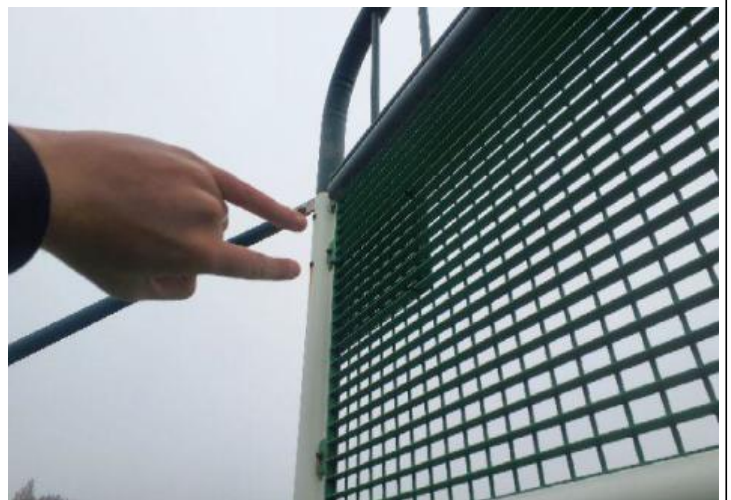
Finding: The item has been damaged

Action: Repair or replace the item / affected part

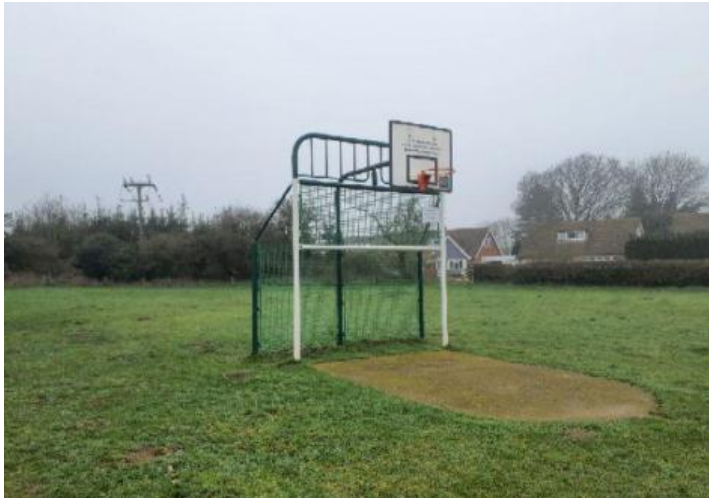
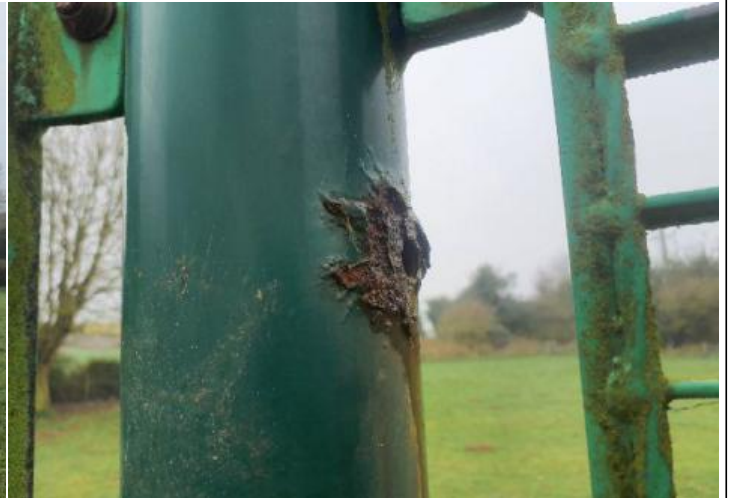
Finding: Parts of the steel on this item have corroded excessively

Action: Ensure all affected areas are treated and repaired
