Annual Inspection

Mid Suffolk District Council

Thurston Recreation Ground

Church Road, Thurston, Suffolk, IP31 3RP

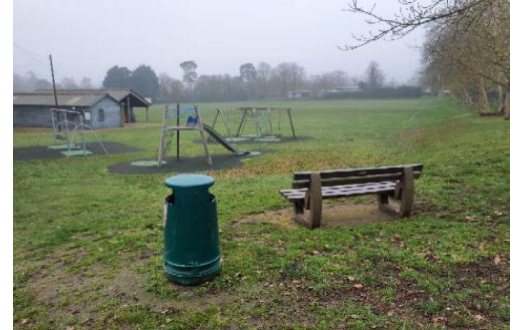
Item: Site General
Manufacturer: Owner/Operator
Surface Type: N/A
Item Quantity: 1
Equipment Compliance: N/A
Surface Area Compliance: N/A

There is weed / vegetation growth within the surface - Remove weed / vegetation growth

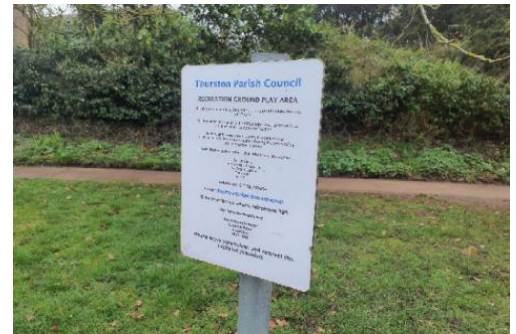
Item: Sign
Manufacturer: Not Identified
Surface Type: Grass
Item Quantity: 1
Equipment Compliance: N/A
Surface Area Compliance: N/A

There is / are post or end caps missing / damaged on the item - Replace missing / damaged post or end caps

There are projecting bolt thread(s) present - Remove excess thread length and deburr or provide cap

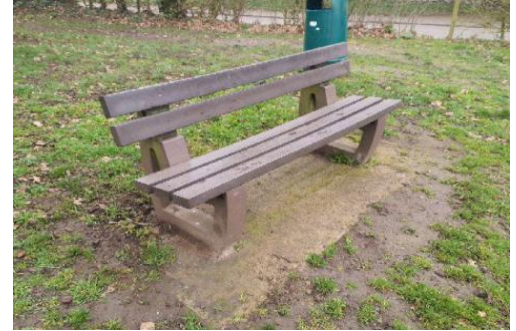
Item: Bench
Manufacturer: Not Identified
Surface Type: Concrete
Item Quantity: 1
Equipment Compliance: N/A
Surface Area Compliance: N/A

The surface has eroded in some areas and may be slippery in wet conditions - Reinstate the surface

A number of fixing(s) have worked loose - Secure all loose fixings

There are projecting bolt thread(s) present - Remove excess thread length and deburr or provide cap

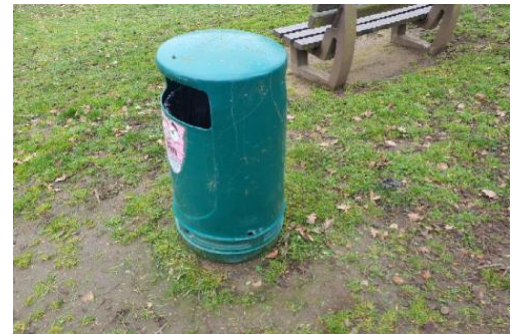
Item: Litter Bin
Manufacturer: Not Identified
Surface Type: Grass
Item Quantity: 1
Equipment Compliance: N/A
Surface Area Compliance: N/A

The lid or door of the litter bin is not secured - Ensure the lid or door is kept locked

The item has been damaged - Monitor for any further deterioration and replace as required

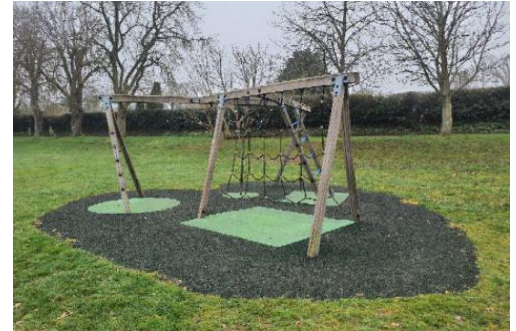
Item: Climbing Frame
Manufacturer: Kompan Ltd
Surface Type: Bonded Rubber Mulch
Item Quantity: 1
Equipment Compliance: Yes
Surface Area Compliance: Yes
Life Expectancy: 5 -10 Years
Total Findings: 4

Bolt cap cover/s missing or damaged - Replace

The ropes/nets are worn/damaged in places - Monitor for any further deterioration and repair or replace as required

The paint has worn off the metalwork - Rub down and re-paint

There is algae or moss on the surface of the equipment - Clean and treat appropriately

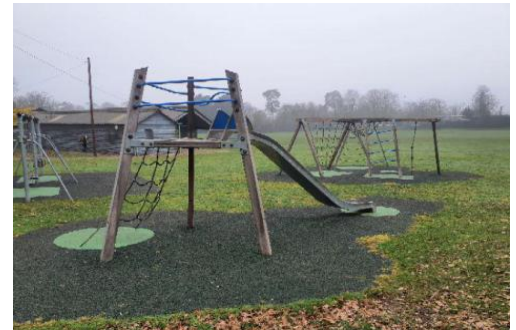
Item: Multi Play (Junior)
Manufacturer: Kompan Ltd
Surface Type: Bonded Rubber Mulch
Item Quantity: 1
Equipment Compliance: No
Surface Area Compliance: Yes
Life Expectancy: 5 -10 Years
Total Findings: 3

There are a number of dents in the slide surface - Monitor for any further deterioration and repair as required

Bolt cap cover/s missing or damaged - Replace

There is/are finger entrapment/s in the slide starting section and the item fails to meet the requirements of BS EN 1176 Part 1 4.2.7.6 Entrapment of fingers - Monitor - No action given the risk assessment

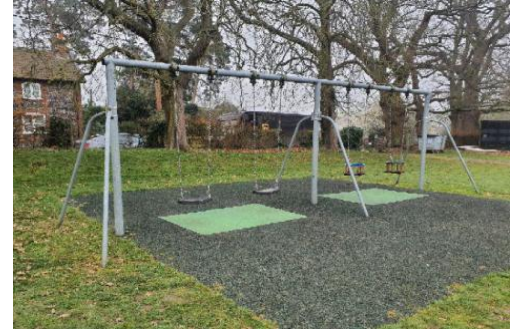
Item: 2 Bay (2 Flat, 2 Cradle)
Manufacturer: Kompan Ltd
Surface Type: Bonded Rubber Mulch
Item Quantity: 1
Equipment Compliance: No
Surface Area Compliance: Yes
Life Expectancy: 5 -10 Years
Total Findings: 5

The seat clearance from finished surface level to the underside of the seat is too low and does not meet the requirements of BS EN 1176 Part 2 (350mm minimum clearance required) - Adjust seat height/s (400mm-500mm is recommended)

The connecting links are in excess of 8.6mm and less than 12mm and fail the requirements of BS EN 1176 Part 1; clause 4.2.13, Chains - Monitor use and replace with compliant links at the next maintenance cycle

The suspension lugs are showing signs of wear - Monitor for any further deterioration and repair as required

The chain openings are in excess of 8.6mm and do not meet the recommendations of BS EN 1176 Part 1 - Monitor - No action given the risk assessment

There is some notable evidence of chain wear - Monitor for any further deterioration and replace when 40% worn

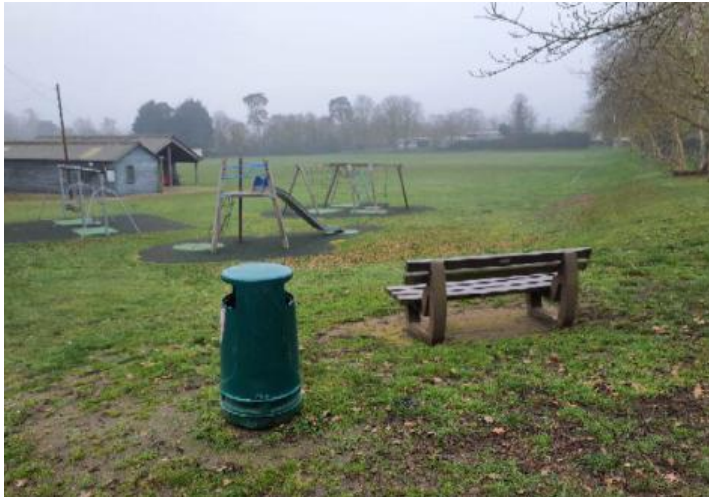
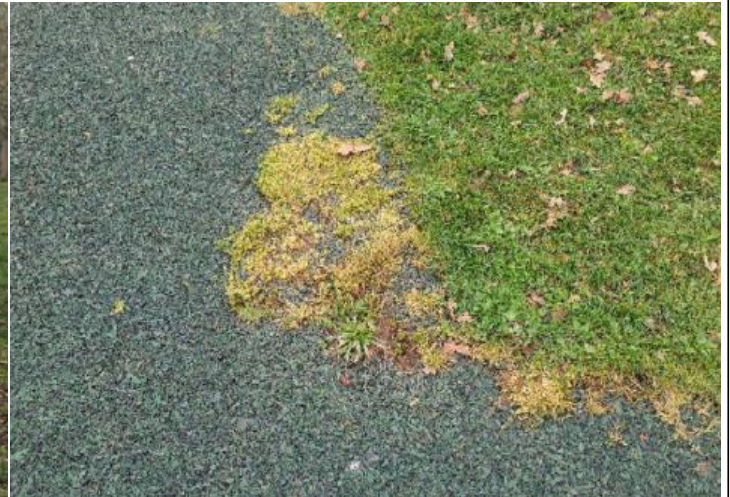
Item: Ancillary Items - Site General
Manufacturer: Owner/Operator

Finding: There is weed / vegetation growth within the surface

Action: Remove weed / vegetation growth

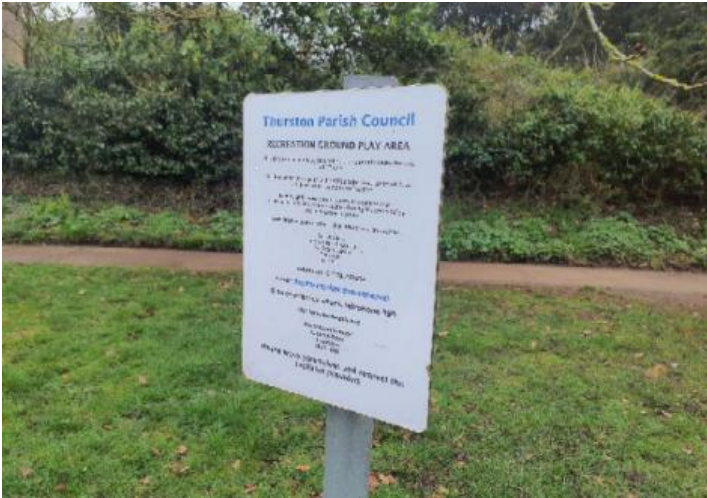
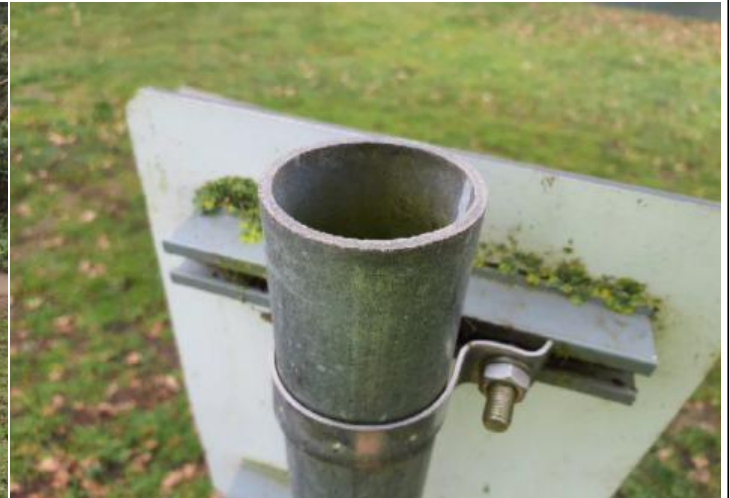
Item: Ancillary Items - Sign
Manufacturer: Not Identified

Finding: There is / are post or end caps missing / damaged **Action:** Replace missing / damaged post or end caps on the item

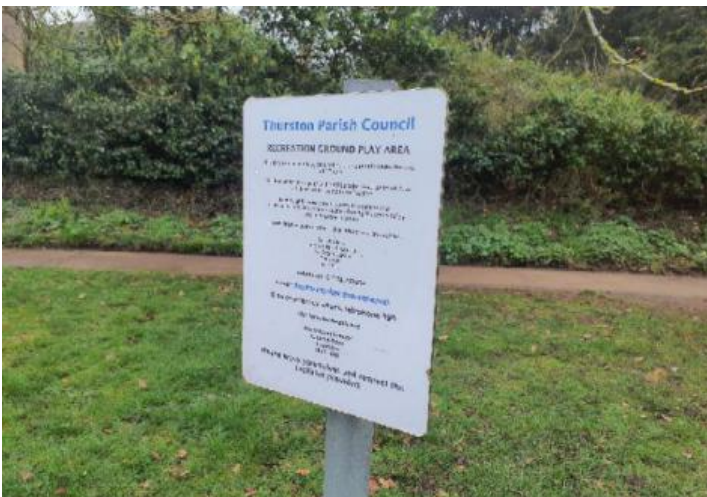
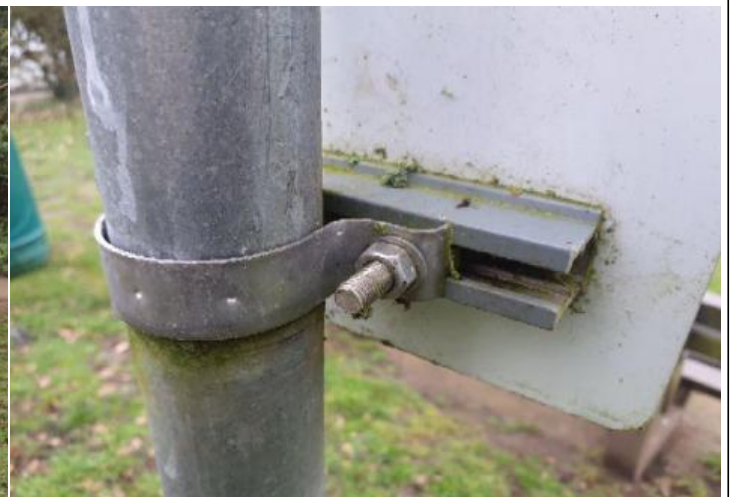
Item: Ancillary Items - Sign
Manufacturer: Not Identified

Finding: There are projecting bolt thread(s) present **Action:** Remove excess thread length and deburr or provide cap

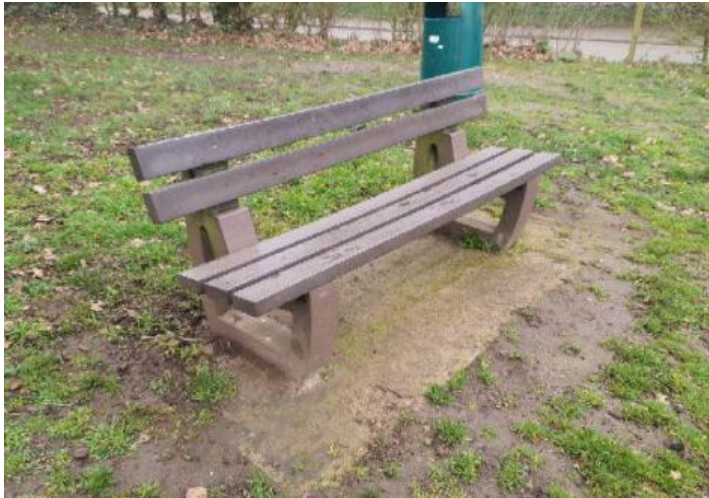
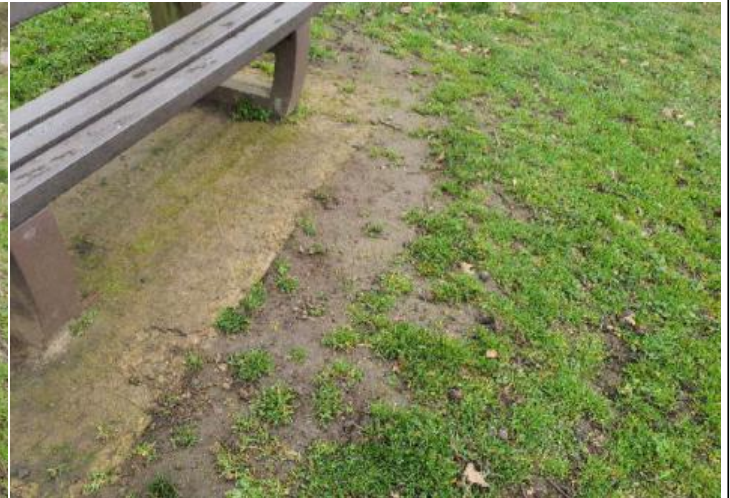
Item: Ancillary Items - Bench
Manufacturer: Not Identified

Finding: The surface has eroded in some areas and may be slippery in wet conditions
Action: Reinstate the surface

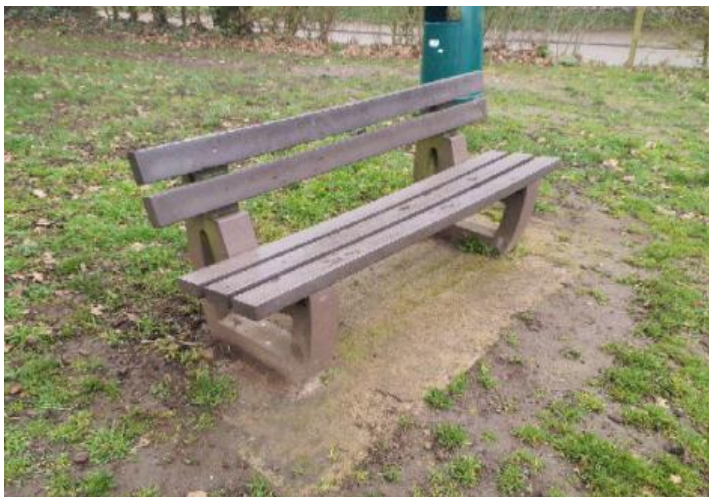
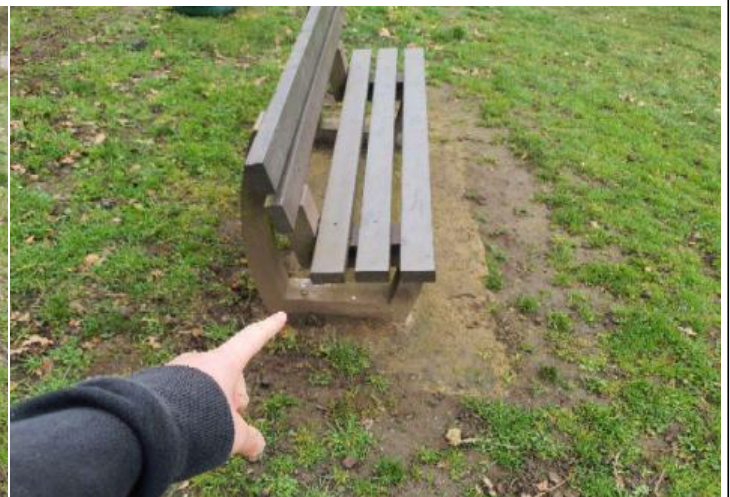
Item: Ancillary Items - Bench
Manufacturer: Not Identified

Finding: A number of fixing(s) have worked loose
Action: Secure all loose fixings

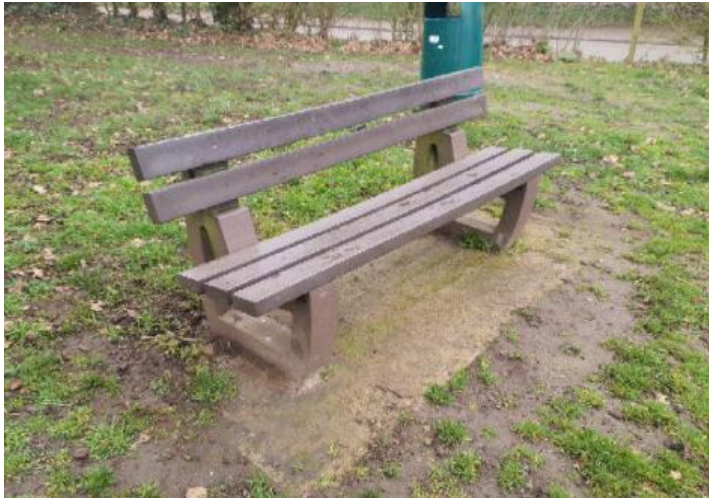
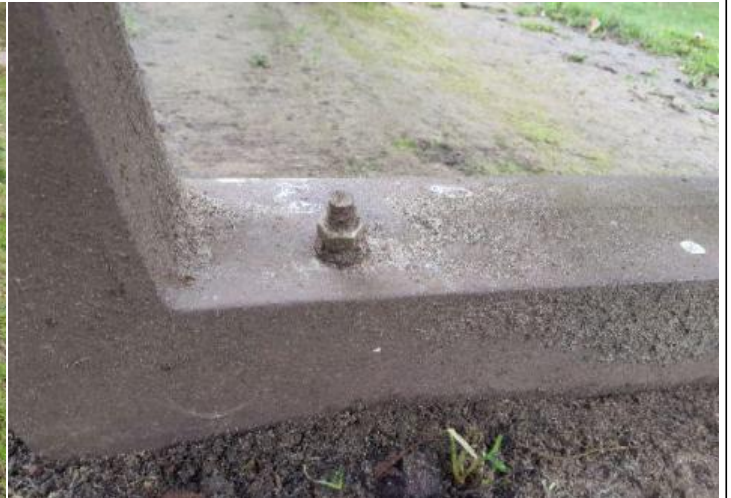
Item: Ancillary Items - Bench
Manufacturer: Not Identified

Finding: There are projecting bolt thread(s) present

Action: Remove excess thread length and deburr or provide cap

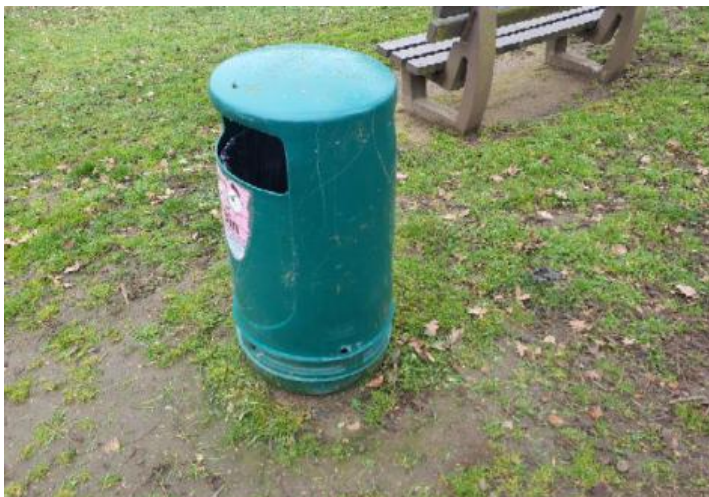
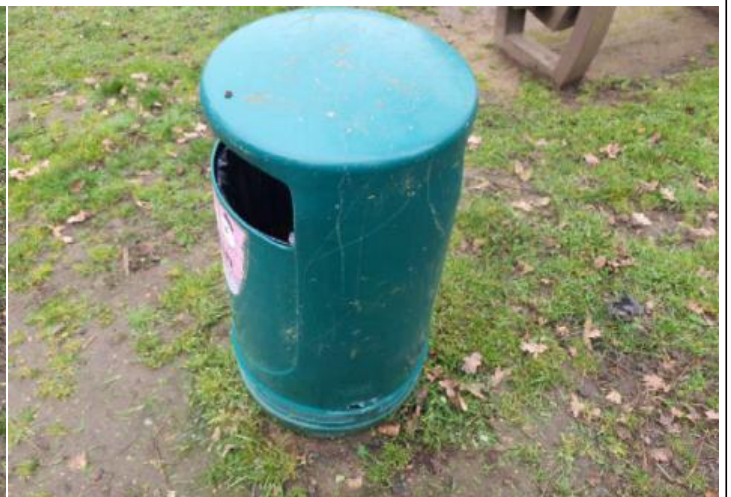
Item: Ancillary Items - Litter Bin
Manufacturer: Not Identified

Finding: The lid or door of the litter bin is not secured

Action: Ensure the lid or door is kept locked

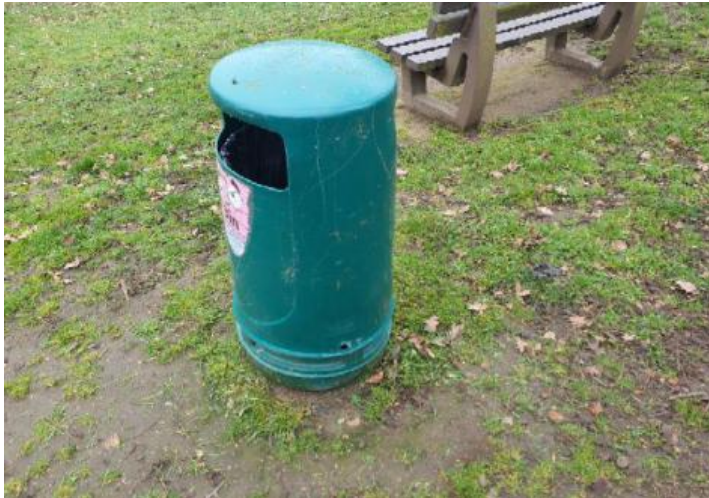
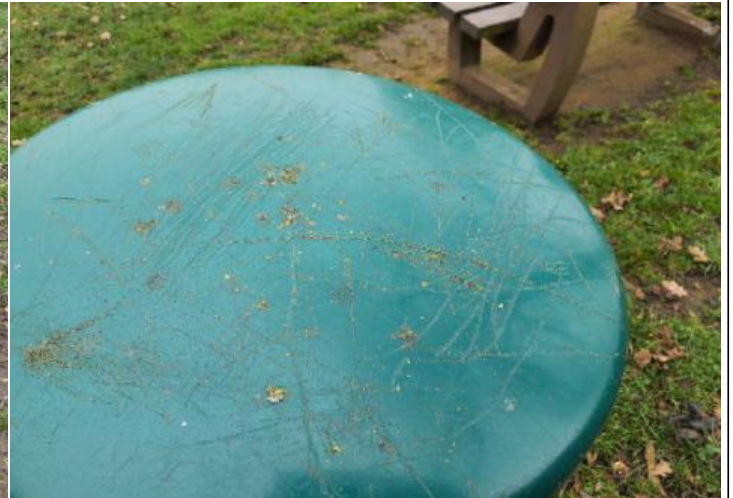
Item: Ancillary Items - Litter Bin
Manufacturer: Not Identified

Finding: The item has been damaged

Action: Monitor for any further deterioration and replace as required

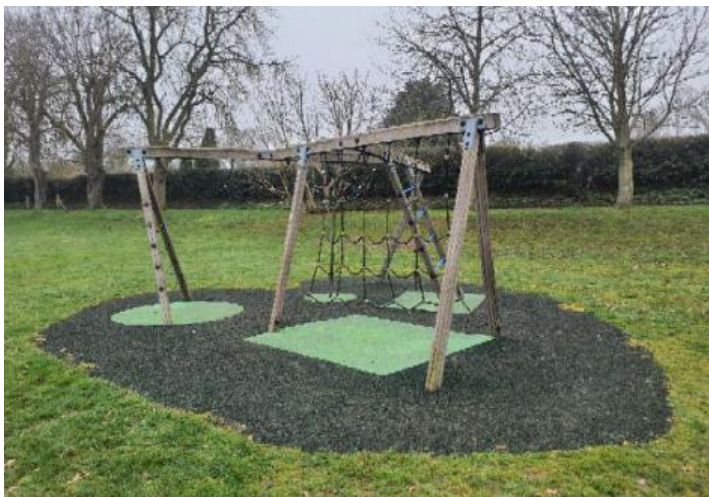
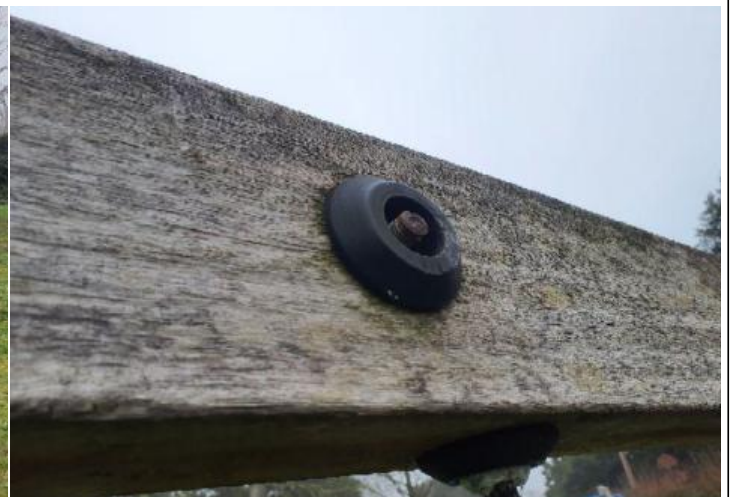
Item: Activity Equipment - Climbing Frame
Manufacturer: Kompan Ltd

Finding: Bolt cap cover/s missing or damaged

Action: Replace

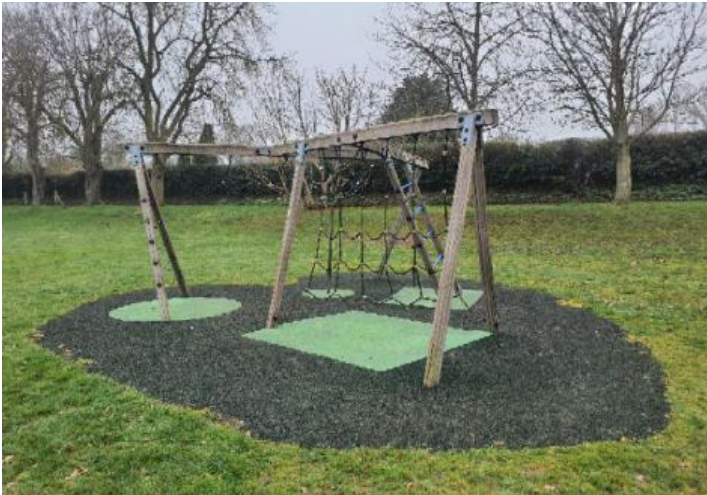
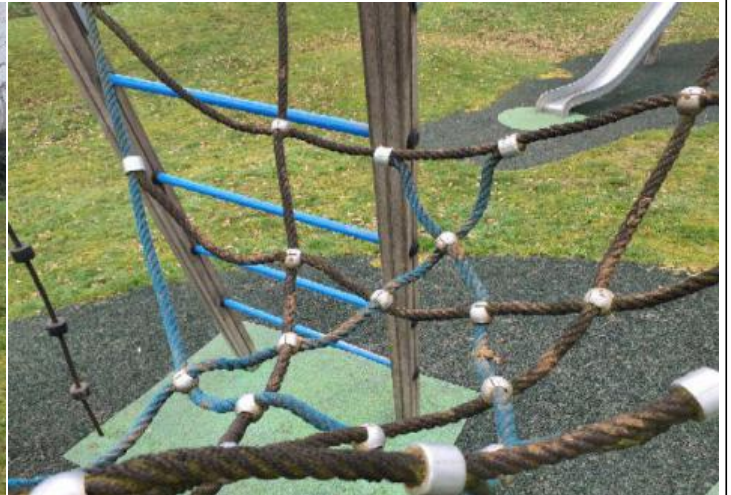
Item: Activity Equipment - Climbing Frame
Manufacturer: Kompan Ltd

Finding: The ropes/nets are worn/damaged in places

Action: Monitor for any further deterioration and repair or replace as required

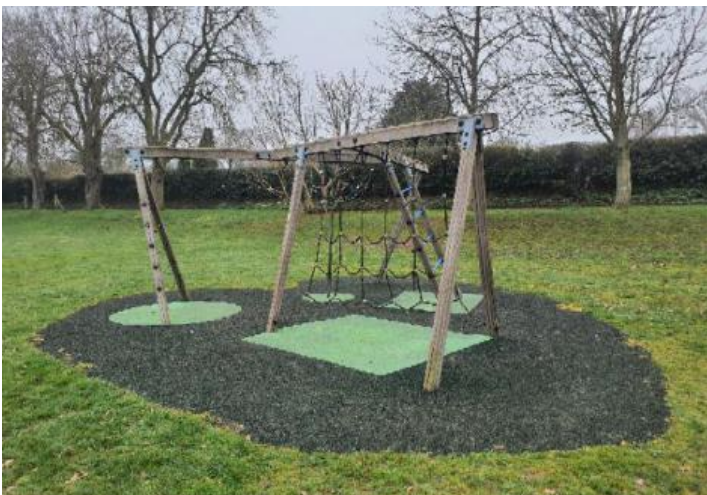
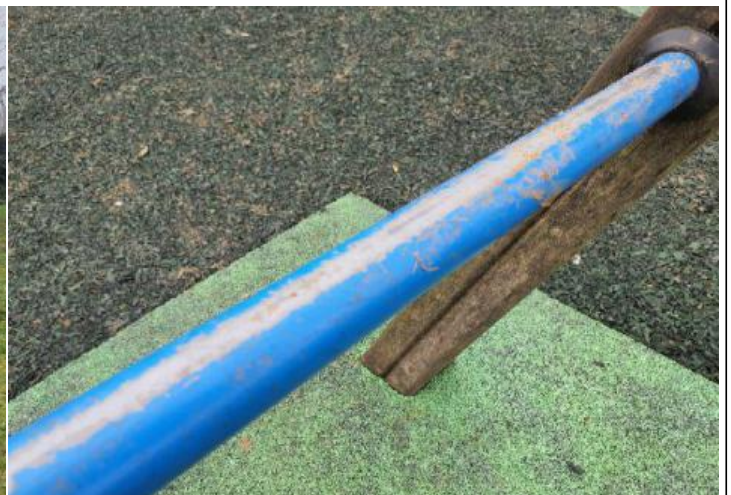
Item: Activity Equipment - Climbing Frame
Manufacturer: Kompan Ltd

Finding: The paint has worn off the metalwork

Action: Rub down and re-paint

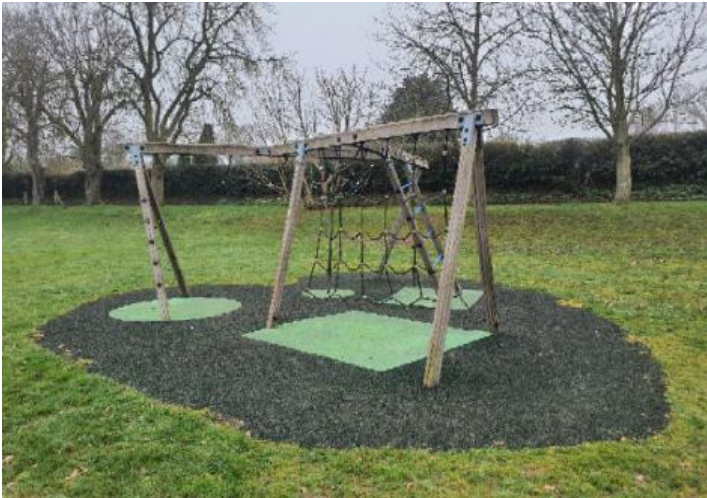
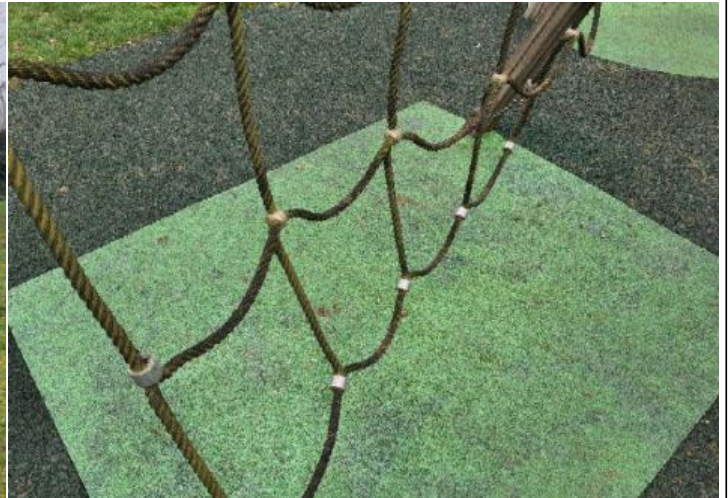
Item: Activity Equipment - Climbing Frame
Manufacturer: Kompan Ltd

Finding: There is algae or moss on the surface of the equipment

Action: Clean and treat appropriately

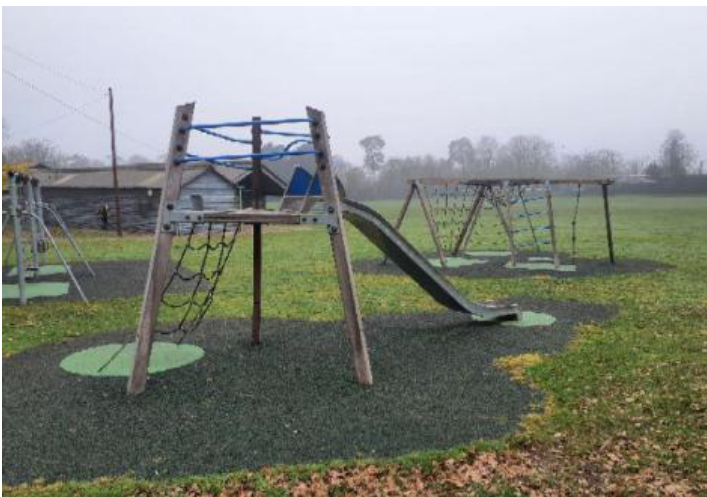
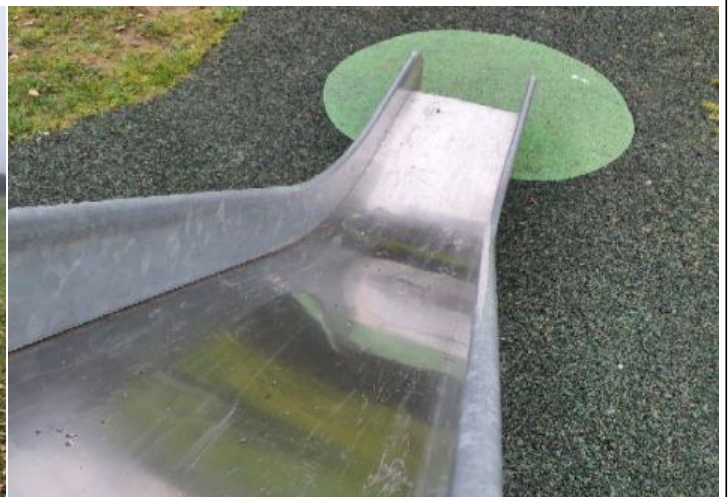
Item: Activity Equipment - Multi Play (Junior)
Manufacturer: Kompan Ltd

Finding: There are a number of dents in the slide surface

Action: Monitor for any further deterioration and repair as required

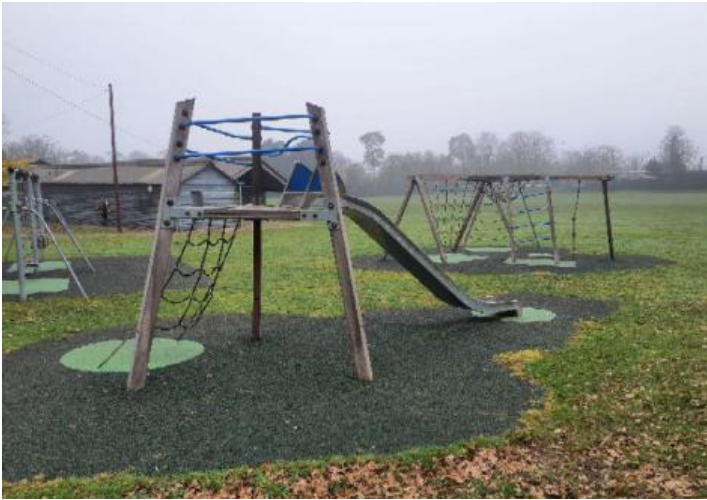
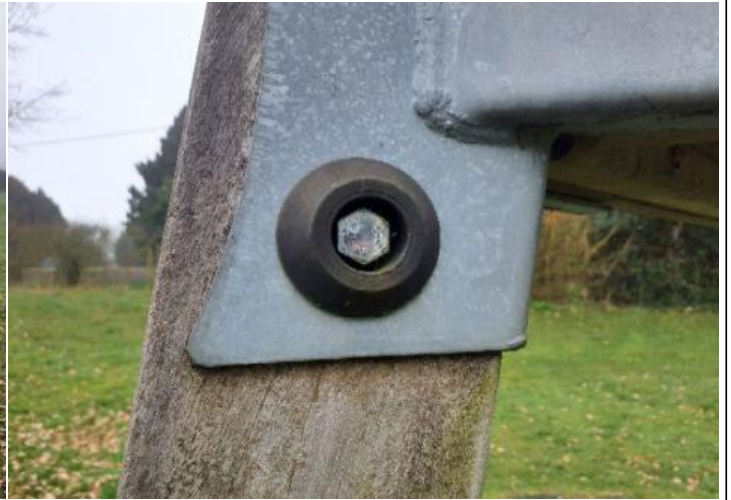
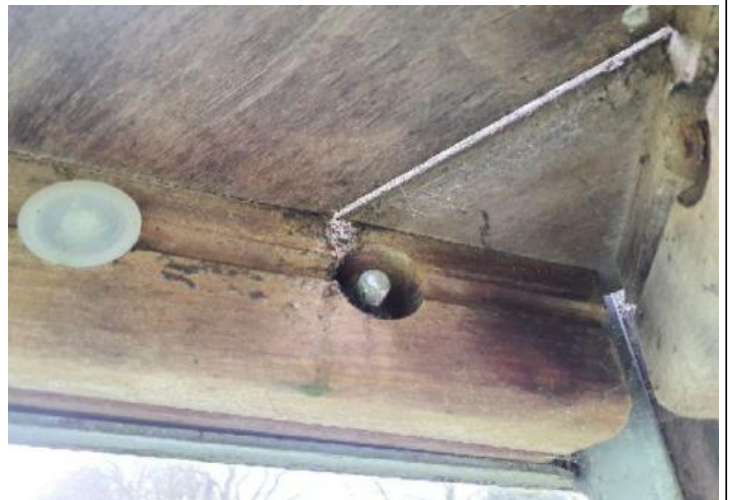
Item: Activity Equipment - Multi Play (Junior)
Manufacturer: Kompan Ltd

Finding: Bolt cap cover/s missing or damaged

Action: Replace

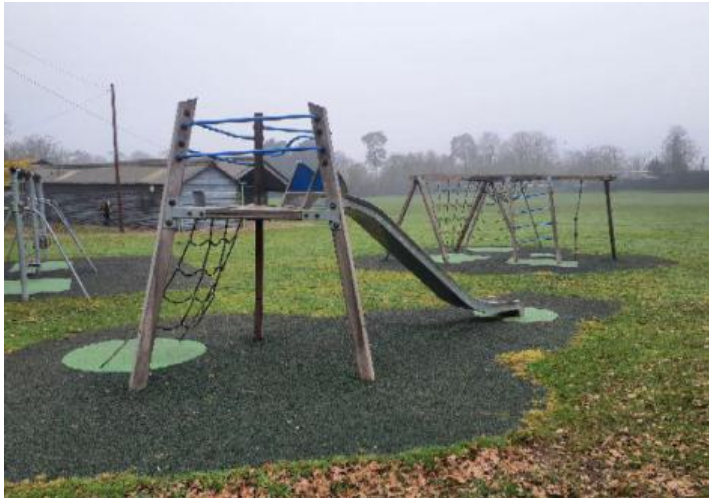
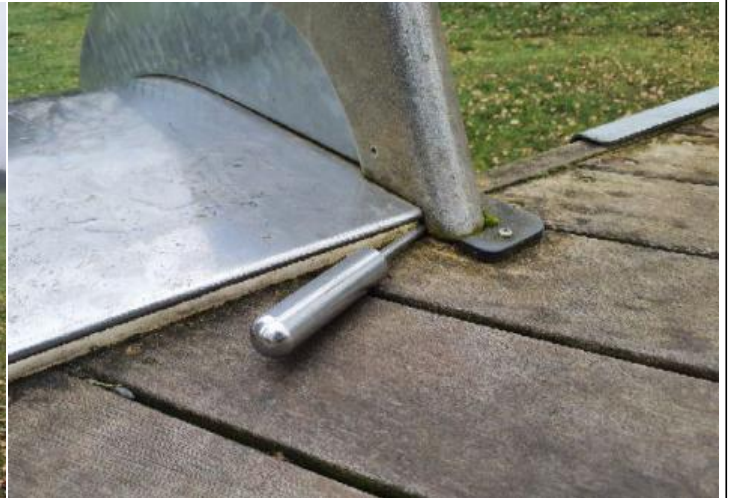
Item: Activity Equipment - Multi Play (Junior)
Manufacturer: Kompan Ltd

Finding: There is/are finger entrapment/s in the slide starting section and the item fails to meet the requirements of BS EN 1176 Part 1 4.2.7.6 Entrapment of fingers

Action: Monitor - No action given the risk assessment

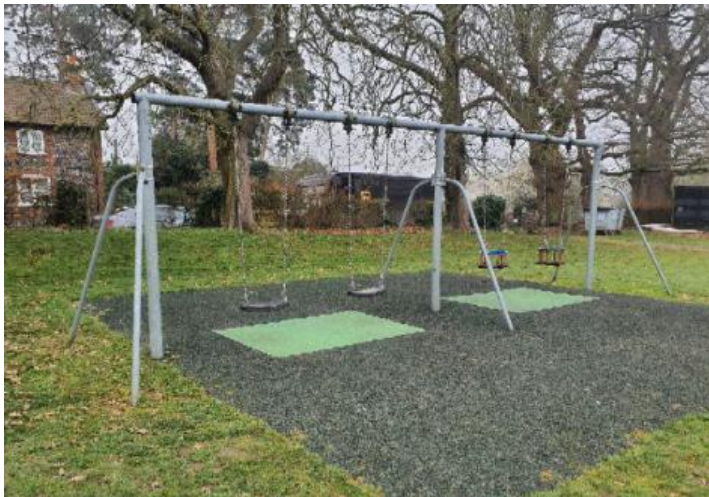
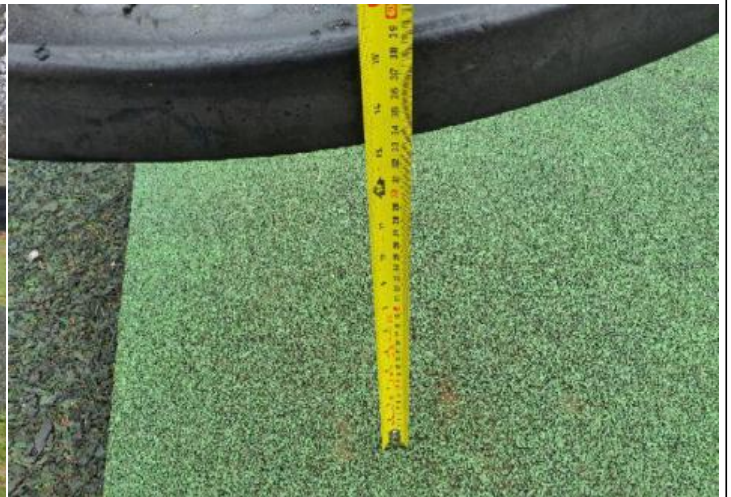
Item: Swings - 2 Bay (2 Flat, 2 Cradle)
Manufacturer: Kompan Ltd

Finding: The seat clearance from finished surface level to the underside of the seat is too low and does not meet the requirements of BS EN 1176 Part 2 (350mm minimum clearance required)

Action: Adjust seat height/s (400mm-500mm is recommended)

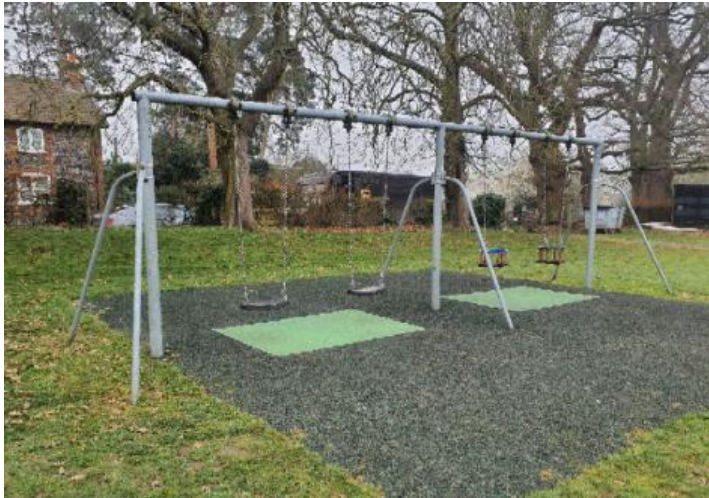
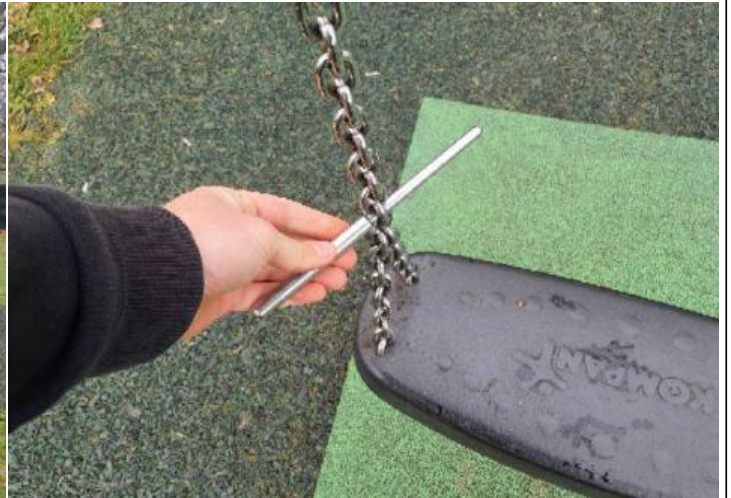
Item: Swings - 2 Bay (2 Flat, 2 Cradle)
Manufacturer: Kompan Ltd

Finding: The chain openings are in excess of 8.6mm and do not meet the recommendations of BS EN 1176 Part 1

Action: Monitor - No action given the risk assessment

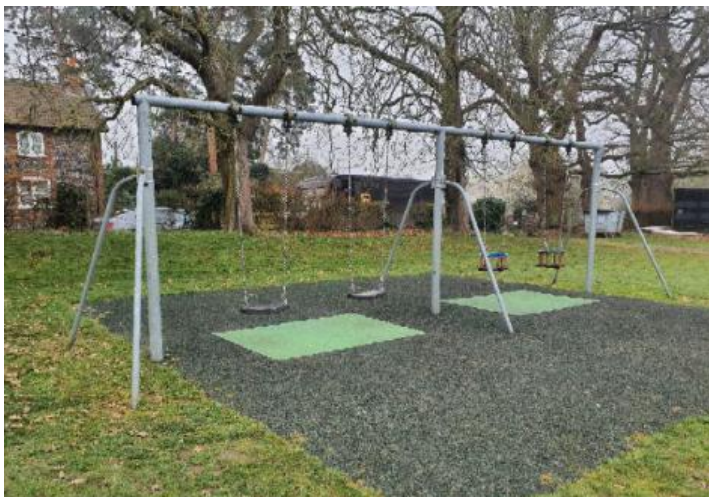
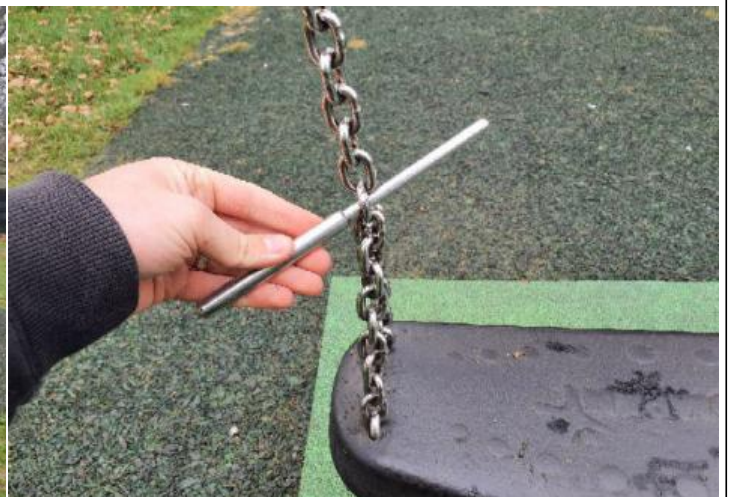
Item: Swings - 2 Bay (2 Flat, 2 Cradle)
Manufacturer: Kompan Ltd

Finding: The connecting links are in excess of 8.6mm and less than 12mm and fail the requirements of BS EN 1176 Part 1; clause 4.2.13, Chains

Action: Monitor use and replace with compliant links at the next maintenance cycle

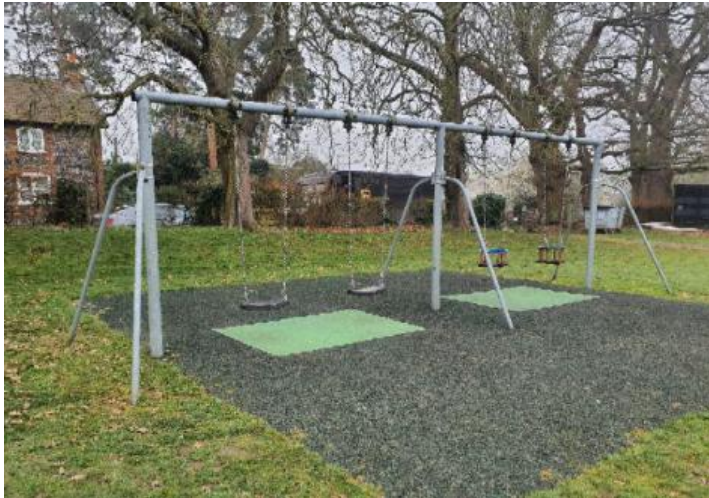
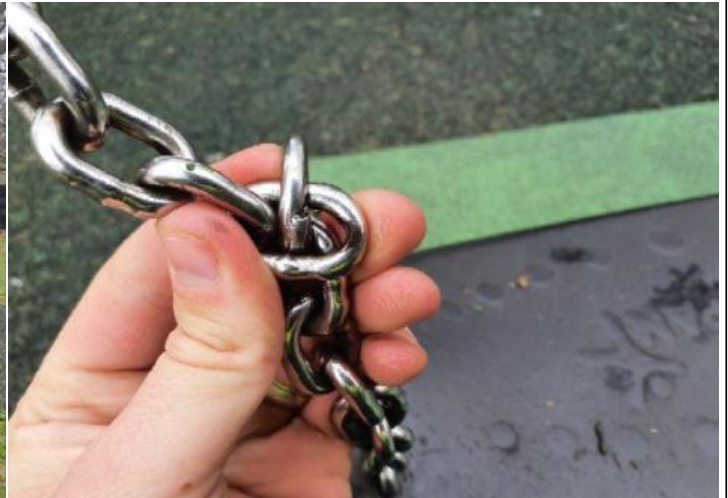
Item: Swings - 2 Bay (2 Flat, 2 Cradle)
Manufacturer: Kompan Ltd

Finding: There is some notable evidence of chain wear

Action: Monitor for any further deterioration and replace when 40% worn

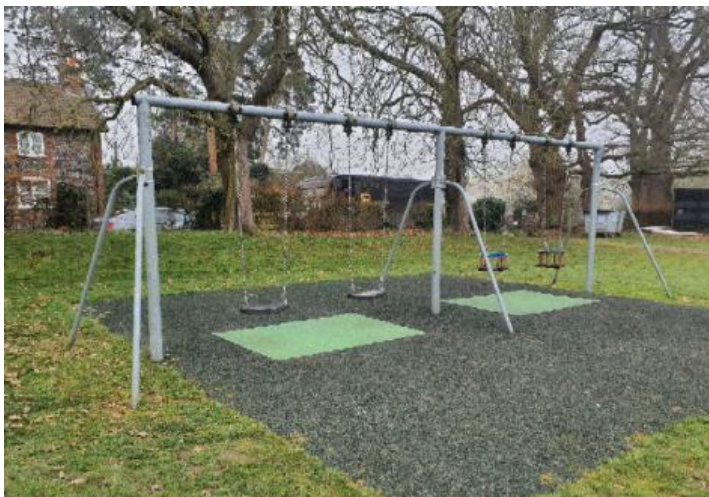
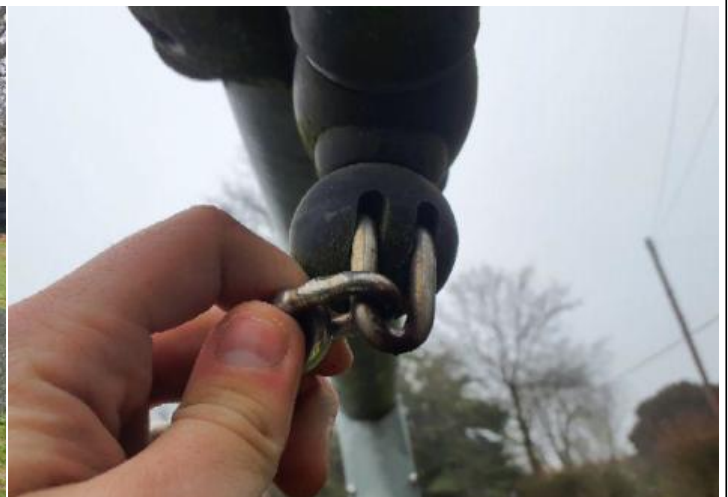
Item: Swings - 2 Bay (2 Flat, 2 Cradle)
Manufacturer: Kompan Ltd

Finding: The suspension lugs are showing signs of wear

Action: Monitor for any further deterioration and repair as required
