## Annual Inspection

Mid Suffolk District Council

Thurston Trim Trail Fitness Area

New Green Centre, Station Hill, Thurston, Suffolk, IP31  
3QU

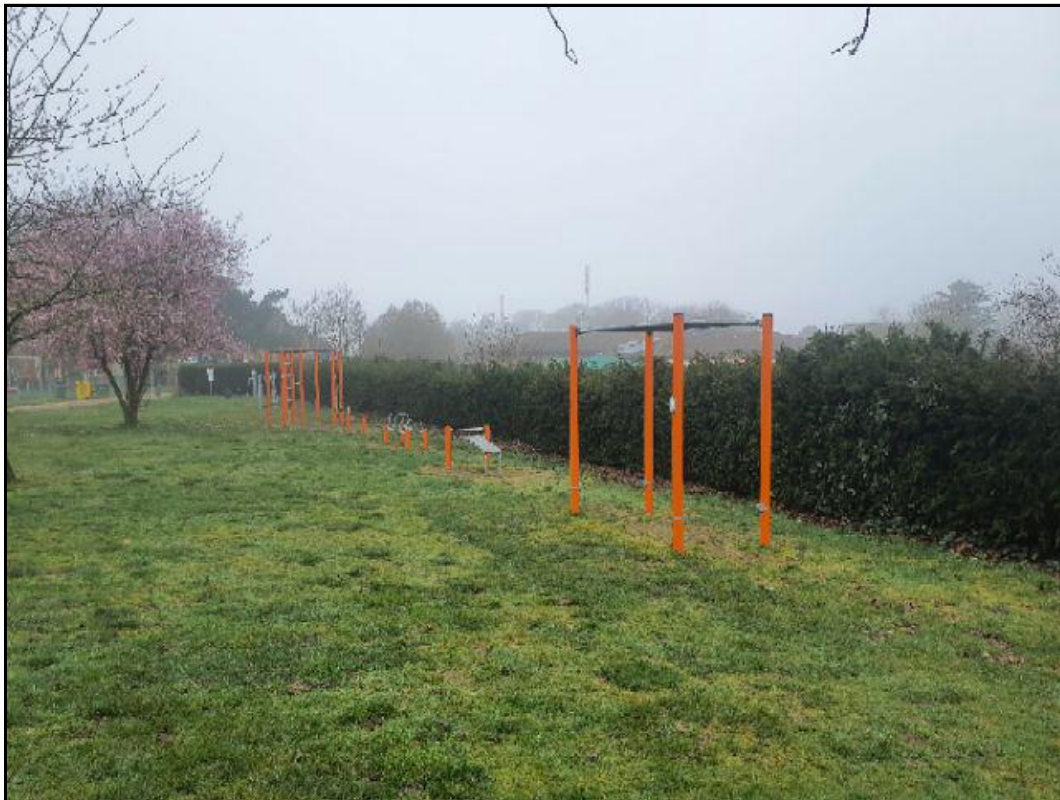
Risk Assessment: 10 Low Risk

The site is located in an area of public open space and is not directly overlooked by any properties in the local community.

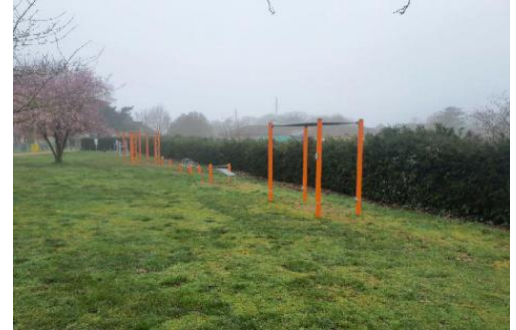
**Item:** Site General  
**Manufacturer:** Owner/Operator  
**Surface Type:** N/A  
**Item Quantity:** 1  
**Equipment Compliance:** N/A  
**Surface Area Compliance:** N/A

Works have taken place adjacent to the area leaving temporary fence and low metal pins - Provide a more suitable isolation method or complete works

The grass mats are silted up, the soil is compacted and the area will become very slippery when the soil is wet. - Reinstate as required

There are gaps opening between the grass mat tiles - Provide additional ties or secure / reinstate surface

There is a lack of growth within the grass area - Encourage growth with grass seeds

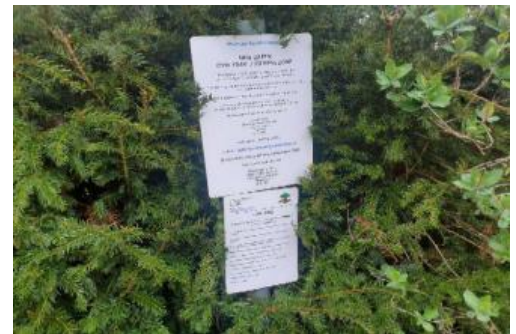
**Item:** Sign  
**Manufacturer:** Not Identified  
**Surface Type:** Grass  
**Item Quantity:** 1  
**Equipment Compliance:** N/A  
**Surface Area Compliance:** N/A

This item is satisfactory - no work required -

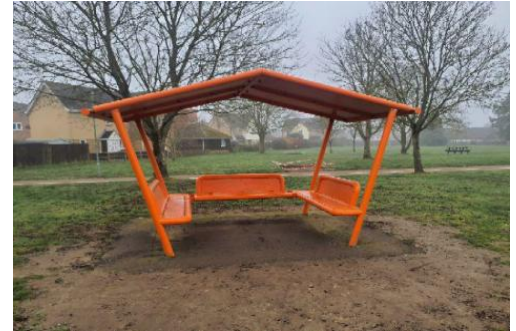
**Item:** Shelter  
**Manufacturer:** Caloo  
**Surface Type:** All Weather Surface  
**Item Quantity:** 1  
**Equipment Compliance:** N/A  
**Surface Area Compliance:** N/A

The surface has eroded in some areas and may be slippery in wet conditions - Reinstate the surface

Bolt cap cover/s missing or damaged - Replace

There are trip hazards at the edges of the surface - Remove trip hazard

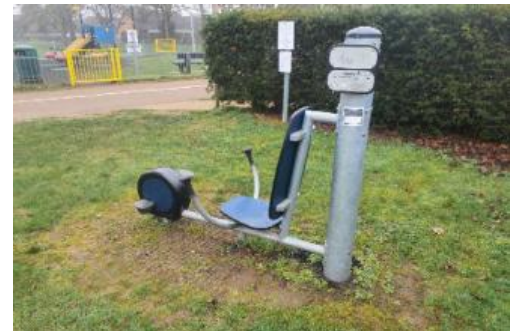
**Item:** Cycle  
**Manufacturer:** Kompan Ltd  
**Surface Type:** Grass Matrix Tiles  
**Item Quantity:** 1  
**Equipment Compliance:** Yes  
**Surface Area Compliance:** Yes

This item is satisfactory - no work required -

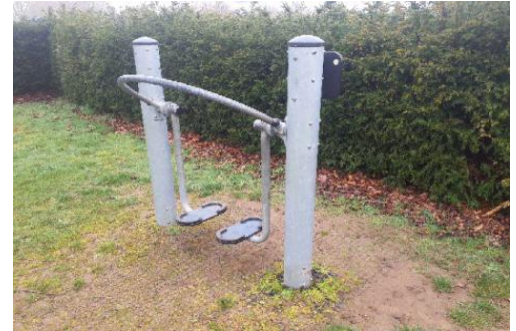
**Item:** Air Walker  
**Manufacturer:** Kompan Ltd  
**Surface Type:** Grass Matrix Tiles  
**Item Quantity:** 1  
**Equipment Compliance:** No  
**Surface Area Compliance:** Yes

There are obstacles located within the movement space of the item in contravention of the requirements of BS EN 16630  
 - Cut back and maintain a 1.5m movement space

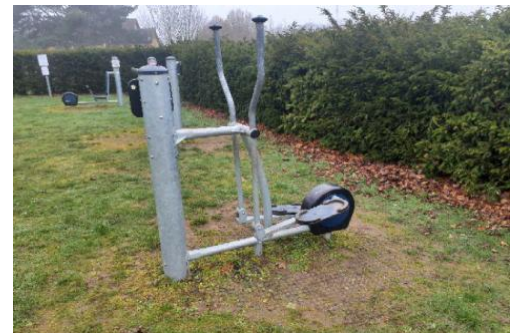
**Item:** Cross Trainer  
**Manufacturer:** Kompan Ltd  
**Surface Type:** Grass Matrix Tiles  
**Item Quantity:** 1  
**Equipment Compliance:** Yes  
**Surface Area Compliance:** Yes

The bearing is showing signs of wear - Monitor for any further deterioration and replace as required

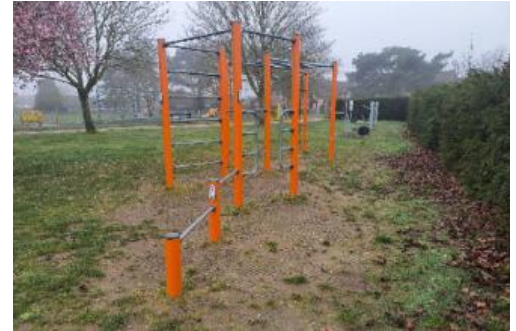
**Item:** Activity Station  
**Manufacturer:** Kompan Ltd  
**Surface Type:** Grass Matrix Tiles  
**Item Quantity:** 1  
**Equipment Compliance:** Yes  
**Surface Area Compliance:** Yes

This item is satisfactory - no work required -

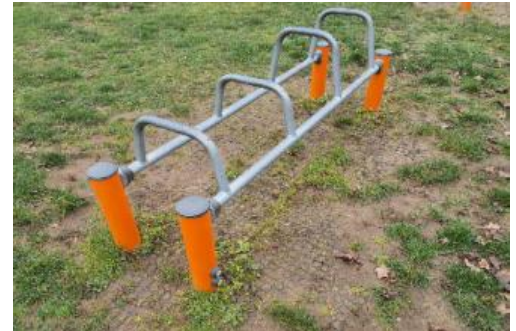
**Item:** Dip Station  
**Manufacturer:** Kompan Ltd  
**Surface Type:** Grass Matrix Tiles  
**Item Quantity:** 1  
**Equipment Compliance:** Yes  
**Surface Area Compliance:** Yes

This item is satisfactory - no work required -

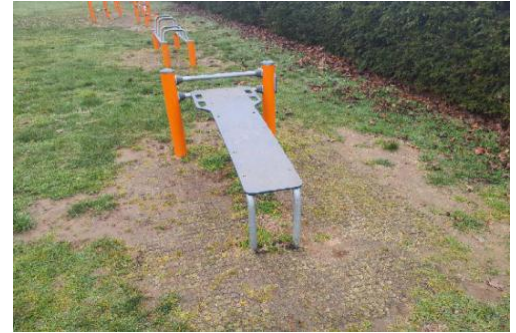
**Item:** Sit Up Station  
**Manufacturer:** Kompan Ltd  
**Surface Type:** Grass Matrix Tiles  
**Item Quantity:** 1  
**Equipment Compliance:** Yes  
**Surface Area Compliance:** Yes

The item has been damaged - Monitor for any further deterioration and replace as required

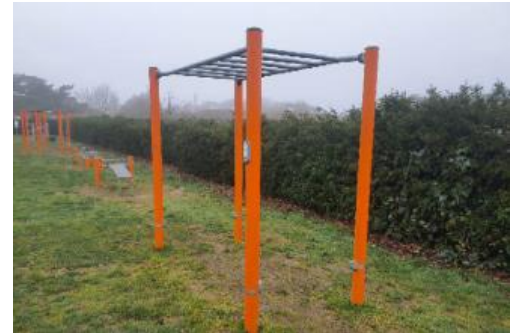
**Item:** Overhead Bars  
**Manufacturer:** Kompan Ltd  
**Surface Type:** Grass Matrix Tiles  
**Item Quantity:** 1  
**Equipment Compliance:** Yes  
**Surface Area Compliance:** Yes

This item is satisfactory - no work required -

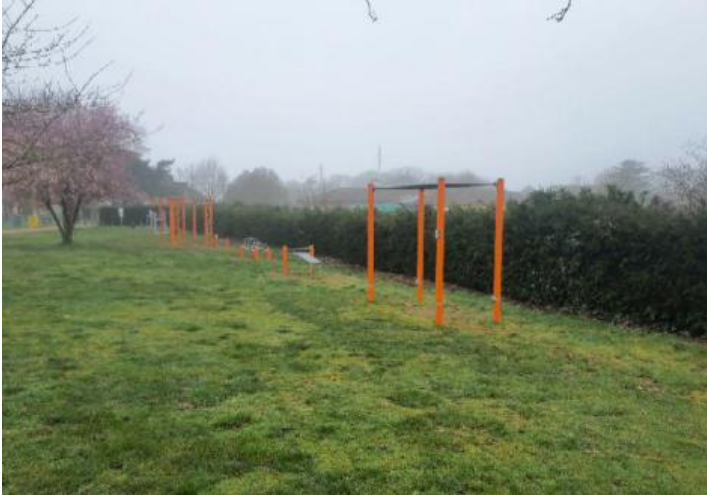
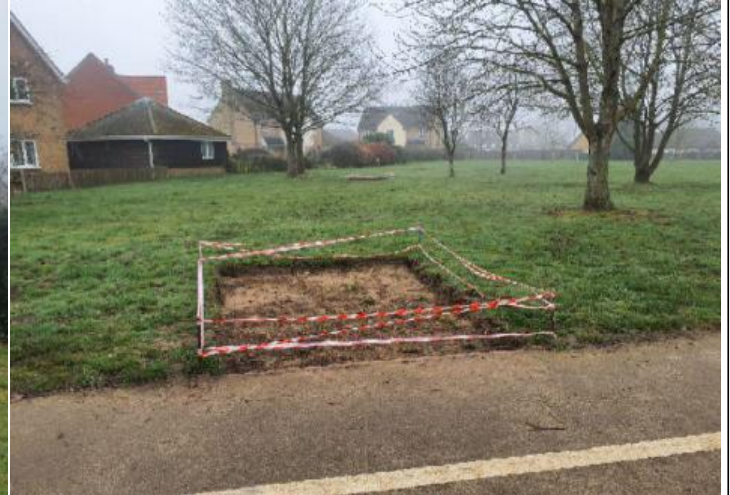
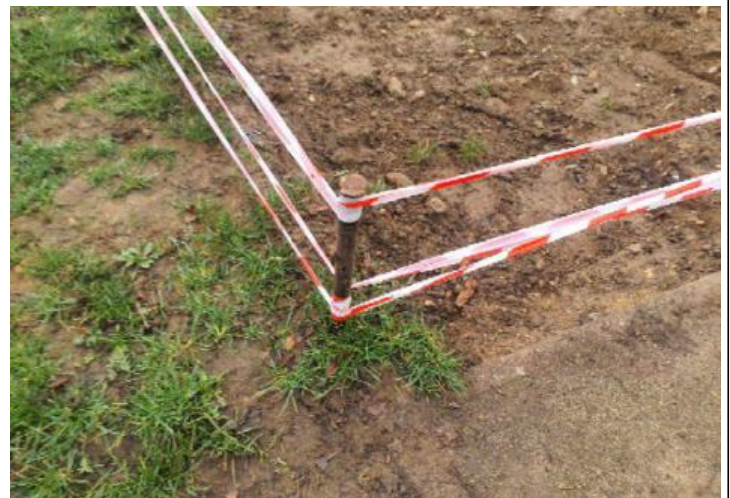
**i** 10 - Low Risk (Finding 1)

**Finding:** Works have taken place adjacent to the area leaving temporary fence and low metal pins

**Action:** Provide a more suitable isolation method or complete works

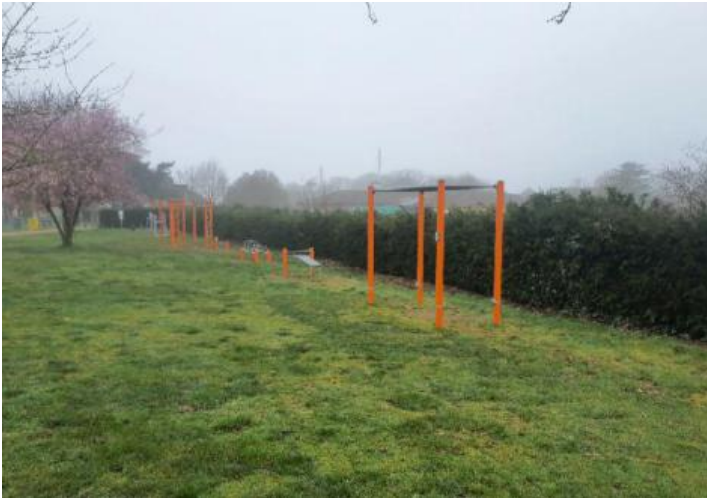
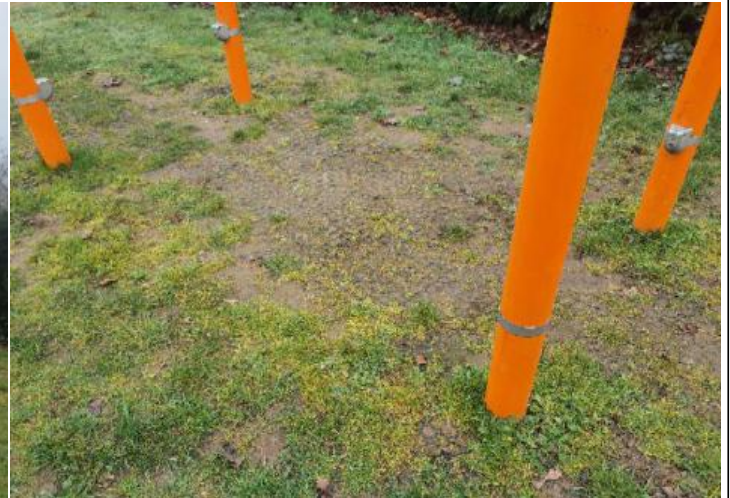
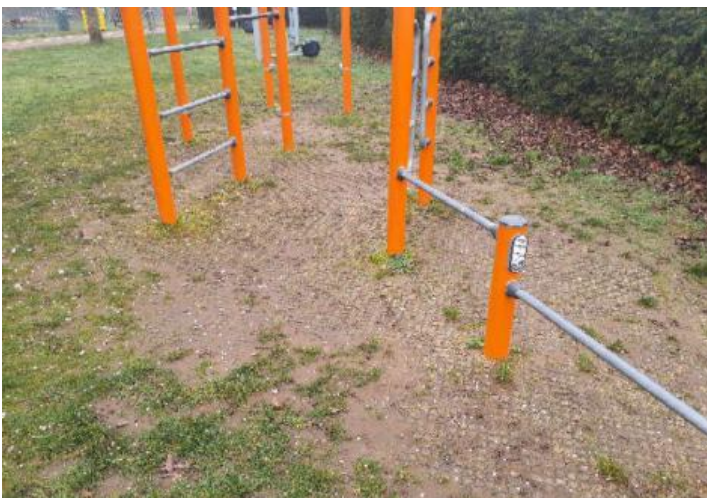
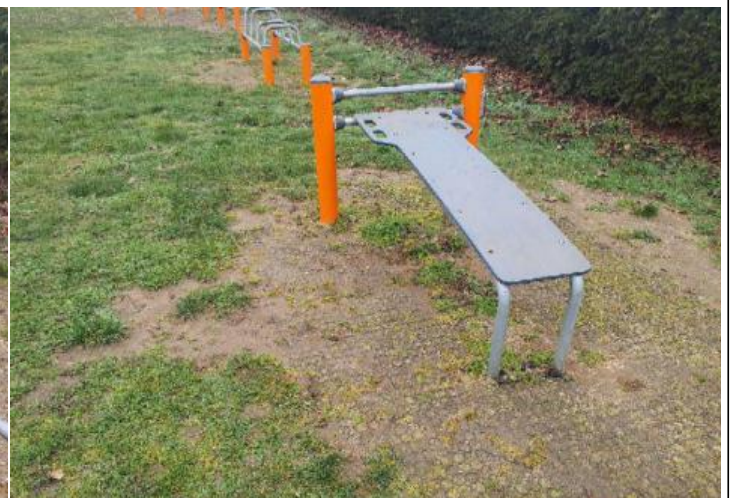
**i** 8 - Low Risk (Finding 2)

**Finding:** The grass mats are silted up, the soil is compacted and the area will become very slippery when the soil is wet. **Action:** Reinstate as required

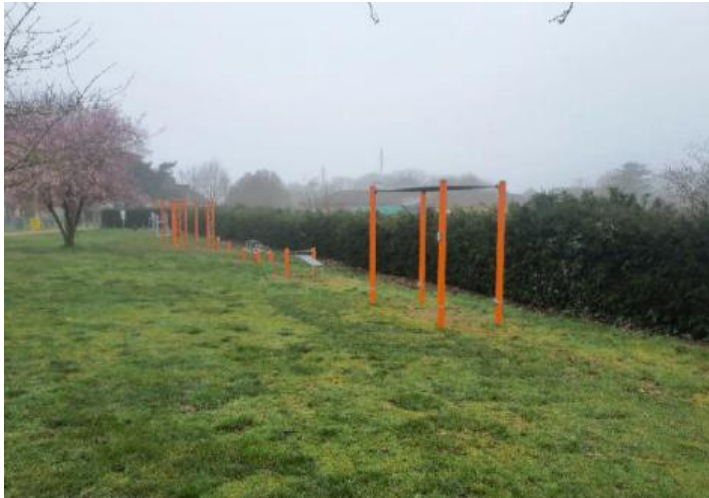
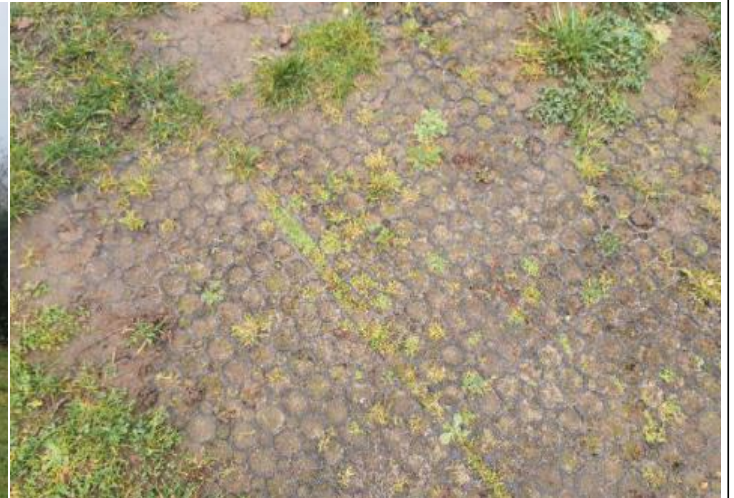
**i** 6 - Low Risk (Finding 3)

**Finding:** There are gaps opening between the grass mat tiles      **Action:** Provide additional ties or secure / reinstate surface tiles

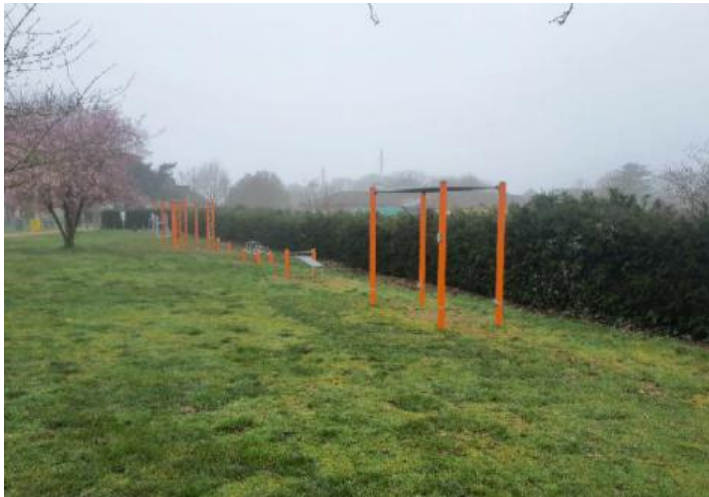
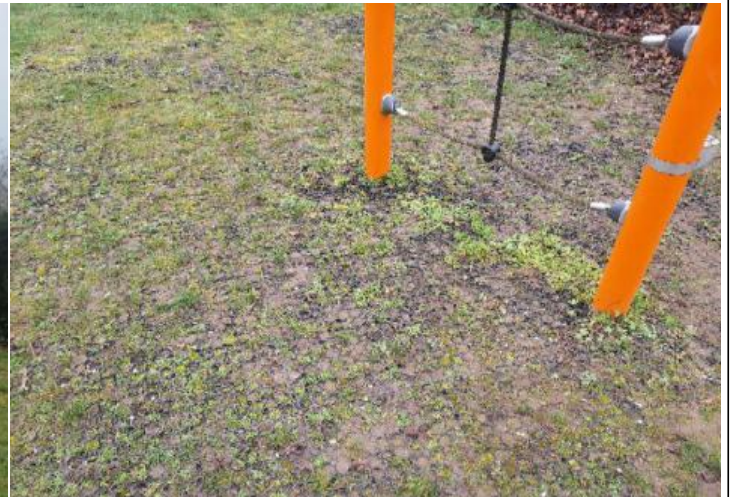
**i** 6 - Low Risk (Finding 4)

**Finding:** There is a lack of growth within the grass area      **Action:** Encourage growth with grass seeds

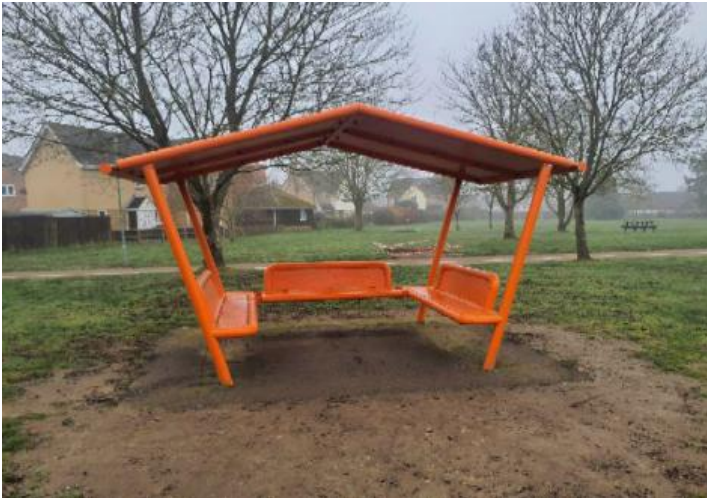
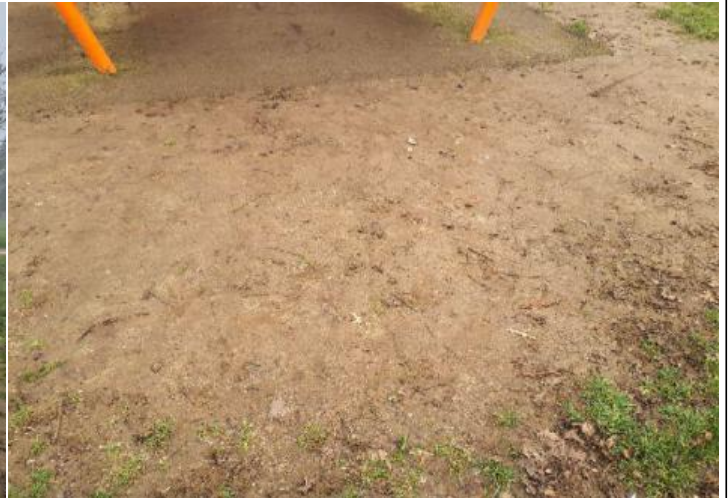
**i** 6 - Low Risk (Finding 1)

**Finding:** The surface has eroded in some areas and may be slippery in wet conditions  
**Action:** Reinstate the surface

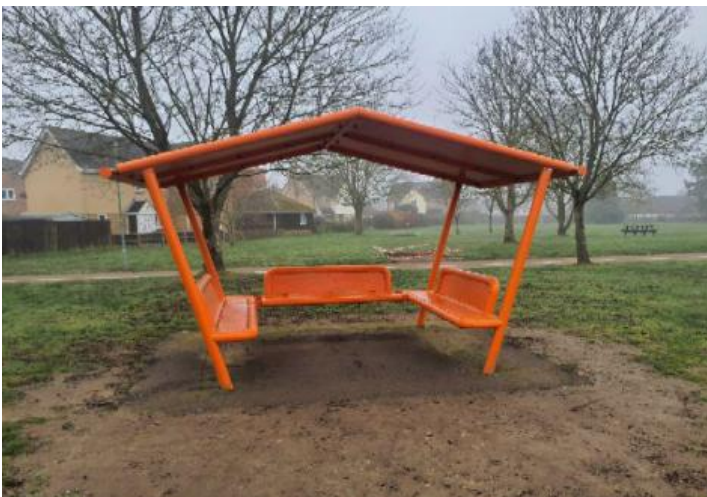
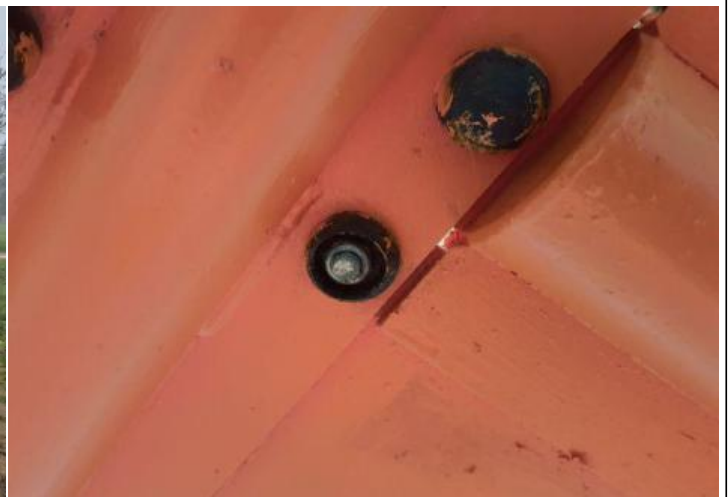
**i** 4 - Very Low Risk (Finding 2)

**Finding:** Bolt cap cover/s missing or damaged  
**Action:** Replace

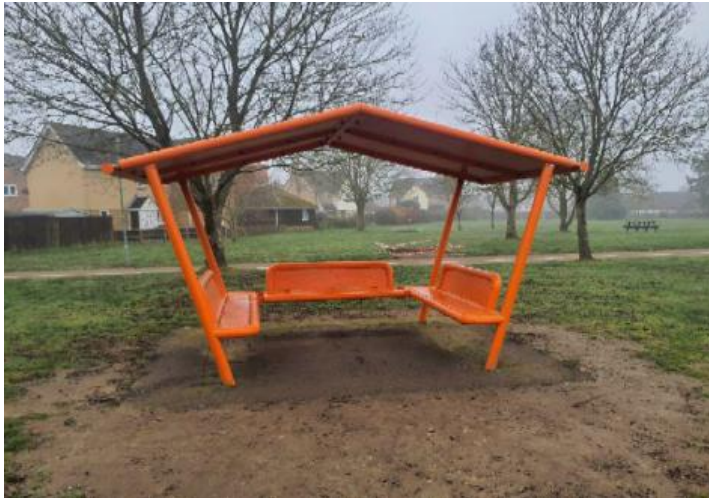
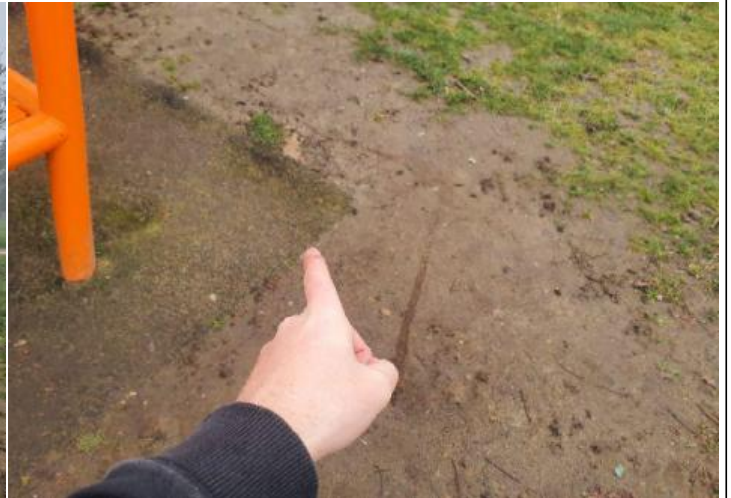
**i** 8 - Low Risk (Finding 3)

**Finding:** There are trip hazards at the edges of the surface **Action:** Remove trip hazard

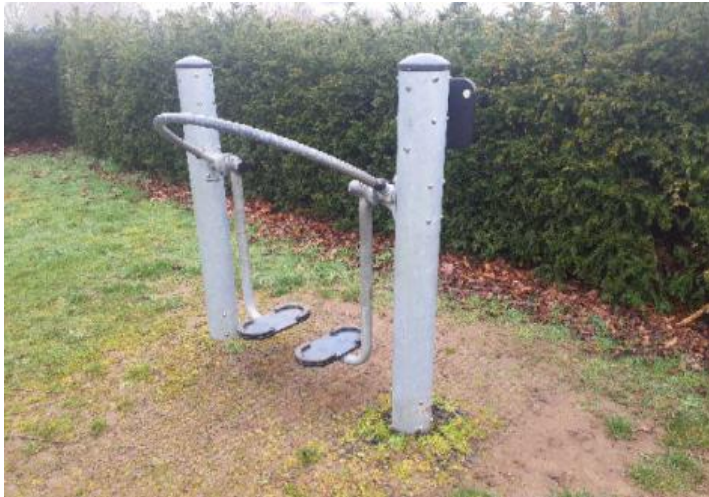
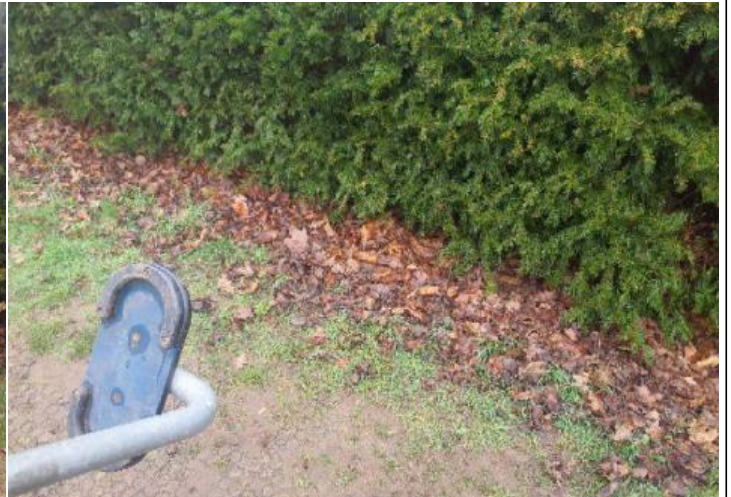
**i** 8 - Low Risk (Finding 1)

**Finding:** There are obstacles located within the movement space of the item in contravention of the requirements of BS EN 16630 **Action:** Cut back and maintain a 1.5m movement space

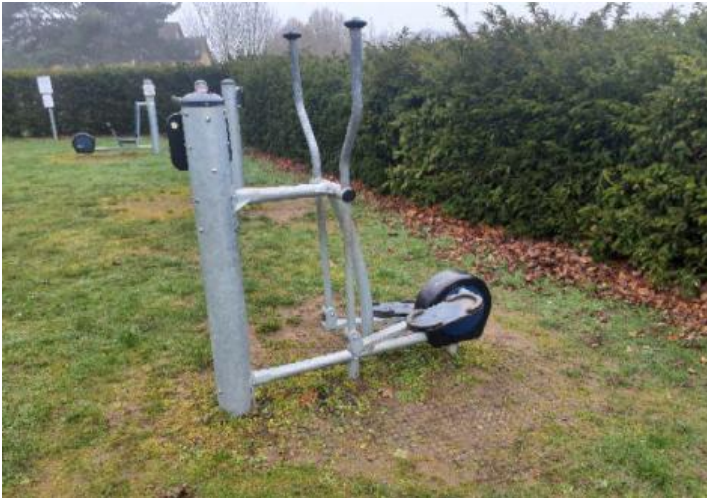
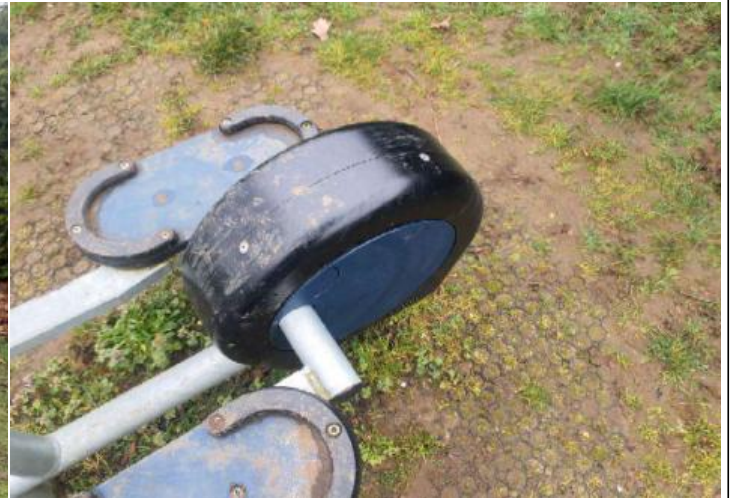
**i** 8 - Low Risk (Finding 1)

**Finding:** The bearing is showing signs of wear

**Action:** Monitor for any further deterioration and replace as required

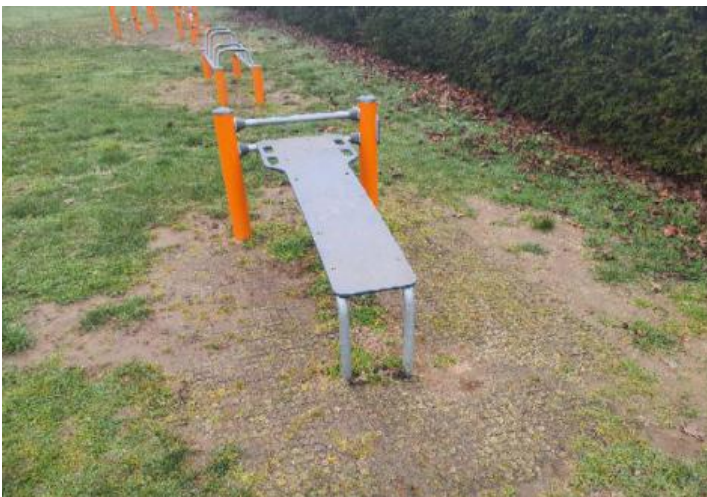
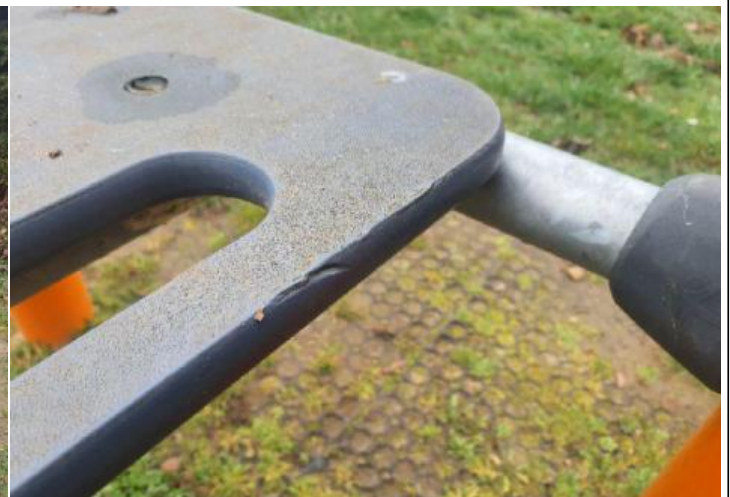
**i** 6 - Low Risk (Finding 1)

**Finding:** The item has been damaged

**Action:** Monitor for any further deterioration and replace as required
