## Annual Inspection

Mid Suffolk District Council

Thurston - Thedwastre Park

Adj to New Green Centre, Station Hill, Thurston, Suffolk,  
IP31 3QU

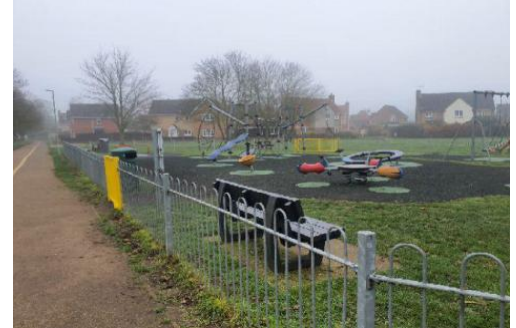
**Item:** Site General  
**Manufacturer:** Owner/Operator  
**Surface Type:** N/A  
**Item Quantity:** 1  
**Equipment Compliance:** N/A  
**Surface Area Compliance:** N/A

There is weed / vegetation growth within the surface -  
 Remove weed / vegetation growth

The wetpour is crumbling in areas - Monitor for any further  
 deterioration and repair as required

The surface is lifting at the edges and creating trip points -  
 Repair perimeter of surfacing to remove trip points

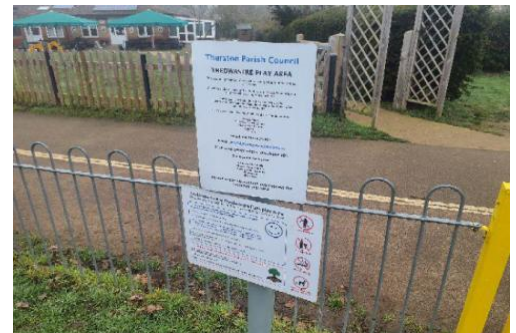
**Item:** Sign  
**Manufacturer:** Not Identified  
**Surface Type:** Grass  
**Item Quantity:** 1  
**Equipment Compliance:** N/A  
**Surface Area Compliance:** N/A

There are projecting bolt thread(s) present - Remove excess thread length and deburr or provide cap

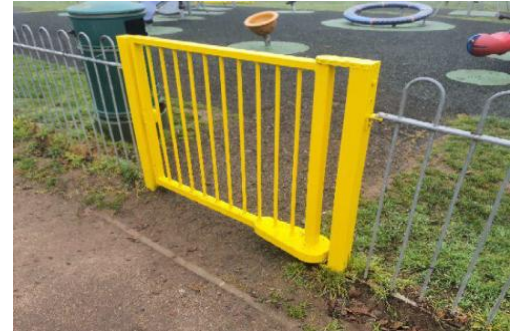
**Item:** Gate - Self Closing  
**Manufacturer:** I.A.E. Fencing  
**Surface Type:** Mixed Surface  
**Item Quantity:** 2  
**Equipment Compliance:** N/A  
**Surface Area Compliance:** N/A

The surface has eroded in some areas and may be slippery in wet conditions - Reinstate the surface

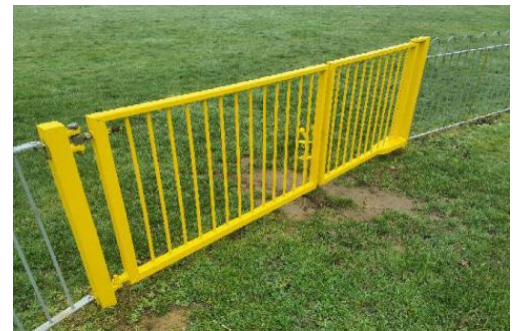
**Item:** Gate - Combination  
**Manufacturer:** I.A.E. Fencing  
**Surface Type:** Grass  
**Item Quantity:** 1  
**Equipment Compliance:** N/A  
**Surface Area Compliance:** N/A

The surface has eroded in some areas and may be slippery in wet conditions - Reinstate the surface

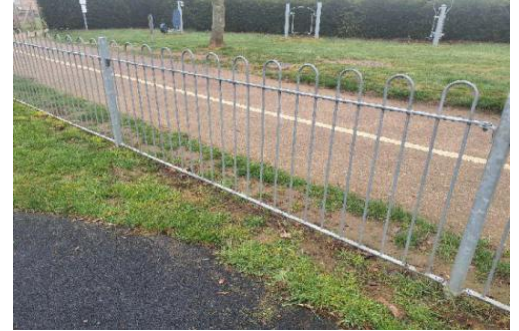
**Item:** Fence - Bow Top  
**Manufacturer:** Not Identified  
**Surface Type:** Grass  
**Item Quantity:** 1  
**Equipment Compliance:** N/A  
**Surface Area Compliance:** N/A

There are holes in the surface that may cause users to trip or roll ankles - Infill to provide a sound reasonably level surface.

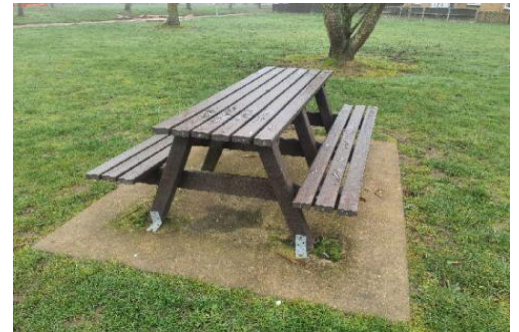
**Item:** Picnic Table  
**Manufacturer:** Not Identified  
**Surface Type:** Concrete  
**Item Quantity:** 1  
**Equipment Compliance:** N/A  
**Surface Area Compliance:** N/A

There are trip hazards at the edges of the surface - Remove trip hazard

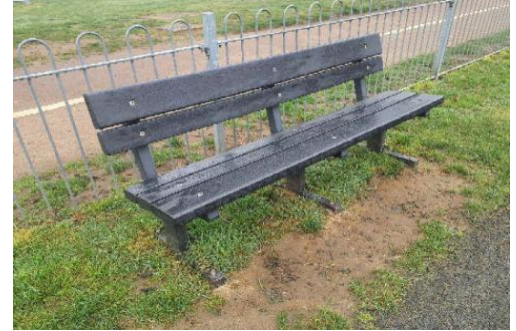
**Item:** Bench  
**Manufacturer:** Not Identified  
**Surface Type:** Paving Slabs  
**Item Quantity:** 2  
**Equipment Compliance:** N/A  
**Surface Area Compliance:** N/A

The surface has eroded in some areas and may be slippery in wet conditions - Reinstate the surface

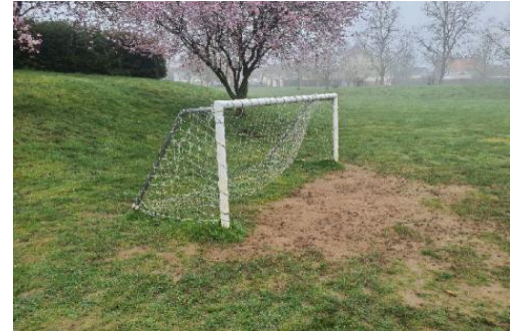
**Item:** 5 a side Goals  
**Manufacturer:** Not Identified  
**Surface Type:** Grass  
**Item Quantity:** 1  
**Equipment Compliance:** N/A  
**Surface Area Compliance:** N/A

The surface has eroded in some areas and may be slippery in wet conditions - Reinstate the surface

The paintwork on this item has been damaged or worn exposing the metal underneath which is rusting / corroding - Treat affected areas and repaint

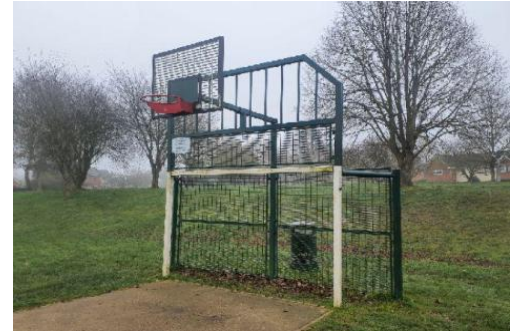
**Item:** Goalmouth and Basketball Post  
**Manufacturer:** Monster Play Systems  
**Surface Type:** Bitmac  
**Item Quantity:** 1  
**Equipment Compliance:** Yes  
**Surface Area Compliance:** N/A  
**Life Expectancy:** 5 -10 Years  
**Total Findings:** 6

A clearly visible facility sign should be provided in a prominent position with the wording as detailed BS EN 15312- the equipment is not intended for children less than 3 years old- the warning - Do not climb on the framework or nets- the warning - Do not hang on the ring (if provided)- the warning - Do not wear rings or other jewellery- name and telephone number of the administrator- number to call in case of accident - Provide signage to BS EN 15312

There are trip hazards at the edges of the surface - Remove trip hazard

The surface has eroded in some areas and may be slippery in wet conditions - Reinstate the surface

A number of fixing(s) have worked loose - Secure all loose fixings

The weld(s) on this item have failed - Repair item

Insert/s missing or damaged - Replace

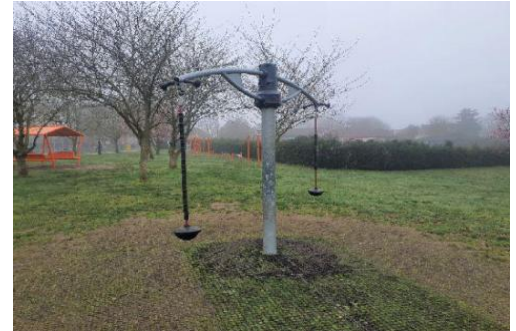
**Item:** Overhead Rotator  
**Manufacturer:** Kompan Ltd  
**Surface Type:** Grass Matrix Tiles  
**Item Quantity:** 1  
**Equipment Compliance:** Yes  
**Surface Area Compliance:** Yes

The grass mats are silted up, the soil is compacted and the area will become very slippery when the soil is wet. - Reinstate as required

There is / are post or end caps missing / damaged on the item - Replace missing / damaged post or end caps

There is moderate damage to the surface - Repair the damaged areas of surfacing

The seat connection cannot be inspected without dismantling the seat - Dismantle the seat to inspect the seat connection for wear

There is or are fixings missing from one of the suspensions (The inspector taped the item at the time of inspection as a temporary measure but further action is required asap) - Replace all missing fixings

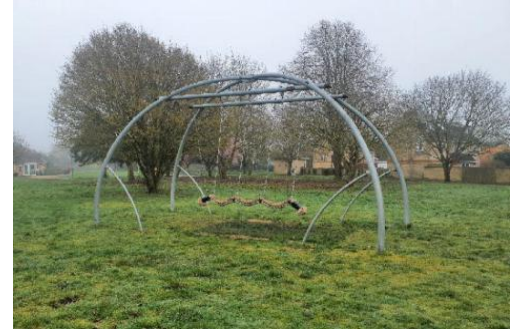
**Item:** Giant Rope Swing  
**Manufacturer:** Kompan Ltd  
**Surface Type:** Grass Matrix Tiles  
**Item Quantity:** 1  
**Equipment Compliance:** Yes  
**Surface Area Compliance:** Yes

NOTE - The fixings or components for this item were in excess of 2.5m above the standing surface and could not be fully accessed by the inspector. We have completed a visual inspection of the fixings from ground level but a maintenance inspection should be undertaken to assess the condition, security and wear of the components at intervals in accordance with the manufacturers recommendations. - Inspect in accordance with the manufacturers recommendations

Bolt cap cover/s missing or damaged - Replace

The seat has minor damage or wear - Monitor for any further deterioration and replace as required

There is some notable evidence of chain wear - Monitor for any further deterioration and replace when 40% worn

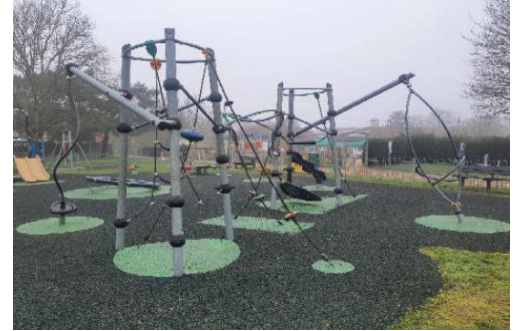
**Item:** Climbing Frame  
**Manufacturer:** Kompan Ltd  
**Surface Type:** Bonded Rubber Mulch  
**Item Quantity:** 1  
**Equipment Compliance:** Yes  
**Surface Area Compliance:** Yes  
**Life Expectancy:** 5 -10 Years  
**Total Findings:** 4

**Finding 1**  
 The rubber coating is deteriorating - Monitor for any further deterioration and replace as required

**Finding 2**  
 There is some notable evidence of chain wear - Monitor for any further deterioration and replace when 40% worn

**Finding 3**  
 The item has been damaged - Monitor for any further deterioration and replace as required

**Finding 4**  
 Bolt cap cover/s missing or damaged - Replace

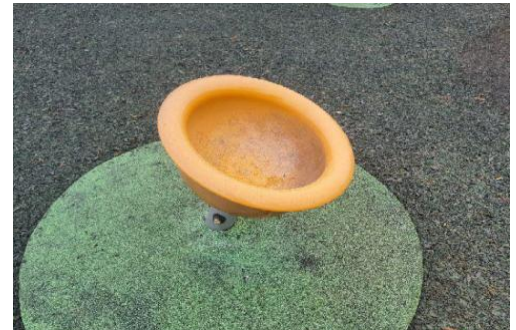
**Item:** Spinner Bowl  
**Manufacturer:** Kompan Ltd  
**Surface Type:** Bonded Rubber Mulch  
**Item Quantity:** 1  
**Equipment Compliance:** Yes  
**Surface Area Compliance:** Yes  
**Life Expectancy:** 5 -10 Years  
**Total Findings:** 1

**Finding 1**  
 The item has been damaged - Monitor for any further deterioration and replace as required

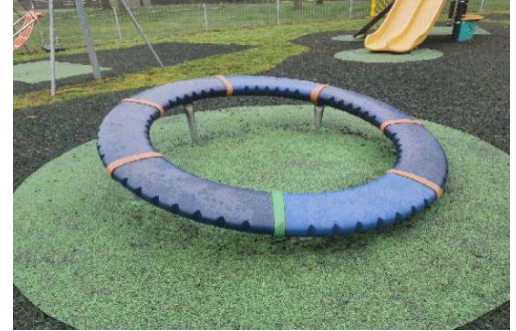
**Item:** Supernova  
**Manufacturer:** Kompan Ltd  
**Surface Type:** Bonded Rubber Mulch  
**Item Quantity:** 1  
**Equipment Compliance:** Yes  
**Surface Area Compliance:** Yes  
**Life Expectancy:** 5 -10 Years  
**Total Findings:** 2

The clearance to the underside less than 117mm and does not meet the manufacturers recommendations - Monitor - No action given the risk assessment

The item has been damaged - Monitor for any further deterioration and replace as required

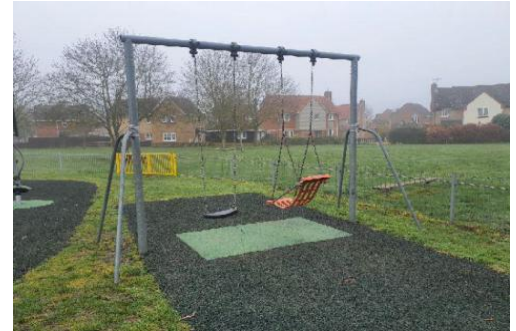
**Item:** 1 Bay 2 Seat (Flat)  
**Manufacturer:** Kompan Ltd  
**Surface Type:** Bonded Rubber Mulch  
**Item Quantity:** 1  
**Equipment Compliance:** No  
**Surface Area Compliance:** Yes  
**Life Expectancy:** 5 -10 Years  
**Total Findings:** 8

NOTE - The fixings or components for this item were in excess of 2.5m above the standing surface and could not be fully accessed by the inspector. We have completed a visual inspection of the fixings from ground level but a maintenance inspection should be undertaken to assess the condition, security and wear of the components at intervals in accordance with the manufacturers recommendations. - Inspect in accordance with the manufacturers recommendations

The chain links are worn excessively and require renewing - Replace worn chains

The connecting links are in excess of 8.6mm and less than 12mm and fail the requirements of BS EN 1176 Part 1; clause 4.2.13, Chains - Monitor use and replace with compliant links at the next maintenance cycle

There is some notable evidence of chain wear - Monitor for any further deterioration and replace when 40% worn

There is / are post or end caps missing / damaged on the item - Replace missing / damaged post or end caps

The seat has minor damage or wear - Monitor for any further deterioration and replace as required

The suspension lugs are showing signs of wear - Monitor for any further deterioration and repair as required

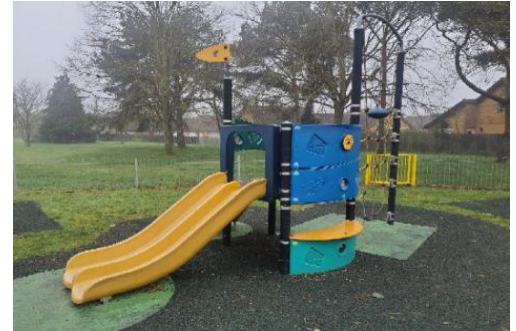
**Item:** Multi Play (Junior)  
**Manufacturer:** Kompan Ltd  
**Surface Type:** Bonded Rubber Mulch  
**Item Quantity:** 1  
**Equipment Compliance:** No  
**Surface Area Compliance:** Yes  
**Life Expectancy:** 5 -10 Years  
**Total Findings:** 4

The item has been damaged - Monitor for any further deterioration and replace as required

The item has missing component(s) - Replace missing components

The chain openings are in excess of 8.6mm and do not meet the recommendations of BS EN 1176 Part 1 - Monitor - No action given the risk assessment

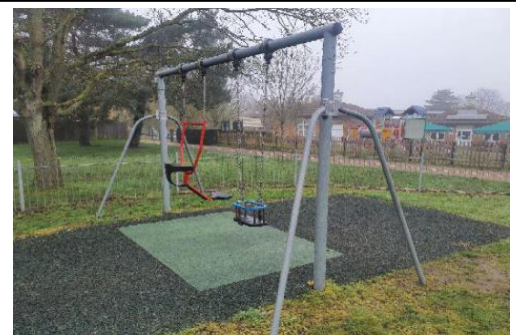
**Item:** 1 Bay 2 Seat (Cradle)  
**Manufacturer:** Kompan Ltd  
**Surface Type:** Bonded Rubber Mulch  
**Item Quantity:** 1  
**Equipment Compliance:** No  
**Surface Area Compliance:** Yes  
**Life Expectancy:** 5 -10 Years  
**Total Findings:** 4

The chain openings are in excess of 8.6mm and do not meet the recommendations of BS EN 1176 Part 1 - Monitor - No action given the risk assessment

There is some notable evidence of chain wear - Monitor for any further deterioration and replace when 40% worn

The suspension lugs are showing signs of wear - Monitor for any further deterioration and repair as required

The bushes are showing signs of wear - Monitor for any further deterioration and replace as required

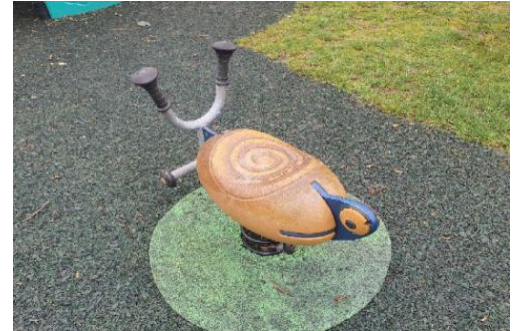
**Item:** Spring Bug  
**Manufacturer:** Kompan Ltd  
**Surface Type:** Bonded Rubber Mulch  
**Item Quantity:** 1  
**Equipment Compliance:** Yes  
**Surface Area Compliance:** Yes  
**Life Expectancy:** 5 -10 Years  
**Total Findings:** 2

The seat has minor damage or wear - Monitor for any further deterioration and replace as required

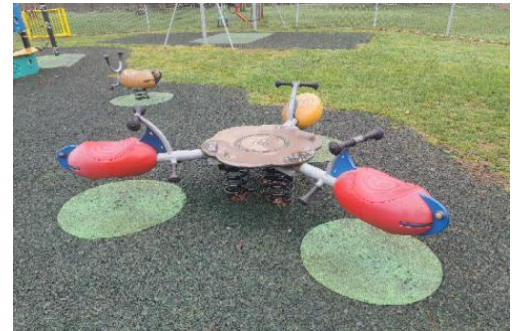
**Item:** Three Way Springer  
**Manufacturer:** Kompan Ltd  
**Surface Type:** Mixed Surface  
**Item Quantity:** 1  
**Equipment Compliance:** Yes  
**Surface Area Compliance:** Yes  
**Life Expectancy:** 5 -10 Years  
**Total Findings:** 1

The item has been damaged - Monitor for any further deterioration and replace as required

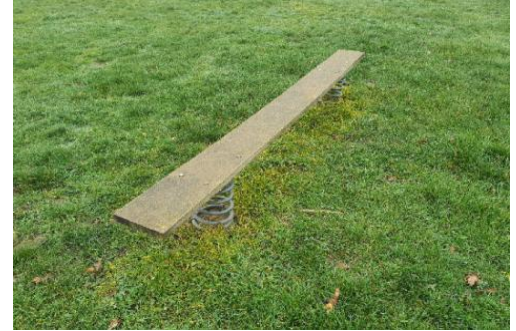
**Item:** Wobble Board  
**Manufacturer:** Not Identified  
**Surface Type:** Grass  
**Item Quantity:** 1  
**Equipment Compliance:** No  
**Surface Area Compliance:** Yes  
**Life Expectancy:** 3 - 5 Years  
**Total Findings:** 1

The fence forms a hard object within the falling space of the equipment and there is also insufficient surfacing provided in contravention of BS EN 1176 Part 1 - Consider re locating the item away from the fence (1.5m)

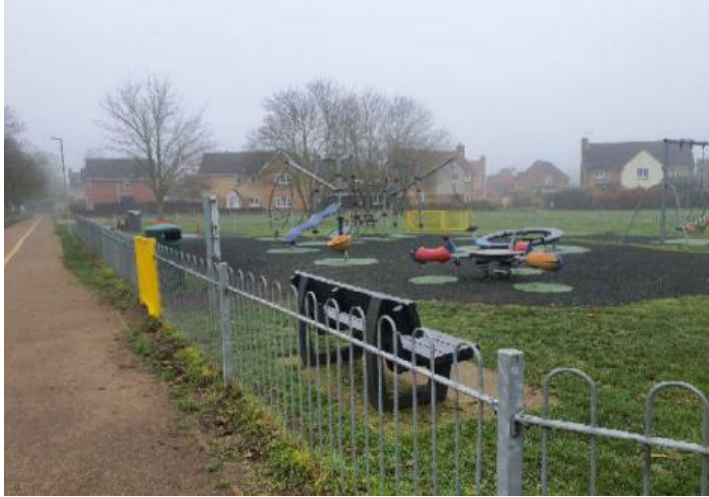
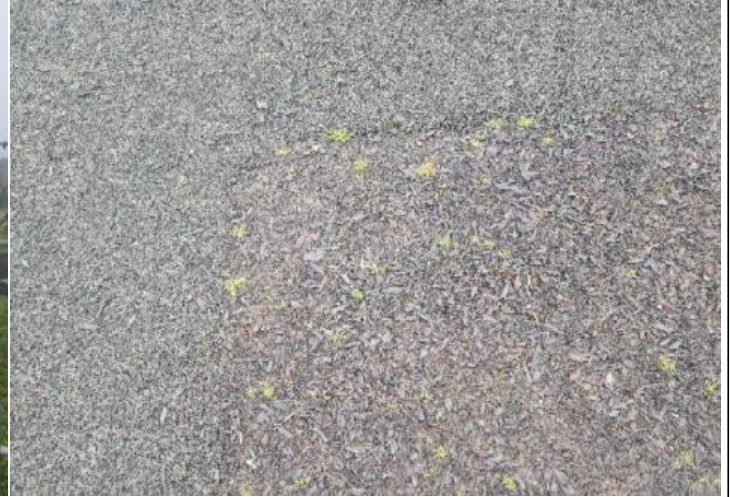
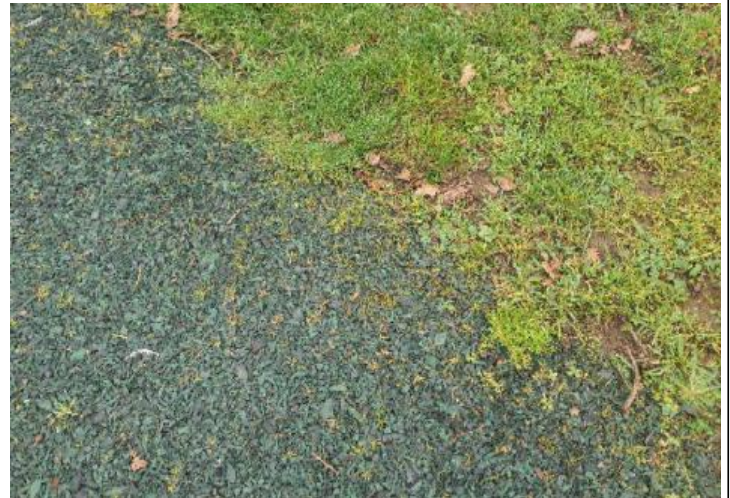
**Item:** Ancillary Items - Site General  
**Manufacturer:** Owner/Operator

**Finding:** There is weed / vegetation growth within the surface

**Action:** Remove weed / vegetation growth

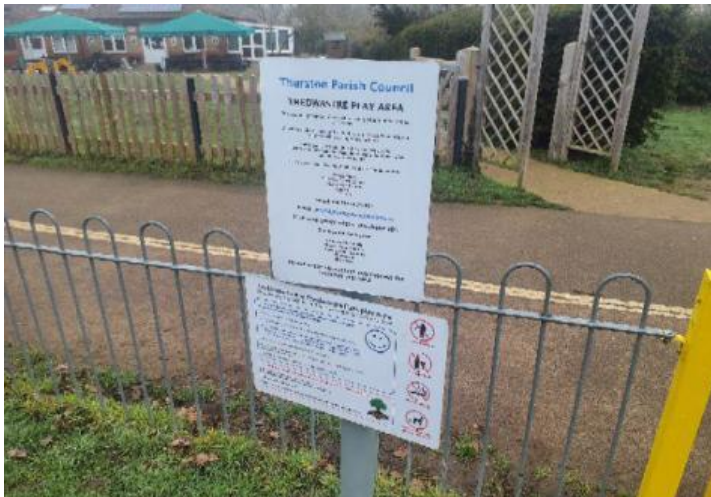
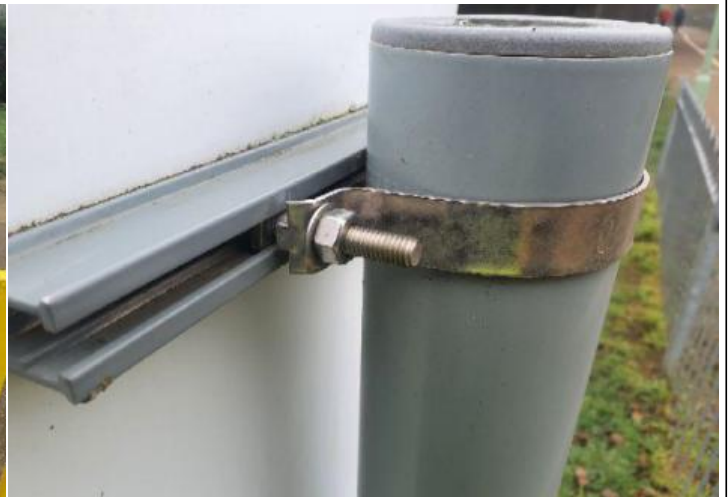
**Item:** Ancillary Items - Sign  
**Manufacturer:** Not Identified

**Finding:** There are projecting bolt thread(s) present  
**Action:** Remove excess thread length and deburr or provide cap

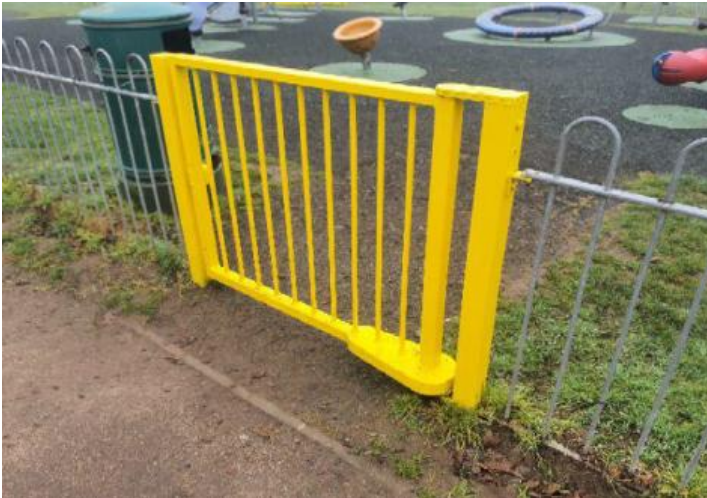
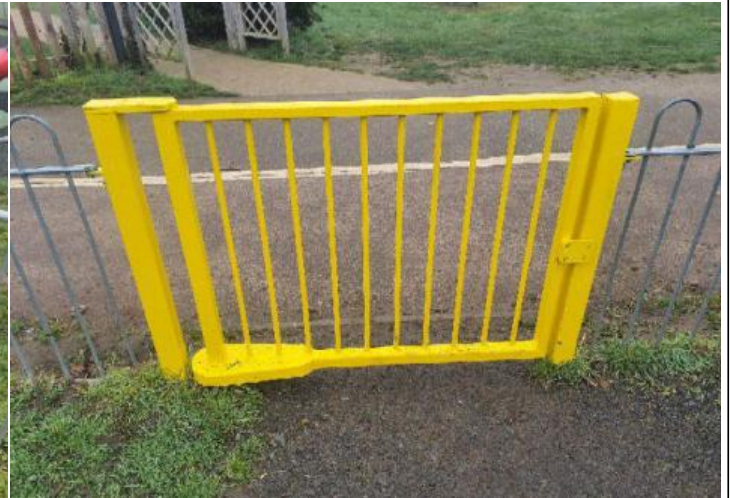
**Item:** Gates - Gate - Self Closing  
**Manufacturer:** I.A.E. Fencing

**Finding:** The gate is closing too quickly (less than 4 seconds)

**Action:** Take corrective action to ensure that the gate closes in 4-8 seconds from 90 degrees

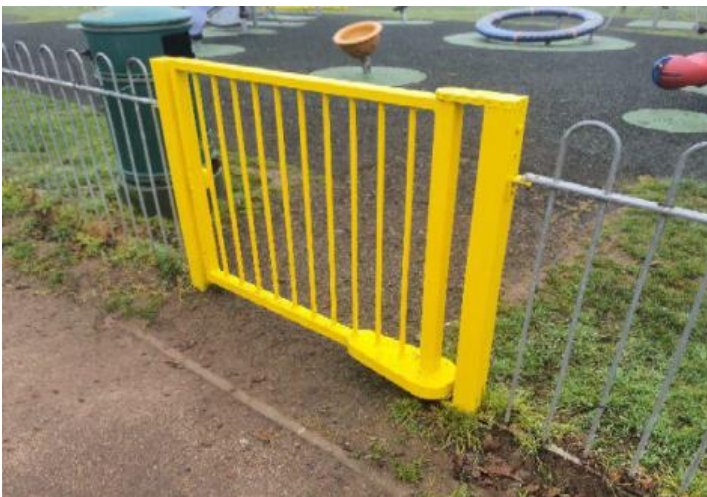
**Item:** Gates - Gate - Self Closing  
**Manufacturer:** I.A.E. Fencing

**Finding:** The surface has eroded in some areas and may be slippery in wet conditions

**Action:** Reinstate the surface

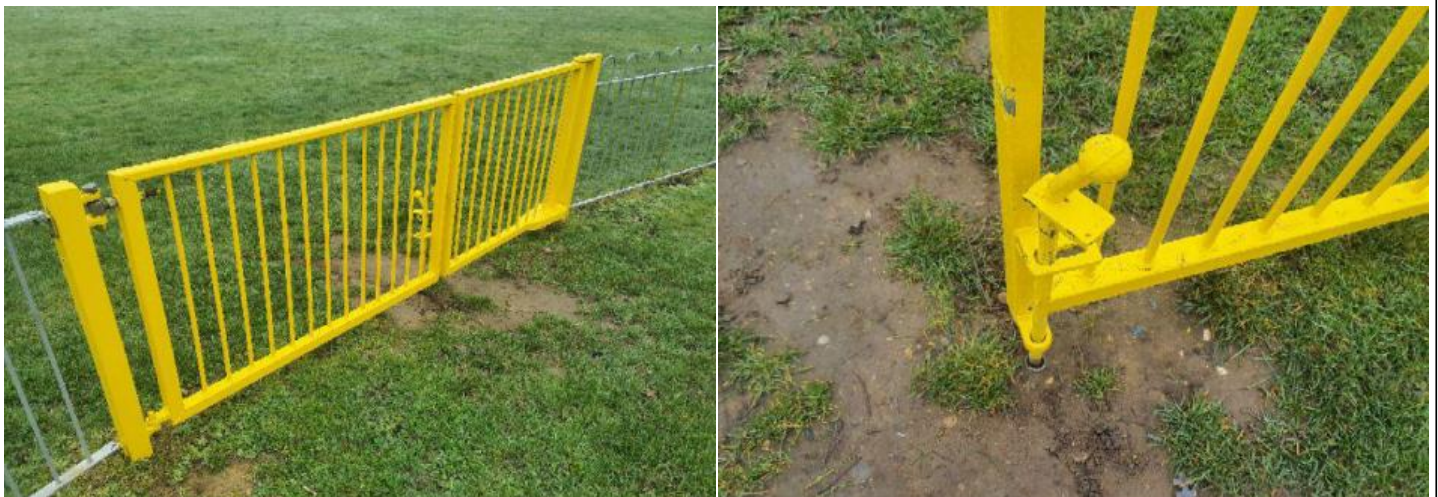
**Item:** Gates - Gate - Combination  
**Manufacturer:** I.A.E. Fencing

**Finding:** There is no padlock on the maintenance gate  
**Action:** Provide a padlock to secure the gate

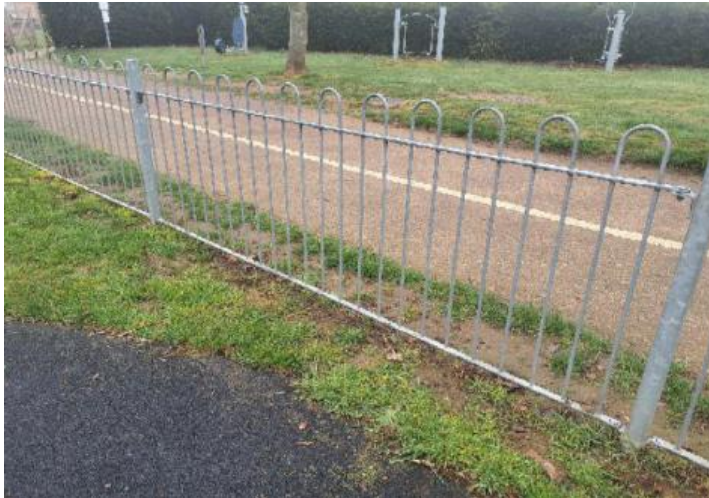
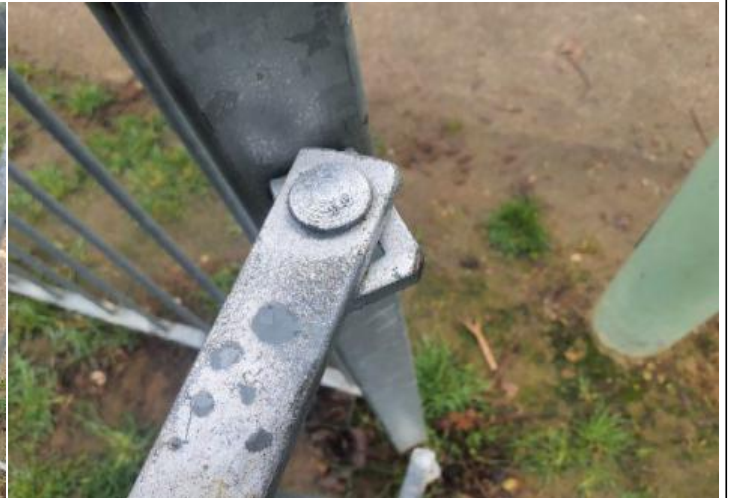
**Item:** Fences - Fence - Bow Top  
**Manufacturer:** Not Identified

**Finding:** There are sharp projections on the corners of the fence line

**Action:** Remove sharp protrusions

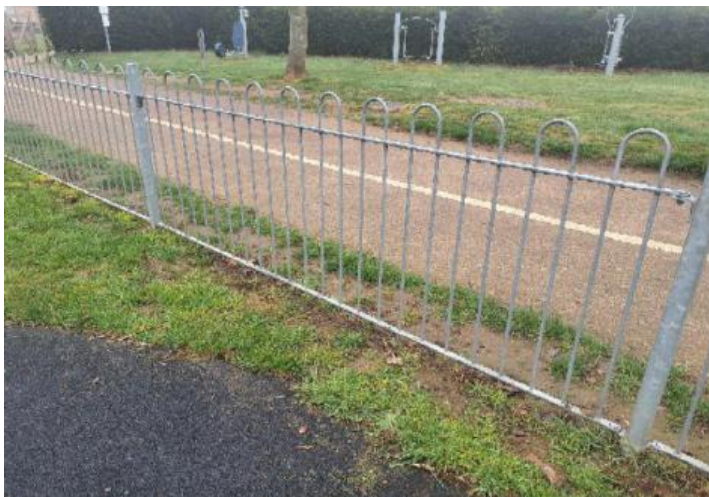
**Item:** Fences - Fence - Bow Top  
**Manufacturer:** Not Identified

**Finding:** There are holes in the surface that may cause users to trip or roll ankles

**Action:** Infill to provide a sound reasonably level surface.

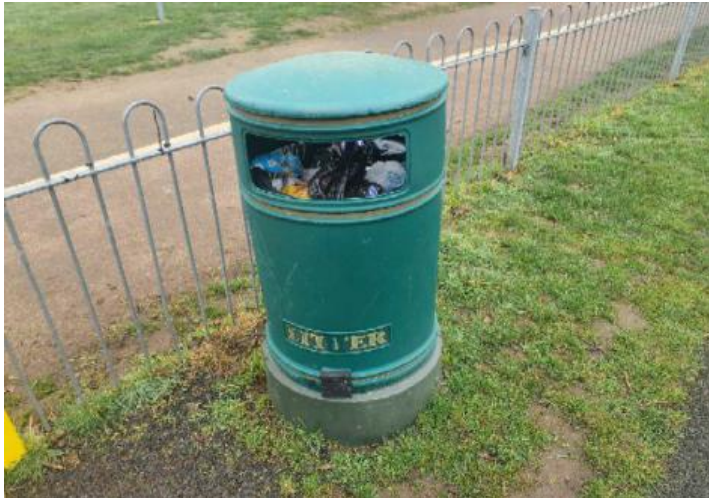
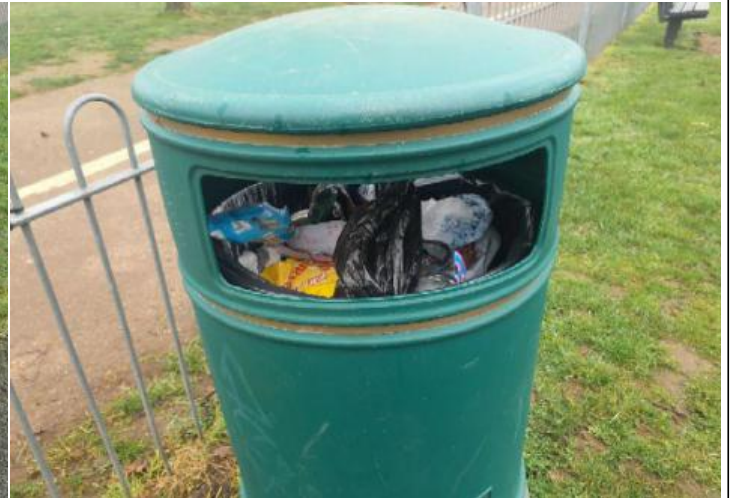
**Item:** Ancillary Items - Litter Bin  
**Manufacturer:** Not Identified

**Finding:** The litter bin is full

**Action:** Empty and review the collection routine

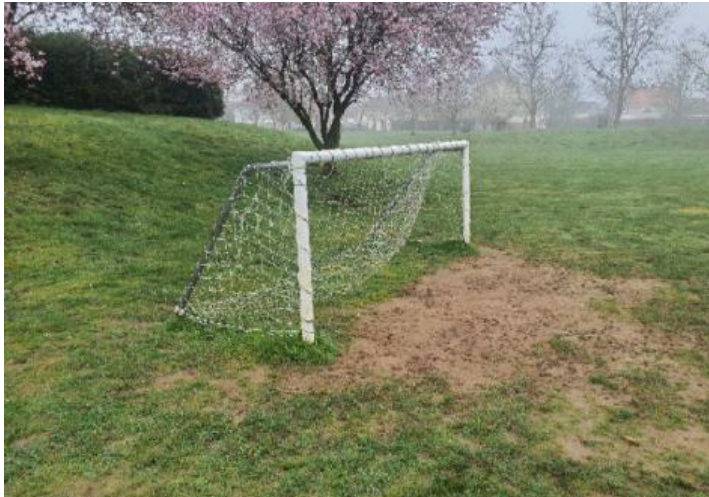
**Item:** Multi Use Games Area - 5 a side Goals  
**Manufacturer:** Not Identified

**Finding:** The surface has eroded in some areas and may be slippery in wet conditions

**Action:** Reinstate the surface

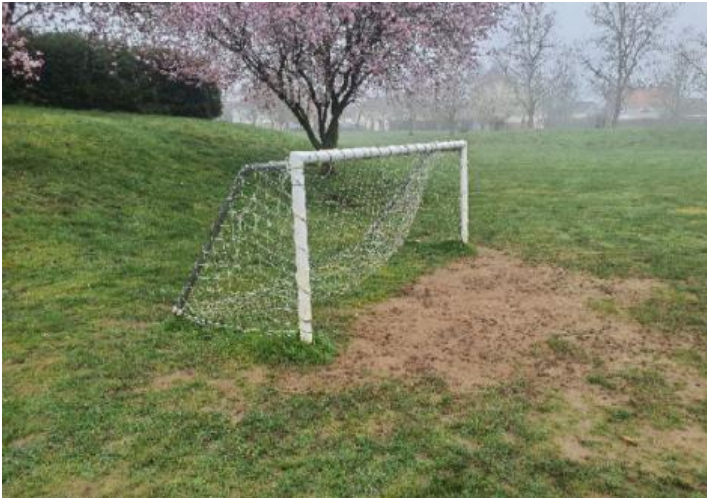
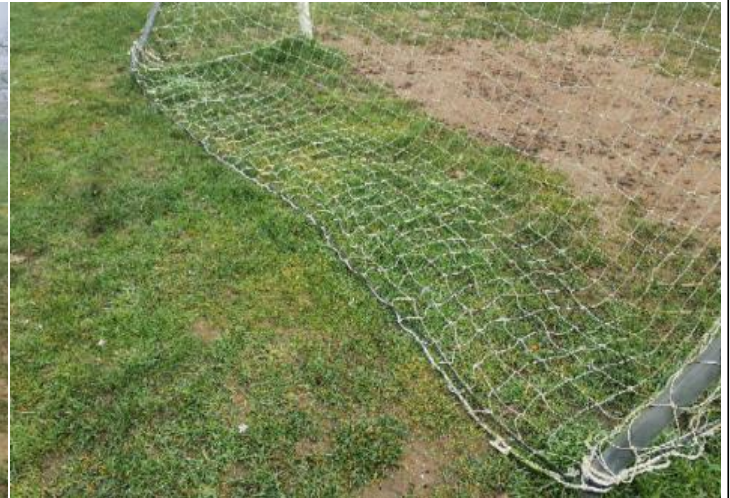
**Item:** Multi Use Games Area - 5 a side Goals  
**Manufacturer:** Not Identified

**Finding:** The net isn't fully secured

**Action:** Secure net

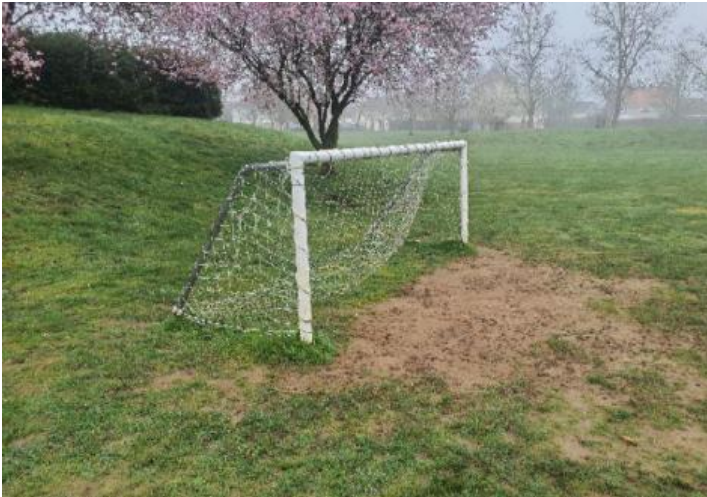
**Item:** Multi Use Games Area - 5 a side Goals  
**Manufacturer:** Not Identified

**Finding:** The paintwork on this item has been damaged or worn exposing the metal underneath which is rusting / corroding

**Action:** Treat affected areas and repaint

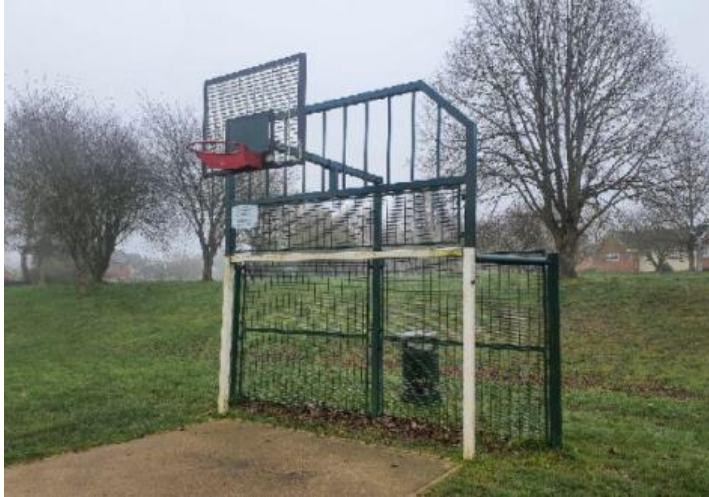
**Item:** Multi Use Games Area - Goalmouth and Basketball Post  
**Manufacturer:** Monster Play Systems

**Finding:** A clearly visible facility sign should be provided in a prominent position with the wording as detailed BS EN 15312- the equipment is not intended for children less than 3 years old- the warning - Do not climb on the framework or nets- the warning - Do not hang on the ring (if provided)- the warning - Do not wear rings or other jewellery- name and telephone number of the administrator- number to call in case of accident

**Action:** Provide signage to BS EN 15312

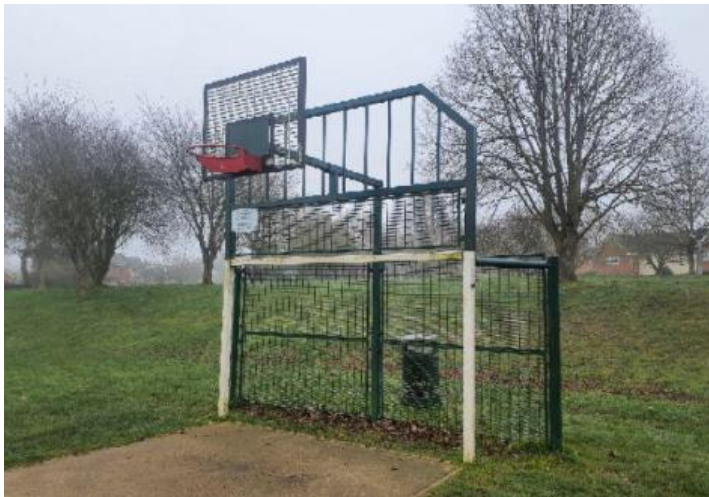
**Item:** Multi Use Games Area - Goalmouth and Basketball Post  
**Manufacturer:** Monster Play Systems

**Finding:** The surface has eroded in some areas and may be slippery in wet conditions **Action:** Reinstate the surface

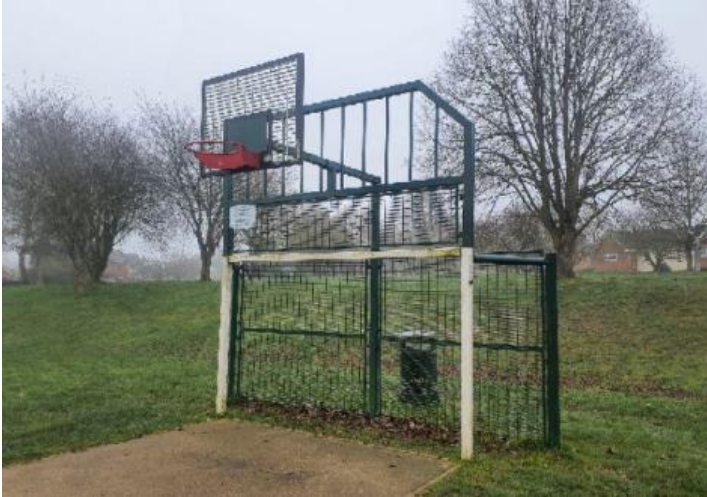
**Item:** Multi Use Games Area - Goalmouth and Basketball Post  
**Manufacturer:** Monster Play Systems

**Finding:** The weld(s) on this item have failed

**Action:** Repair item

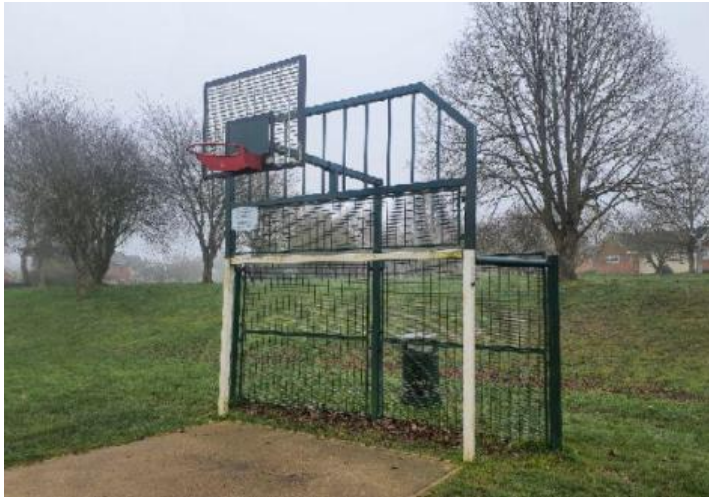
**Item:** Multi Use Games Area - Goalmouth and Basketball Post  
**Manufacturer:** Monster Play Systems

**Finding:** Insert/s missing or damaged

**Action:** Replace

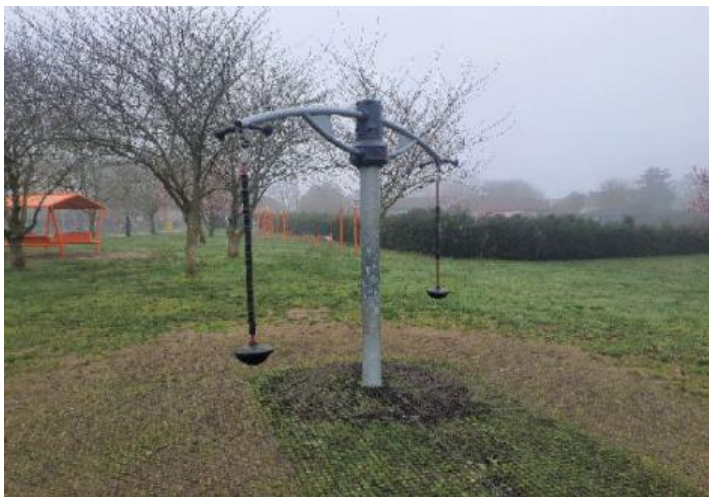
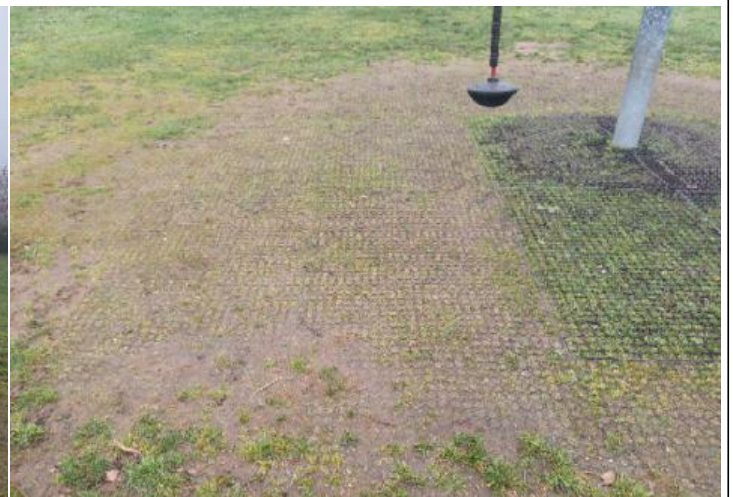
**Item:** Rotor Play - Overhead Rotator  
**Manufacturer:** Kompan Ltd

**Finding:** The grass mats are silted up, the soil is compacted and the area will become very slippery when the soil is wet. **Action:** Reinstate as required

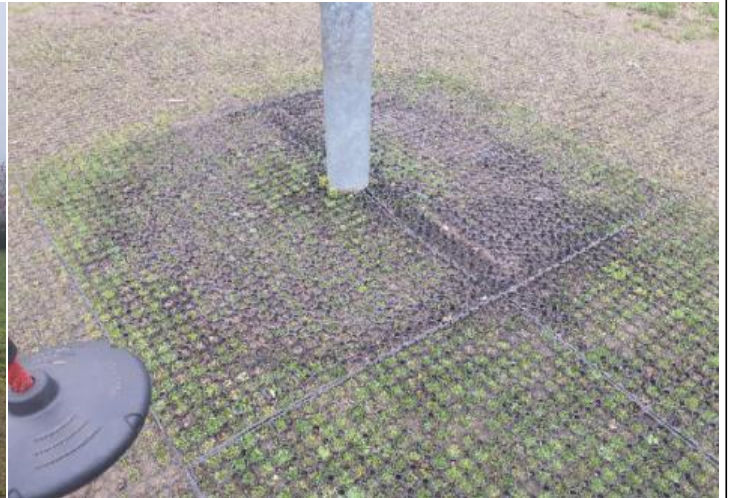
**Item:** Rotor Play - Overhead Rotator  
**Manufacturer:** Kompan Ltd

**Finding:** There is a lack of growth within the grass area

**Action:** Encourage growth with grass seeds

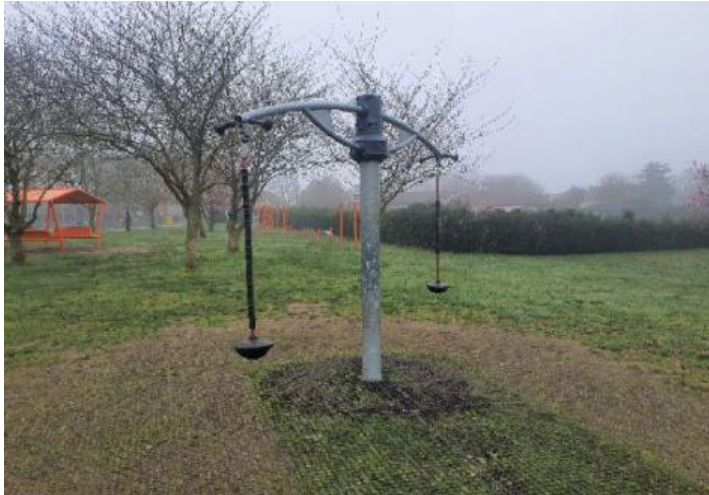
**Item:** Rotor Play - Overhead Rotator  
**Manufacturer:** Kompan Ltd

**Finding:** There is or are fixings missing from one of the suspensions (The inspector taped the item at the time of inspection as a temporary measure but further action is required asap)

**Action:** Replace all missing fixings

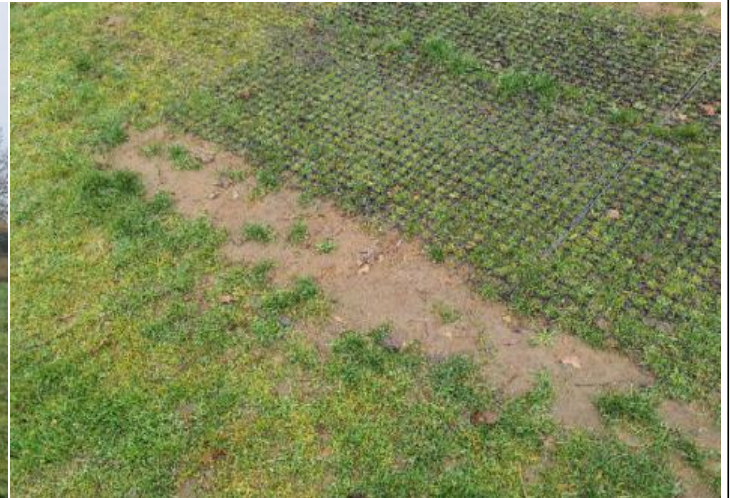
**Item:** Swings - Giant Rope Swing  
**Manufacturer:** Kompan Ltd

**Finding:** The grass has eroded within the impact area of the equipment and may not provide the necessary impact attenuating properties for the equipment fall height; the surface may also be slippery in wet weather  
**Action:** Reinstate the grass or provide an all weather surface

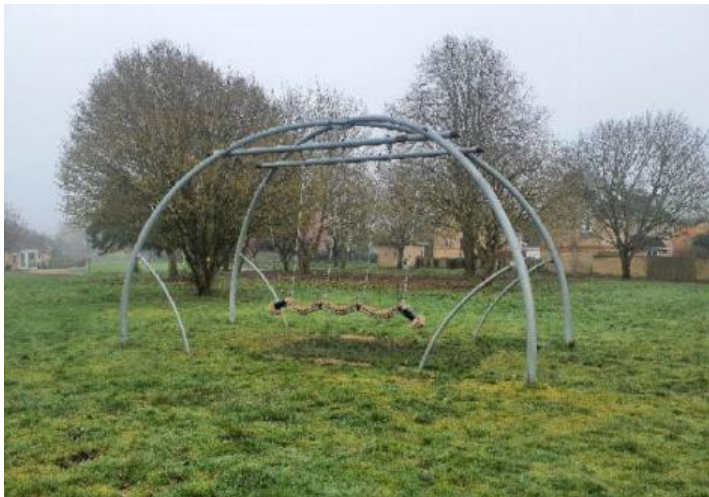
**Item:** Swings - Giant Rope Swing  
**Manufacturer:** Kompan Ltd

**Finding:** Bolt cap cover/s missing or damaged  
**Action:** Replace

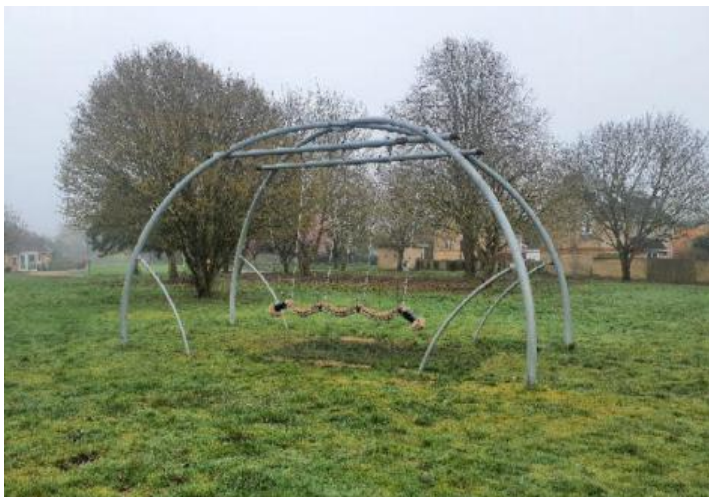
**Item:** Swings - Giant Rope Swing  
**Manufacturer:** Kompan Ltd

**Finding:** There is some notable evidence of chain wear

**Action:** Monitor for any further deterioration and replace when 40% worn

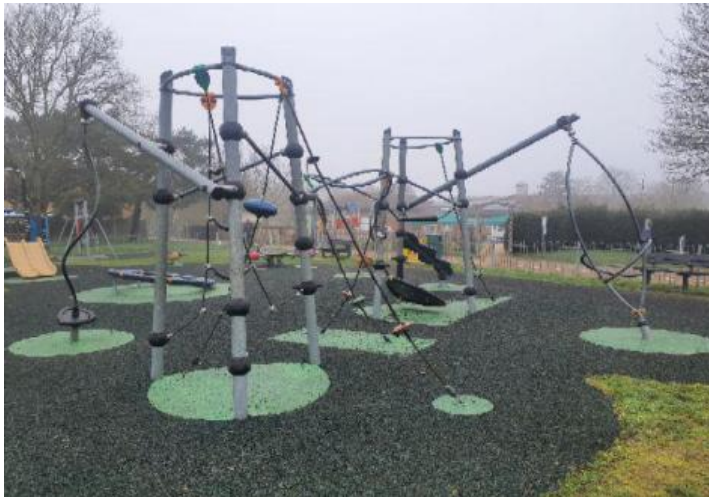
**Item:** Activity Equipment - Climbing Frame  
**Manufacturer:** Kompan Ltd

**Finding:** There is some notable evidence of chain wear

**Action:** Monitor for any further deterioration and replace when 40% worn

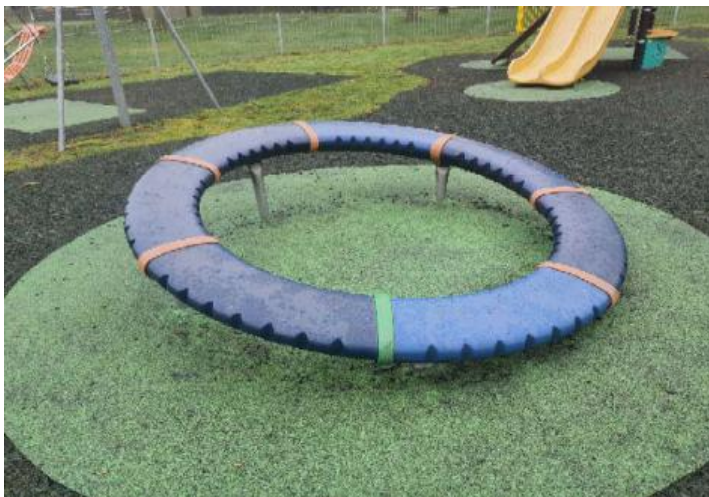
**Item:** Rotor Play - Supernova  
**Manufacturer:** Kompan Ltd

**Finding:** The clearance to the underside less than 117mm and does not meet the manufacturers recommendations

**Action:** Monitor - No action given the risk assessment

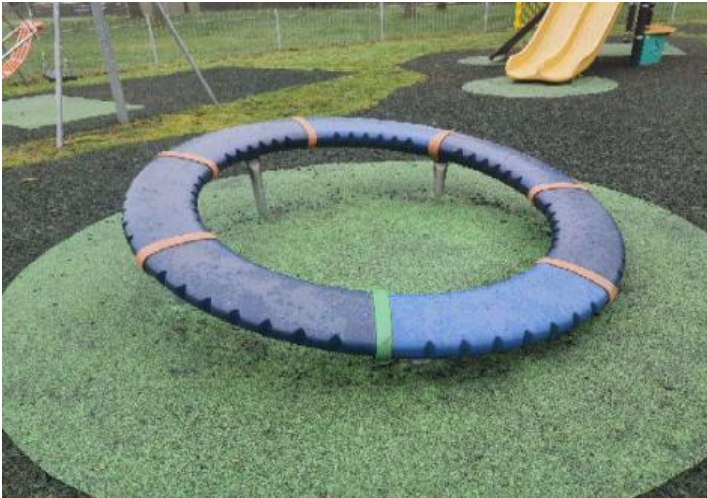
**Item:** Rotor Play - Supernova  
**Manufacturer:** Kompan Ltd

**Finding:** The item has been damaged

**Action:** Monitor for any further deterioration and replace as required

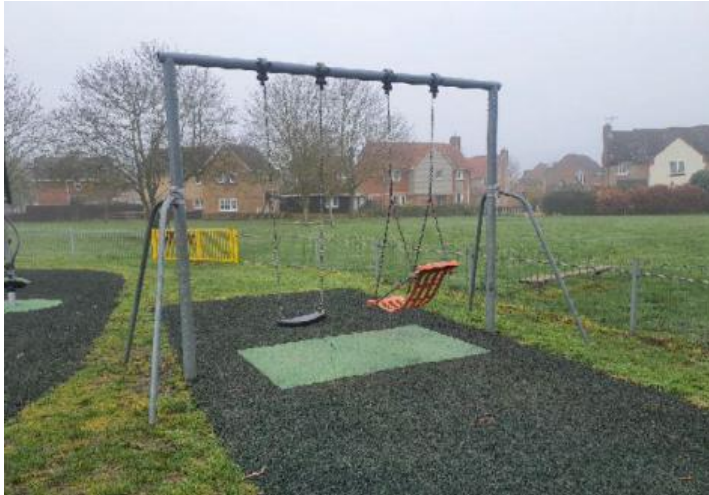
**Item:** Swings - 1 Bay 2 Seat (Flat)  
**Manufacturer:** Kompan Ltd

**Finding:** The chain links are worn excessively and require renewing

**Action:** Replace worn chains

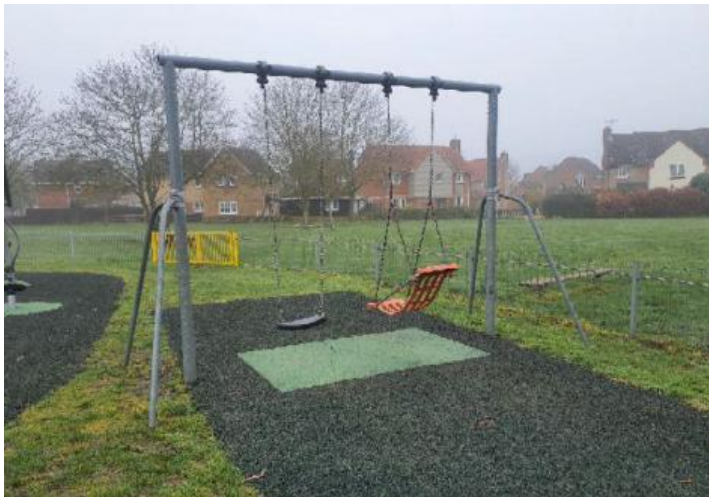
**Item:** Swings - 1 Bay 2 Seat (Flat)  
**Manufacturer:** Kompan Ltd

**Finding:** There is some notable evidence of chain wear

**Action:** Monitor for any further deterioration and replace when 40% worn

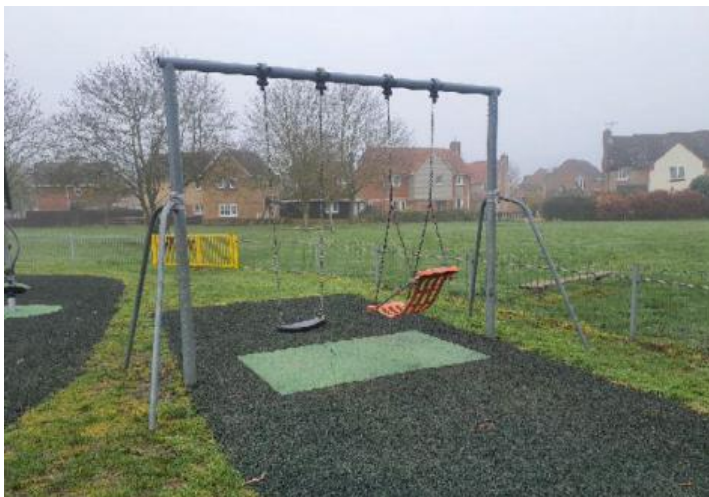
**Item:** Swings - 1 Bay 2 Seat (Flat)  
**Manufacturer:** Kompan Ltd

**Finding:** The connecting links are in excess of 8.6mm and less than 12mm and fail the requirements of BS EN 1176 Part 1; clause 4.2.13, Chains  
**Action:** Monitor use and replace with compliant links at the next maintenance cycle

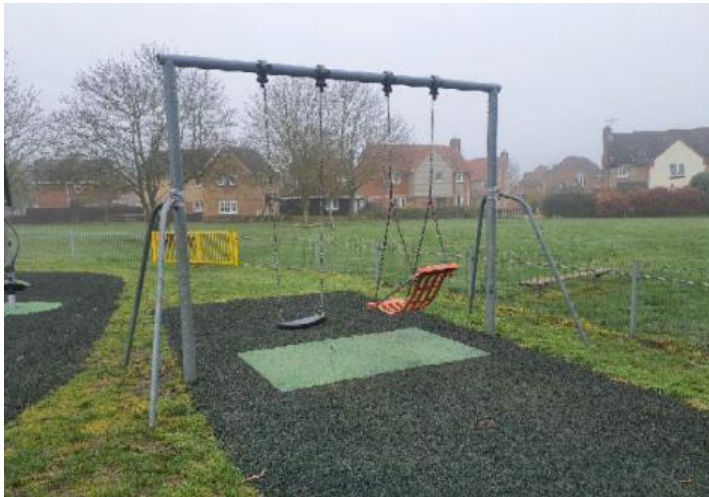
**Item:** Swings - 1 Bay 2 Seat (Flat)  
**Manufacturer:** Kompan Ltd

**Finding:** The suspension lugs are showing signs of wear

**Action:** Monitor for any further deterioration and repair as required

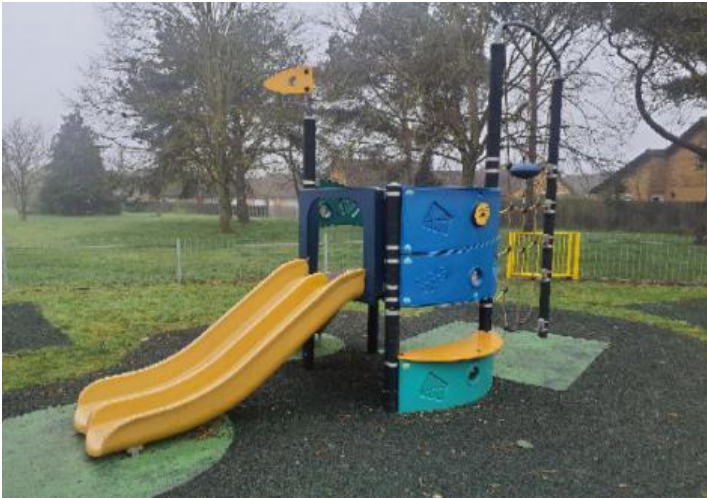
**Item:** Activity Equipment - Multi Play (Junior)  
**Manufacturer:** Kompan Ltd

**Finding:** The item has been damaged

**Action:** Monitor for any further deterioration and replace as required

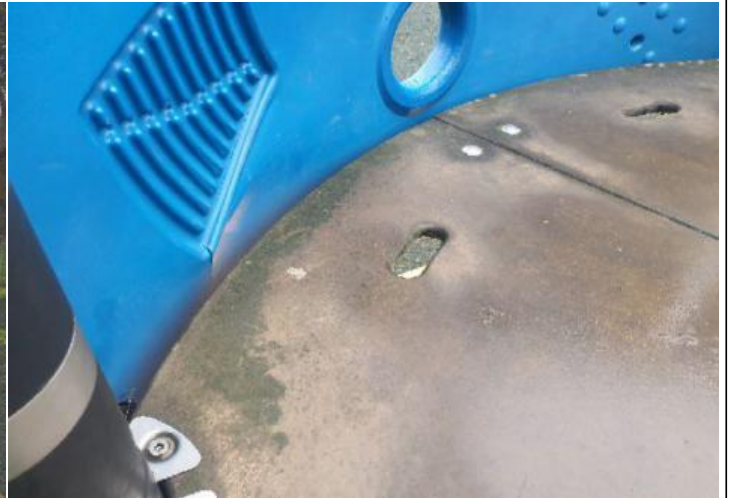
**Item:** Activity Equipment - Multi Play (Junior)  
**Manufacturer:** Kompan Ltd

**Finding:** There is algae or moss on the surface of the equipment

**Action:** Clean and treat appropriately

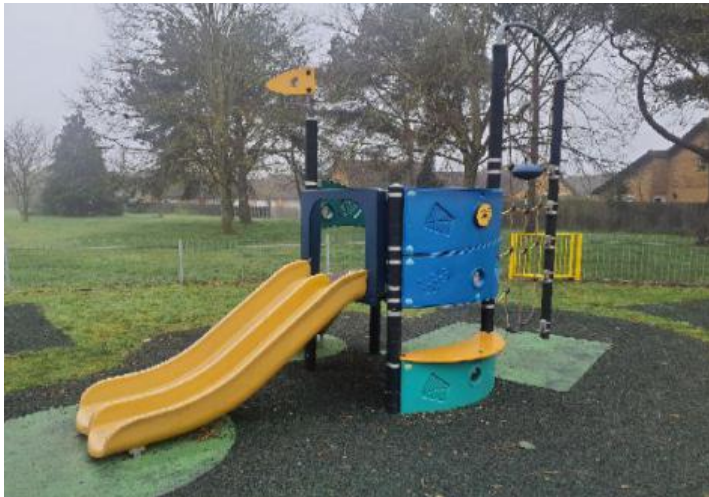
**Item:** Activity Equipment - Multi Play (Junior)  
**Manufacturer:** Kompan Ltd

**Finding:** The item has missing component(s)

**Action:** Replace missing components
