## Annual Inspection

Mid Suffolk District Council

Thurston - Thedwastre Park

Adj to New Green Centre, Station Hill, Thurston, Suffolk,  
IP31 3QU

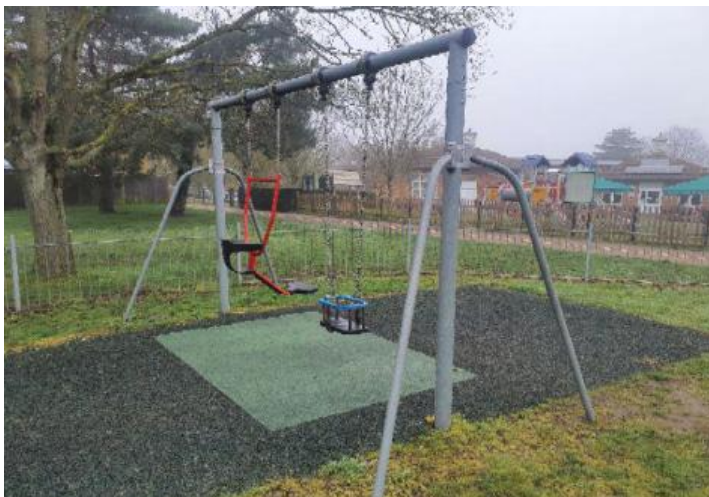
**Item:** Swings - 1 Bay 2 Seat (Cradle)  
**Manufacturer:** Kompan Ltd

**Finding:** The chain openings are in excess of 8.6mm and do not meet the recommendations of BS EN 1176 Part 1

**Action:** Monitor - No action given the risk assessment

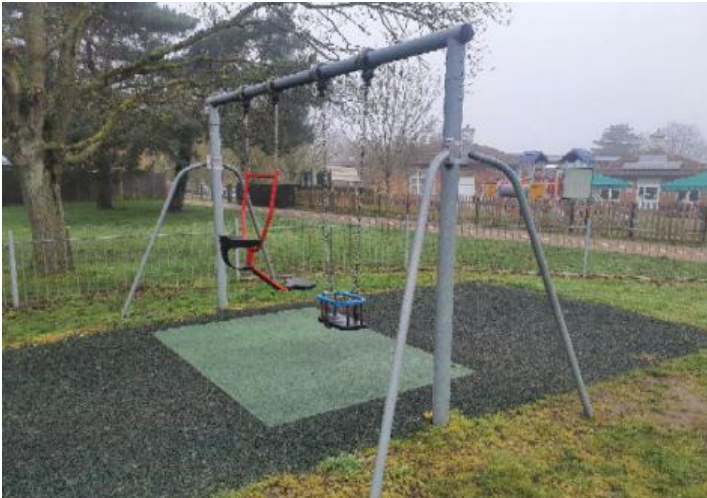
**Item:** Swings - 1 Bay 2 Seat (Cradle)  
**Manufacturer:** Kompan Ltd

**Finding:** There is some notable evidence of chain wear

**Action:** Monitor for any further deterioration and replace when 40% worn

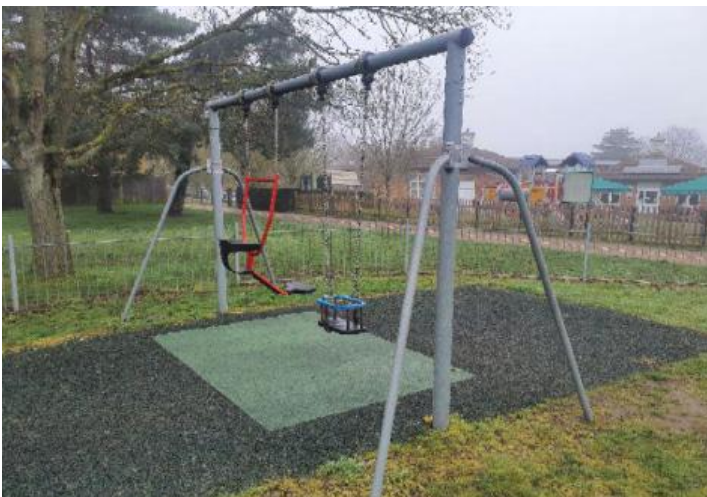
**Item:** Swings - 1 Bay 2 Seat (Cradle)  
**Manufacturer:** Kompan Ltd

**Finding:** The suspension lugs are showing signs of wear

**Action:** Monitor for any further deterioration and repair as required

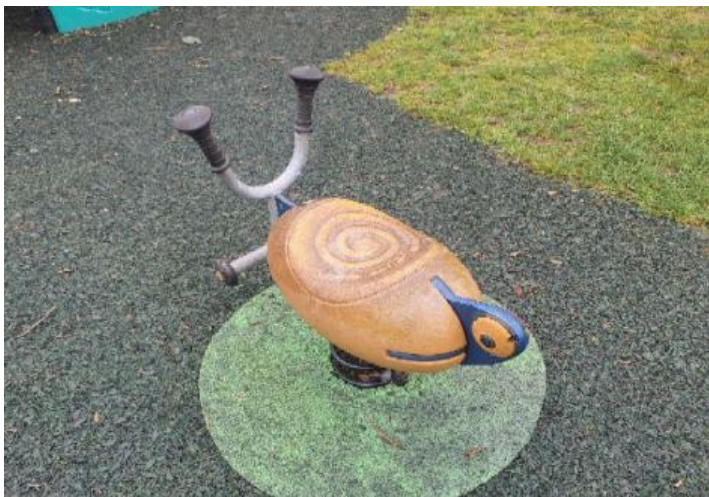
**Item:** Rocking Equipment - Spring Bug  
**Manufacturer:** Kompan Ltd

**Finding:** The seat has minor damage or wear

**Action:** Monitor for any further deterioration and replace as required

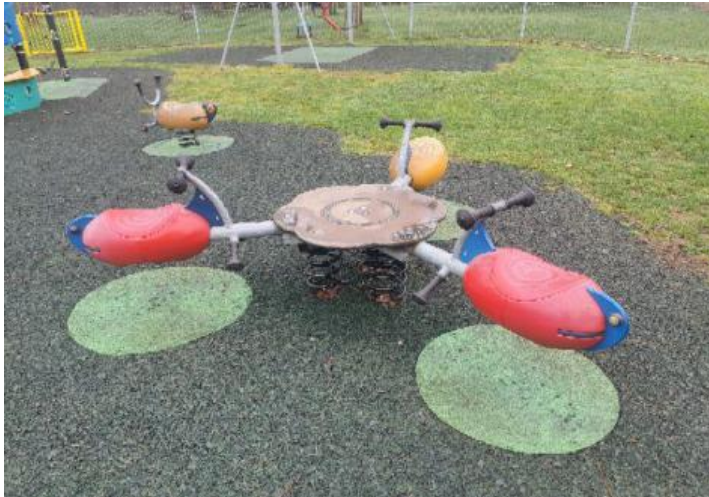
**Item:** Rocking Equipment - Three Way Springer  
**Manufacturer:** Kompan Ltd

**Finding:** The item has been damaged

**Action:** Monitor for any further deterioration and replace as required

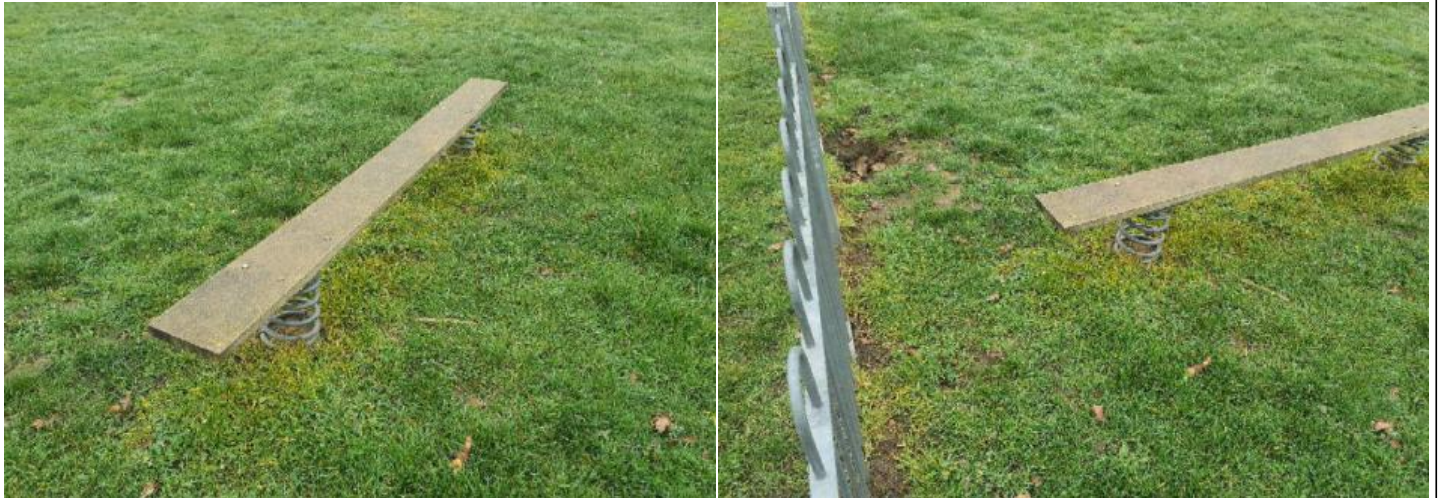
**Item:** Rocking Equipment - Wobble Board  
**Manufacturer:** Not Identified

**Finding:** The fence forms a hard object within the falling space of the equipment and there is also insufficient surfacing provided in contravention of BS EN 1176 Part 1

**Action:** Consider re locating the item away from the fence (1.5m)
