the **play inspection** company

Annual Inspection

Mid Suffolk District Council

Thurston Playing Field

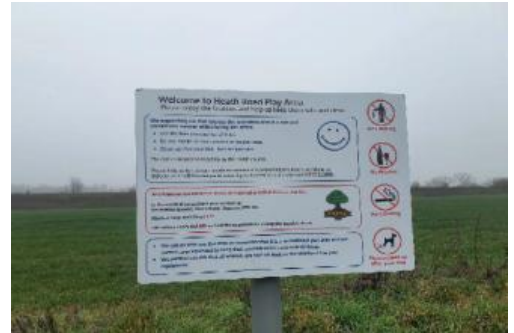
Item: Sign
Manufacturer: Not Identified
Surface Type: N/A
Item Quantity: 2
Equipment Compliance: N/A
Surface Area Compliance: N/A

This item is satisfactory - no work required -

i 8 - Low Risk

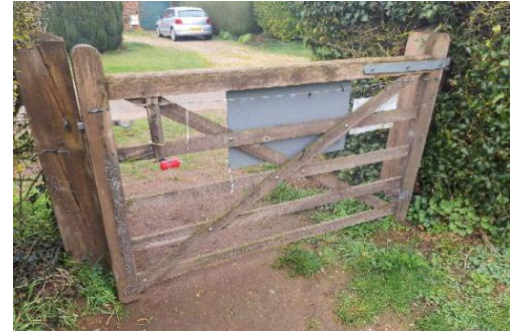
Item: Gate
Manufacturer: Not Identified
Surface Type: Grass
Item Quantity: 1
Equipment Compliance: N/A
Surface Area Compliance: N/A

The surface has eroded in some areas and may be slippery in wet conditions - Reinstate the surface

i 8 - Low Risk

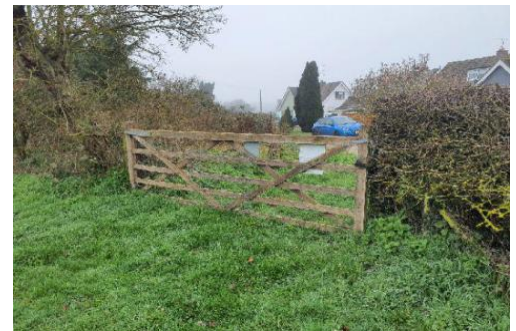
Item: Gate - Maintenance
Manufacturer: Not Identified
Surface Type: Grass
Item Quantity: 1
Equipment Compliance: N/A
Surface Area Compliance: N/A

The mesh is damaged - Replace

The fence is severely damaged in places - Repair or replace all affected sections

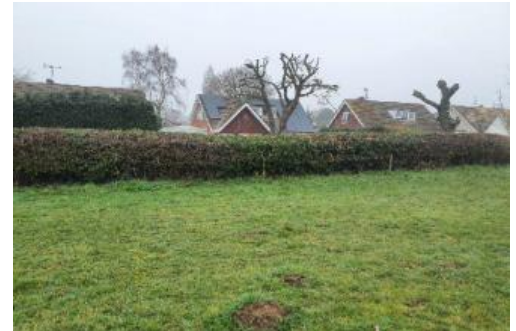
Item: Hedge
Manufacturer: Natural Feature
Surface Type: Grass
Item Quantity: 1
Equipment Compliance: N/A
Surface Area Compliance: N/A

This item is satisfactory - no work required -

i 6 - Low Risk

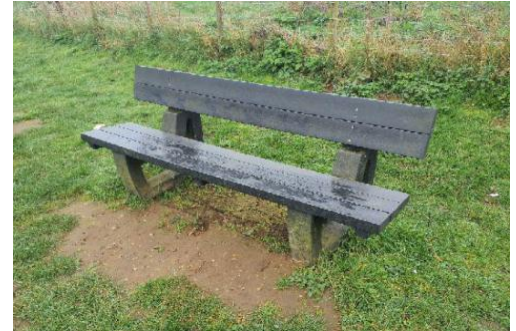
Item: Bench
Manufacturer: Not Identified
Surface Type: Concrete
Item Quantity: 1
Equipment Compliance: N/A
Surface Area Compliance: N/A

The surface has eroded in some areas and may be slippery in wet conditions - Reinstate the surface

i 4 - Very Low Risk

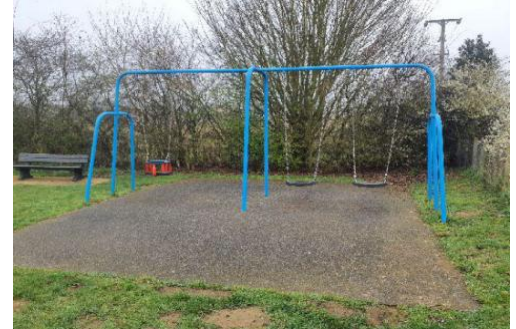
Item: 2 Bay (2 Flat, 2 Cradle)
Manufacturer: Not Identified
Surface Type: Wet Pour
Item Quantity: 1
Equipment Compliance: Yes
Surface Area Compliance: No
Life Expectancy: 5 -10 Years
Total Findings: 11

The seat(s) and suspension were missing at the time of inspection and the inspector was unable to make a full compliance assessment - Replace missing seat(s) and suspension(s) (subject to any other findings needing correction)

There are trip hazards at the edges of the surface - Remove trip hazard

There is algae, silt or moss growth on the surface resulting in slippery conditions - Clean and treat appropriately

There are gaps opening between the surfacing and the edging surround or between the joints in the surfacing - Monitor for any further deterioration and repair as required

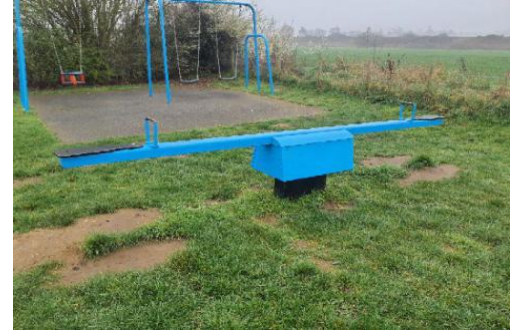
Item: See Saw
Manufacturer: Wicksteed Playgrounds
Surface Type: Grass
Item Quantity: 1
Equipment Compliance: No
Surface Area Compliance: Yes
Life Expectancy: 5 -10 Years
Total Findings: 2

The surface has eroded in some areas and may be slippery in wet conditions - Reinstate the surface

i 9 - Low Risk

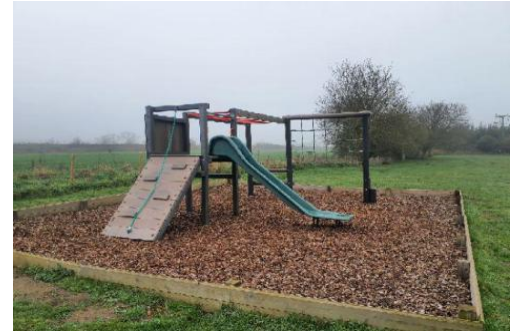
Item: Multi Play (Junior)
Manufacturer: Not Identified
Surface Type: Bark Mulch
Item Quantity: 1
Equipment Compliance: No
Surface Area Compliance: No
Life Expectancy: 5 -10 Years
Total Findings: 12

The depth of the loose fill surfacing is lower than the recommended depth specified in BS EN 1176 for a fall height over 2.0m. A minimum depth of 400mm is recommended (including an extra 100mm to allow for compaction and displacement as per BS EN 1176 Part 1 - Table 4) - Top up loosefill to recommended levels

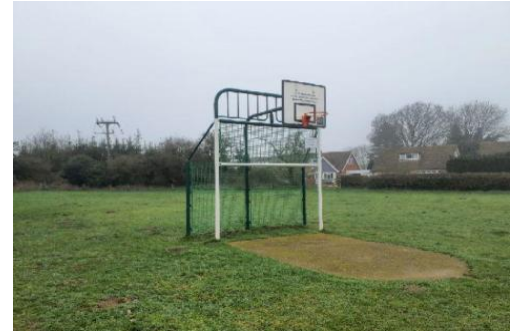
Item: Basketball Goal
Manufacturer: Playquest
Surface Type: Grass
Item Quantity: 1
Equipment Compliance: Yes
Surface Area Compliance: N/A
Life Expectancy: 5 -10 Years
Total Findings: 4

Finding 1
 There is algae, silt or moss growth on the surface resulting in slippery conditions - Clean and treat appropriately

Finding 2
 A number of fixing(s) have worked loose - Secure all loose fixings

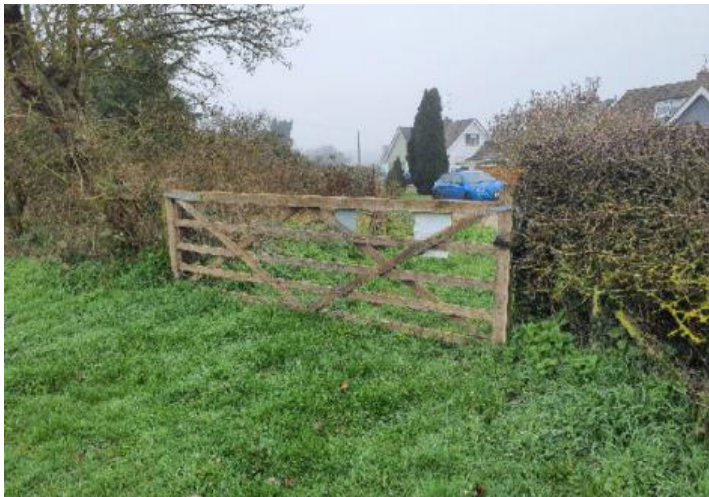
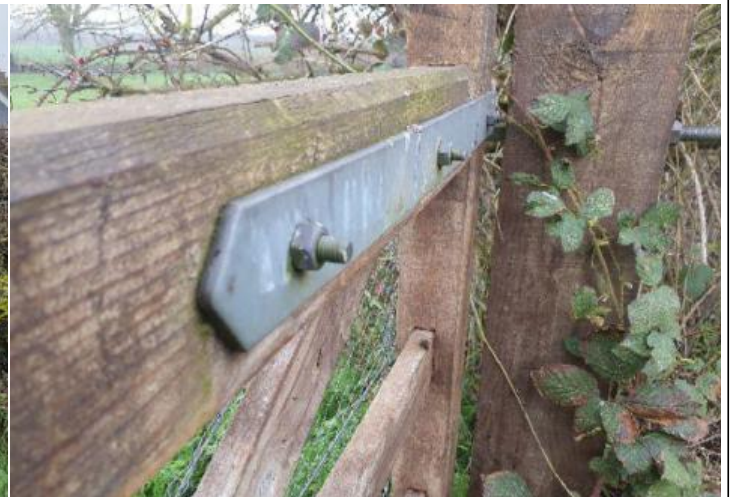
Item: Gates - Gate - Maintenance
Manufacturer: Not Identified

Finding: There are projecting bolt thread(s) present

Action: Remove excess thread length and deburr or provide cap

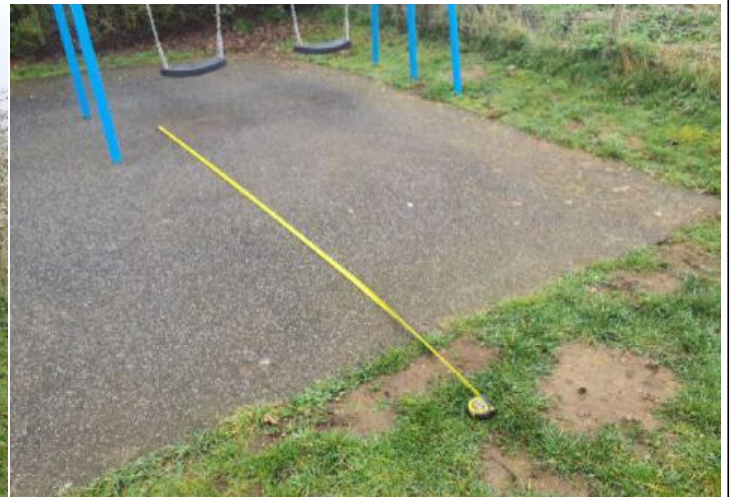
Item: Swings - 2 Bay (2 Flat, 2 Cradle)
Manufacturer: Not Identified

Finding: The kerb forms a hard object within the impact area of the equipment in contravention of the requirements of BS EN 1176 Part 1

Action: Monitor - No action given the risk assessment

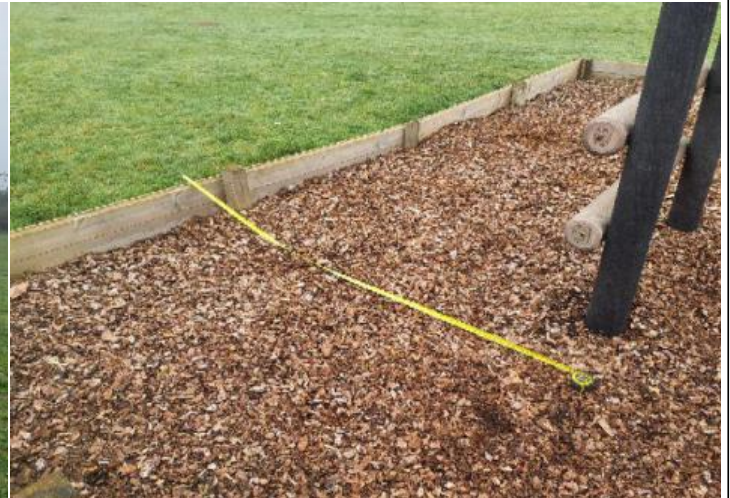
Item: Activity Equipment - Multi Play (Junior)
Manufacturer: Not Identified

Finding: The timber edge forms a hard object within the falling space of the equipment and there is also insufficient surfacing provided in contravention of BS EN 1176 Part 1

Action: Monitor - No action given the risk assessment

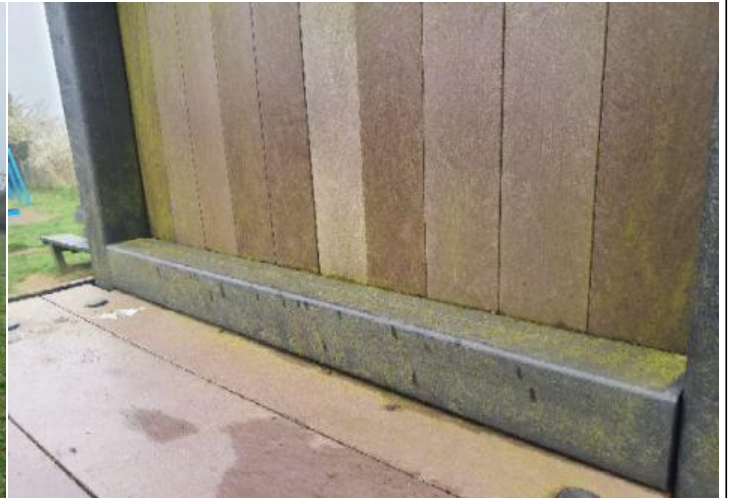
Item: Activity Equipment - Multi Play (Junior)
Manufacturer: Not Identified

Finding: There is algae or moss on the surface of the equipment

Action: Clean and treat appropriately

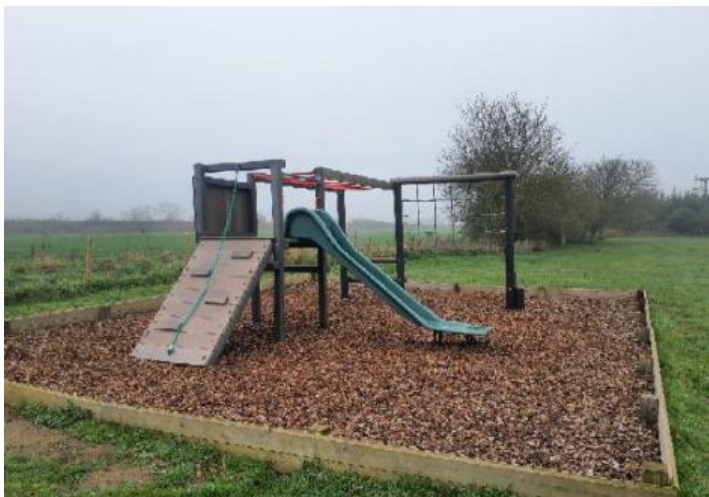
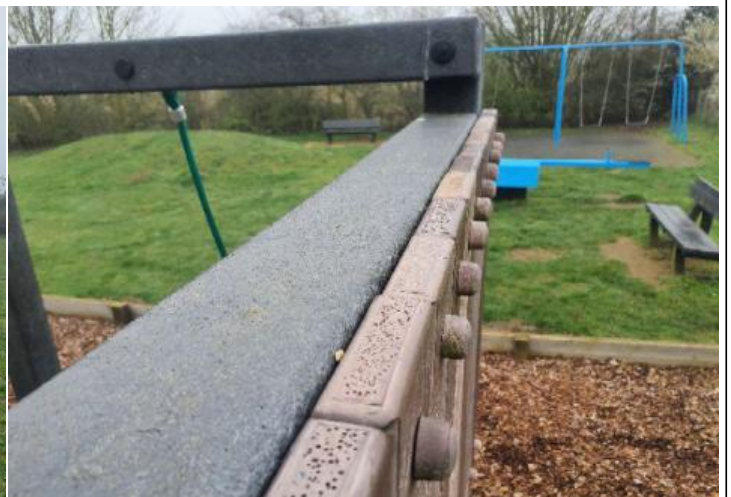
Item: Activity Equipment - Multi Play (Junior)
Manufacturer: Not Identified

Finding: The top of the barrier may encourage standing or sitting, in contravention of the requirements of BS EN 1176 Part 1

Action: Monitor - No action given the risk assessment
