Annual Inspection

Mid Suffolk District Council

Thurston Recreation Ground

Church Road, Thurston, Suffolk, IP31 3RP

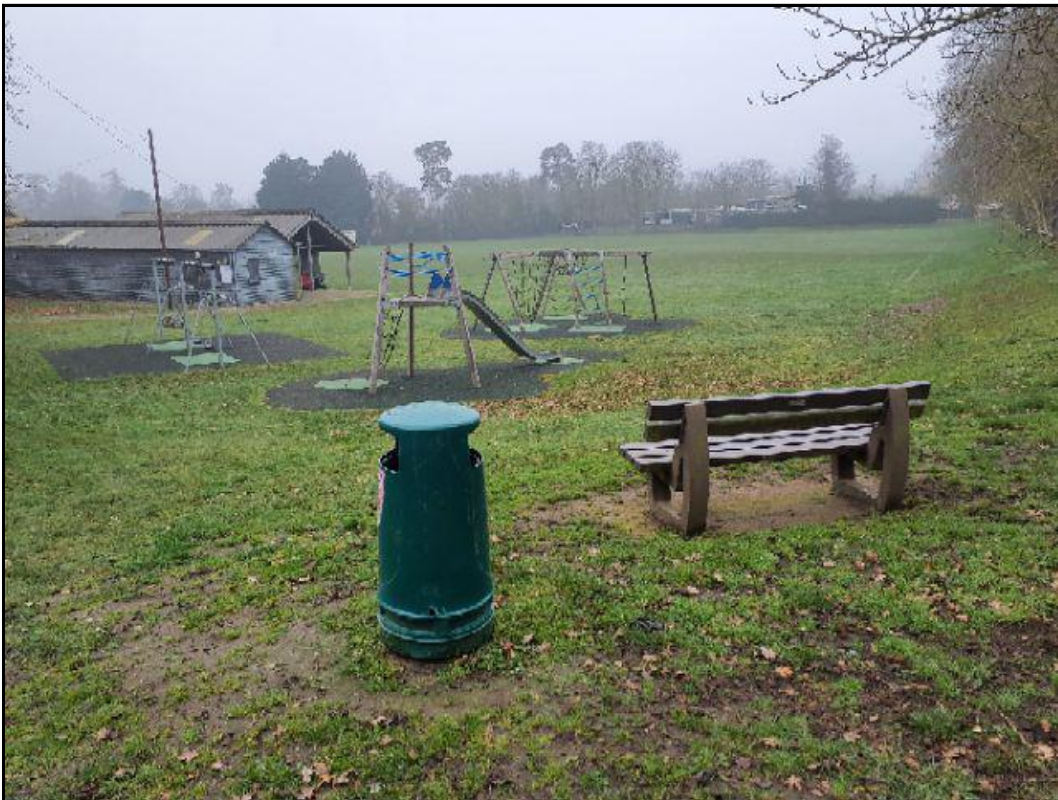
Risk Assessment: 8 Low Risk

The site is located in an area of public open space and is not directly overlooked by any properties in the local community.
